<b>HYUNDAI</b> <b>Technical Service Bulletin</b>	GROUP Fuel System	NUMBER 23-FL-004H
	DATE JUNE 2023	MODEL SONATA (LFA)
<b>SUBJECT:</b>	FUEL PUMP FILTER WARRANTY EXTENSION (TXXS), INSPECTION AND REPLACEMENT

**Description:** Certain 2015-2019MY Sonata (LFA) vehicles may intermittently exhibit reduced engine power, a “Crank/No Start” condition, and/or have DTC P1233 stored in the ECM due to an internally leaking fuel pump filter housing.

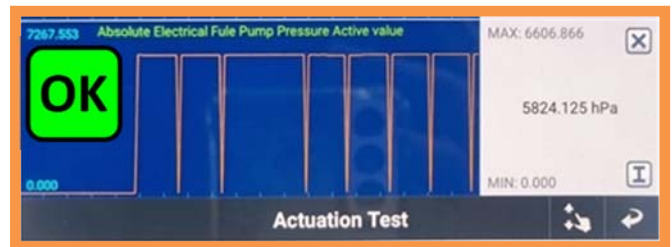
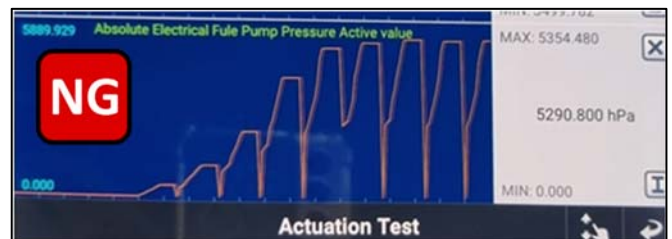
2. Shut engine "OFF" for at least 3 minutes.
3. Afterwards, turn ignition switch to "ON" position.  
**NOTE:** DO NOT start the engine.
4. Using the GDS, select "Data Analysis" and highlight the two items listed on right.
5. Select "Text" and change to "Graph".
6. Select "Actuation Test" tab and "Fuel Pump Relay" item.
7. Start the actuation of the Fuel Pump Relay and observe the "Absolute Electrical Fuel Pump Low Pressure Active Value" on the graph.

- Absolute Electrical Fuel Pump Low Pressure Active Value.
- Absolute Electrical Fuel Pump Low Pressure Set Point.

- **PASS:** Graph displays five (5) or more even and continuous bars of pressure [OK], then no further action is required. **Inspection is complete.** (Continue normal diagnosis of abnormal condition if it still exists.)

- **NO PASS:** Graph displays uneven bars [NG], then follow the **Fuel Filter Replacement** procedure at step 10.

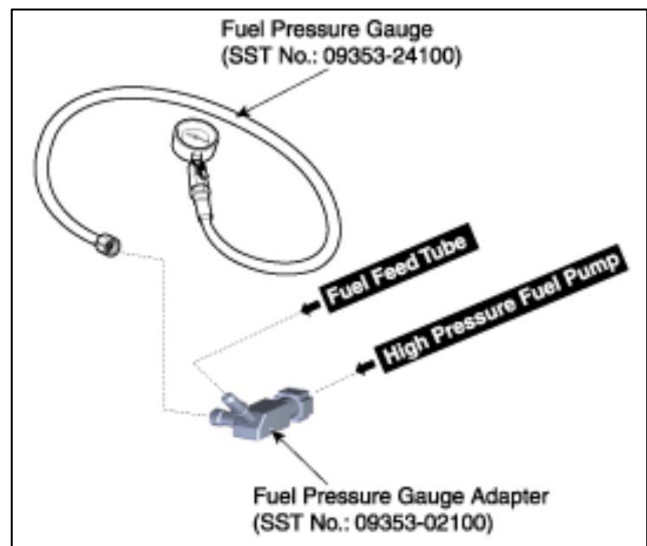
9. Check fuel pressure at idle by referring to the Shop Manual: **Engine Control / Fuel System > Fuel Delivery System > Repair Procedure > Fuel Pressure Test (Low Pressure System),** then shut engine off while monitoring the gauge.

- **PASS:** If fuel pressure gauge reading remains above 14.5 PSI for at least 1 minute, then **inspection is complete**. (Continue normal diagnosis of abnormal condition if it still exists.)

- **NO PASS:** If fuel pressure gauge reading drops below 14.5 PSI within 1 minute, then follow the **Fuel Filter Replacement** procedure at step 10.

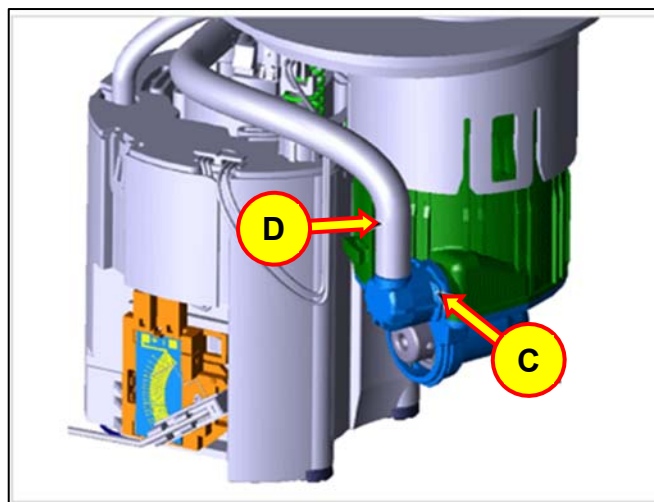
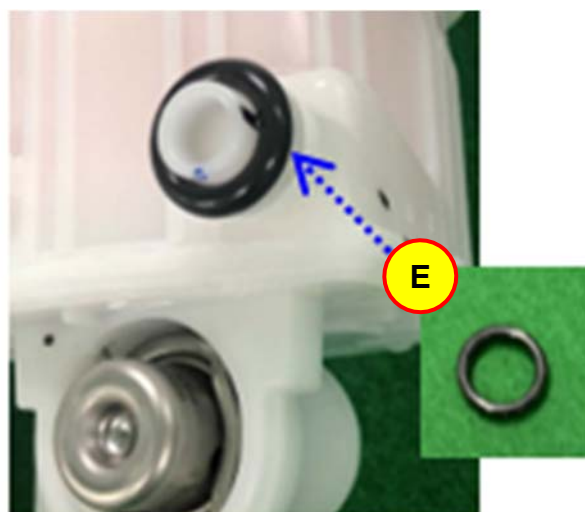
10. Release the residual pressure in fuel line by referring to the Shop Manual: **Engine Control / Fuel System > Fuel Delivery System > Repair Procedure > Release Residual Pressure in Fuel Line**.
11. Remove the fuel pump assembly by referring to the Shop Manual: **Engine Control / Fuel System > Fuel Delivery System > Fuel Pump**.
12. Remove the fixing clip (C) and then disconnect the fuel tube (D).

**NOTE:** Do not discard this O-ring (E). The O-ring shown here must be reused.

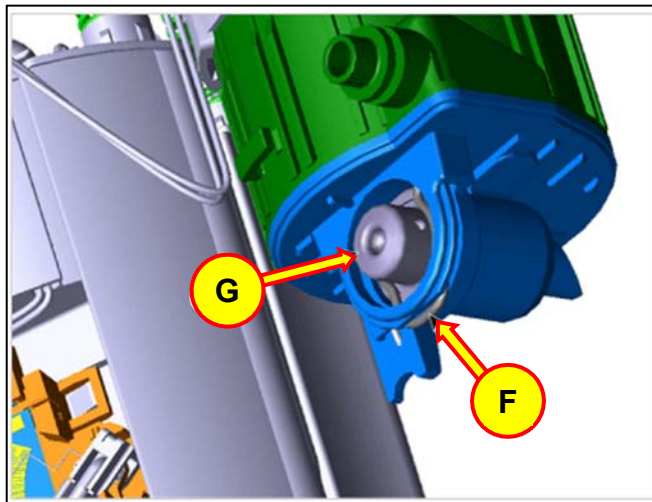
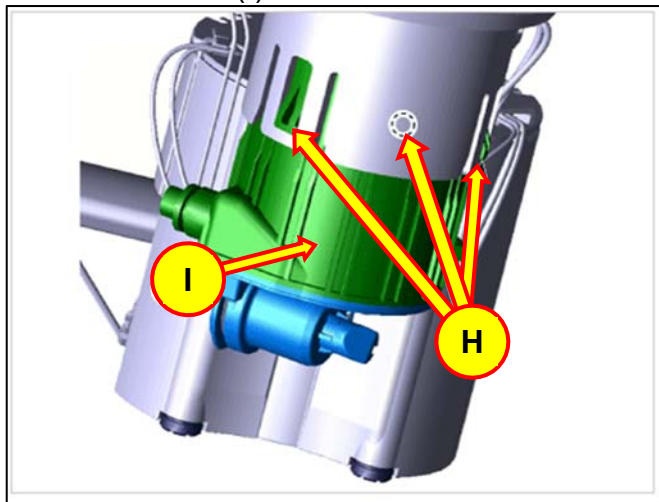
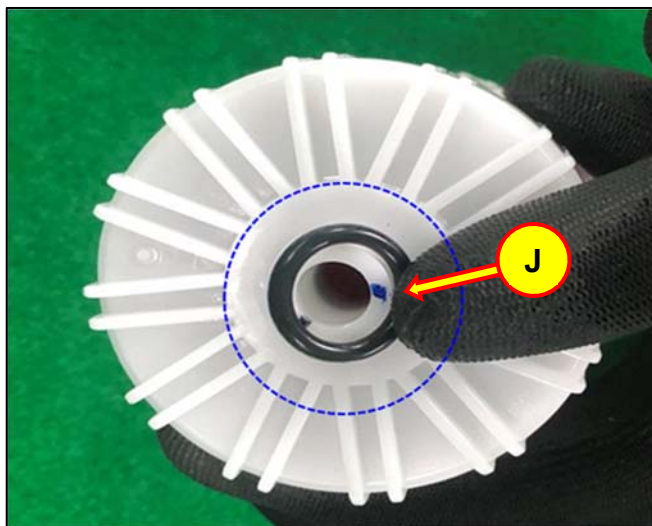
- 13. Remove the fuel pressure regulator-fixing clip (F).
- 14. Remove the fuel pressure regulator (G) from the fuel filter.
- 15. Release the fixing hook (H), and then remove the fuel filter (I).

- When installing the new fuel filter assembly, make sure the orientation of the fixing hook (H) shown in step 15 is correct.
- When reinstalling the fuel pump assembly into the fuel tank, inspect the O-ring (K) for the top plate and reuse. If O-ring appears damaged, then replace with a new part.
  - (O-Ring Part Number: 31123-B9000)

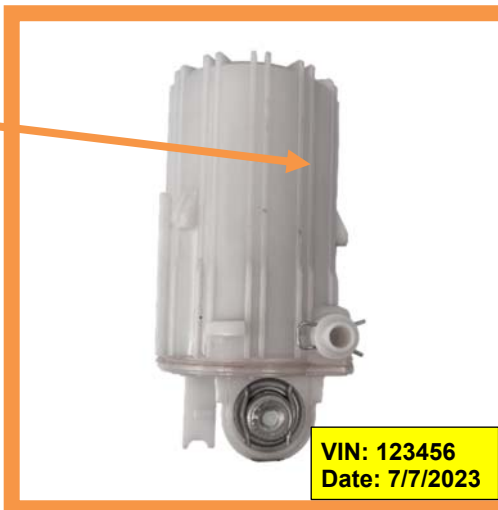
- 16. Remove the O-Ring (J) off the existing fuel filter assembly and install on the new fuel filter assembly.

Using STUI in the GDS, take a picture of the **NEW** fuel filter with last 6-digits of VIN and date of repair on a piece of paper.
