GROUP	MODEL
ENG	2020-2023MY Forte (BDm) w/1.6L T-GDI 6-Speed M/T
NUMBER	DATE
243	June 2023

## TECHNICAL SERVICE BULLETIN

**SUBJECT: LOOSE CRANKSHAFT PULLEY PARTIAL REPAIR**

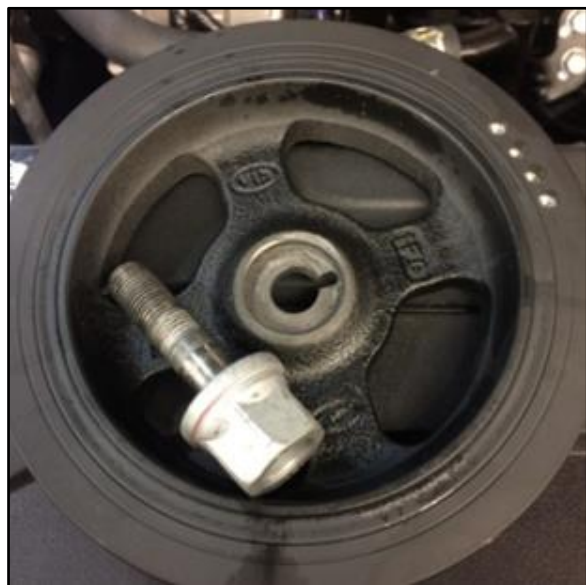
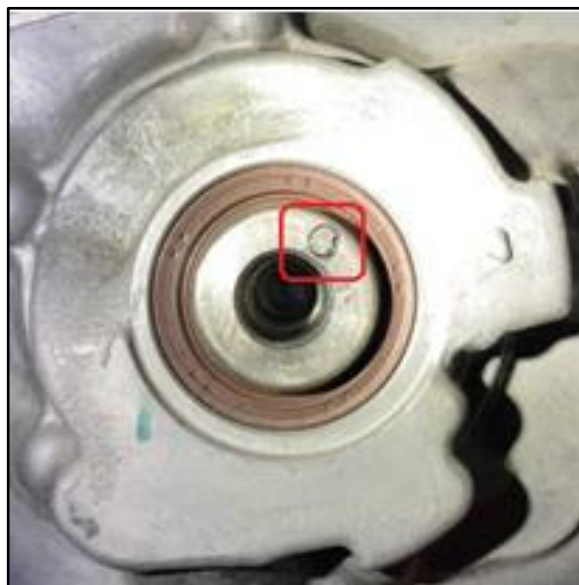
This bulletin provides information regarding a loose crankshaft pulley condition on certain 2020-2023MY Forte (BDm) vehicles equipped with a 1.6L T-GDI and 6-speed manual transmission, produced from May 15, 2019 through present, where excessive engine loads may cause the crankshaft pulley bolt to back out, causing the crankshaft pulley to come loose. If this condition occurs, a loose crankshaft pulley may cause the alignment dowel pin to shear and the crankshaft pulley to separate from the crankshaft. Follow the procedure outlined in this publication to replace the crankshaft pulley, bolt, and alignment dowel pin.

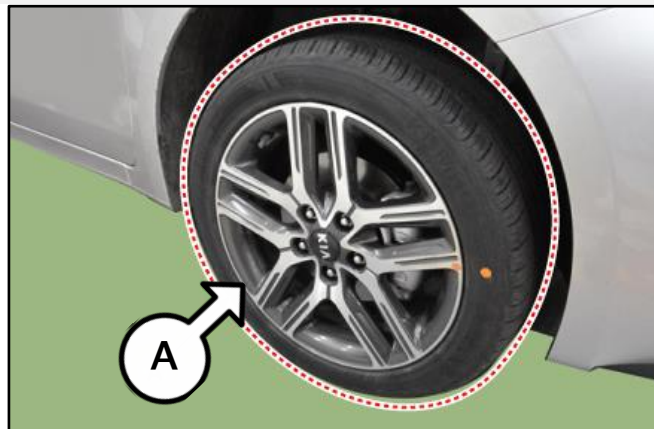
1. Remove the right front wheel (A).

**Note:** If the vehicle is in with a loose crankshaft pulley, it is possible that the drive belt came off. If the crankshaft pulley and belt are still attached, follow the steps below. Otherwise, skip to 4.

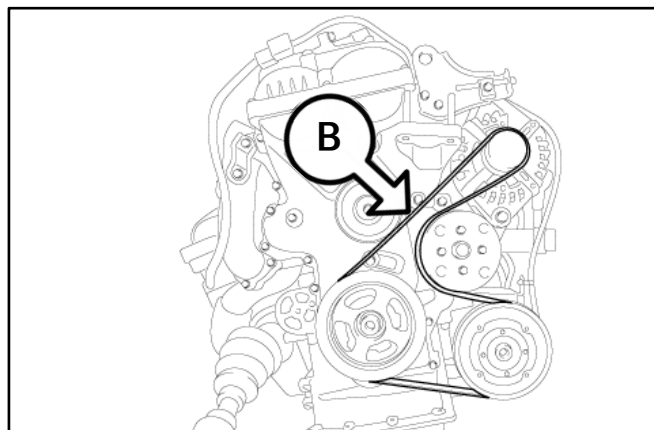
2. **If applicable:** Remove the drive belt (B) by referring to "Maintenance → Powertrain → Drive Belt → Repair procedures" in the applicable Shop Manual on KGIS.

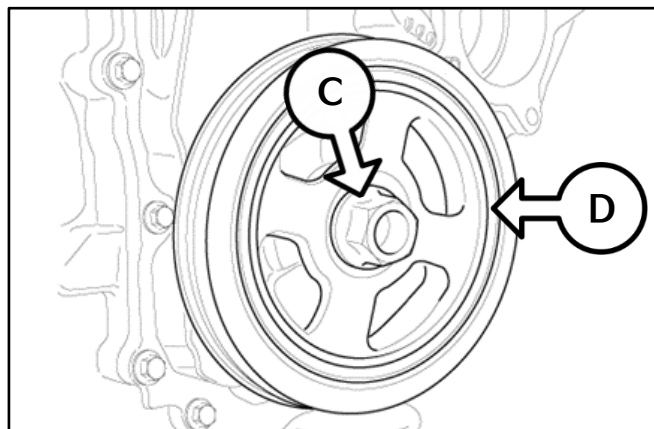
3. **If applicable:** Remove crankshaft bolt (C) to remove the crankshaft pulley (D).

Tightening torque for Crankshaft Bolt (B):  
34.0 - 38.3 lb.ft (46.1 - 52.0 N.m) + 53°

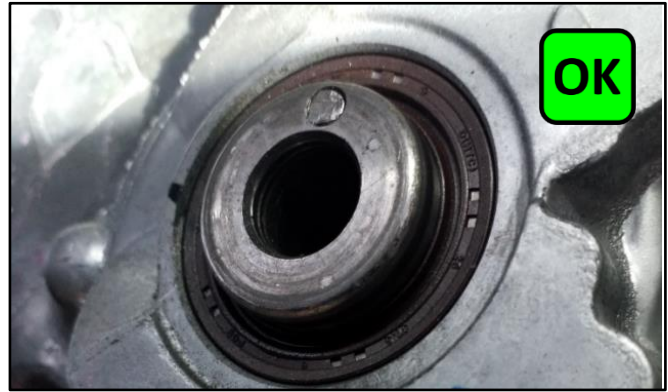
No damage to crankshaft end.

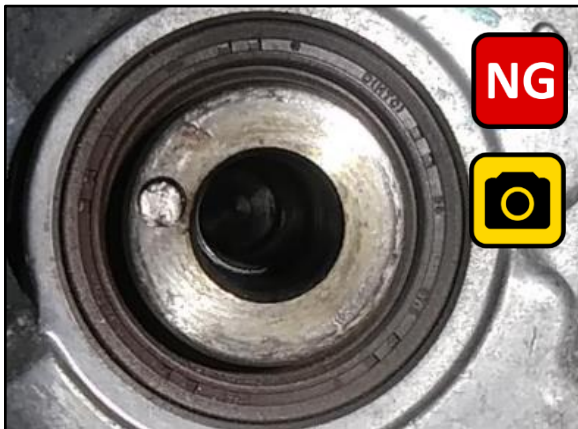
Damaged crankshaft end.

- If crankshaft end is not damaged (**OK**), proceed to the 'Repair Procedure' on page 4.
- If crankshaft end is damaged (**NG**), then the engine will require to be replaced. **DSA-B Dealers: MUST** create a Techline case (PWA) and include photos/video of the damage.

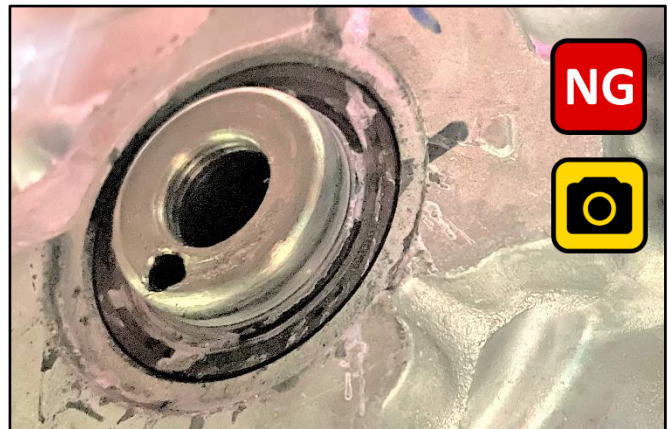
Damaged crankshaft end (dowel pin hole).

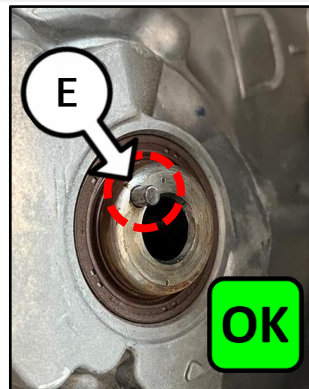
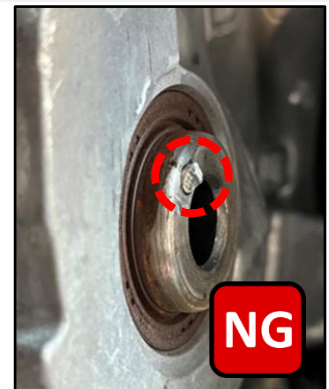
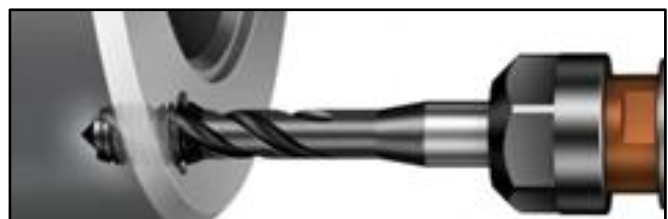
1. Inspect the dowel alignment pin (E).
  - If dowel pin has not sheered off (**OK**), remove dowel pin and proceed to 'Installation Procedure'.
  - If dowel pin has sheered off (**NG**), proceed to step 2-3. The continue to 'Installation Procedure' on page 5.
2. Carefully drill a hole into the dowel pin, using a drill bit smaller than the dowel pin diameter.
3. Using a bolt extractor, carefully remove the broken dowel pin.

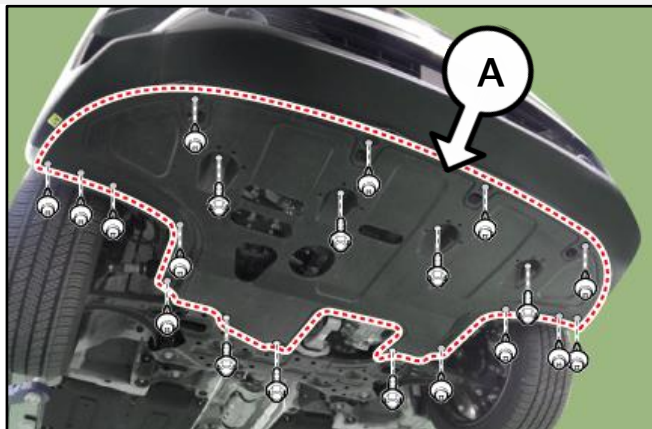
1. Remove the engine room under cover (A).

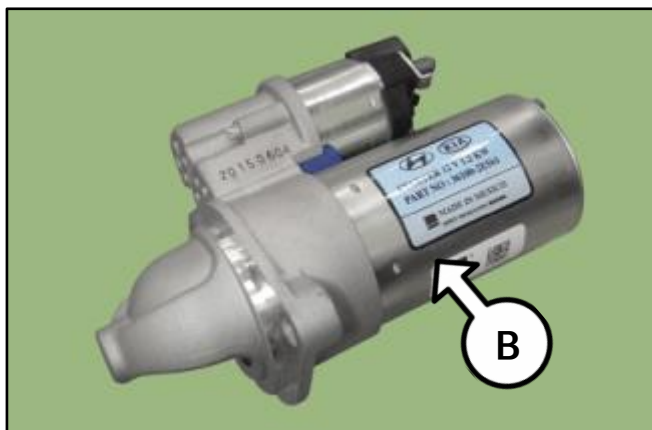
2. Remove the starter (B) by referring to "Engine Mechanical System → Starting System → Starter → Repair procedures" in the applicable Shop Manual on KGIS.

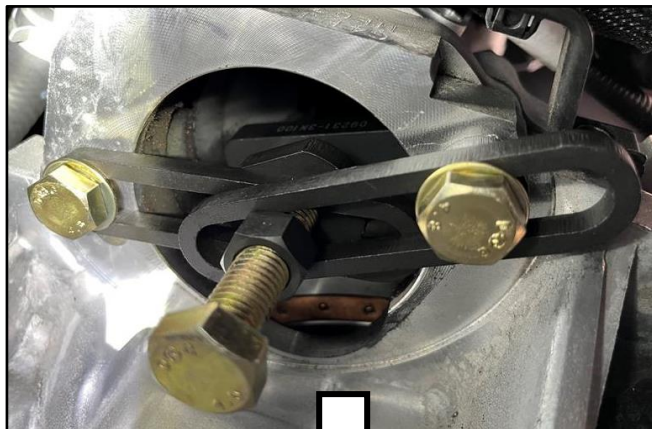
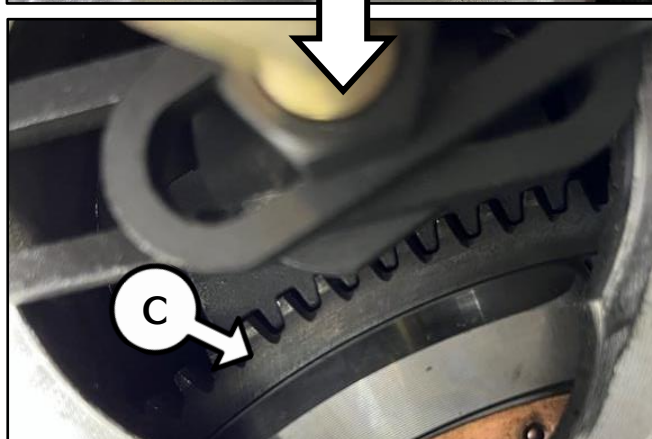
3. Install the SST ring gear stopper/adaptor to the flywheel (C), as shown.

- SST 09231 3N100
- SST 09321 2B100

SST 09231 3N100 and 09321 2B100 align with the flywheel teeth to ensure the flywheel does not move when torquing the crankshaft bolt.

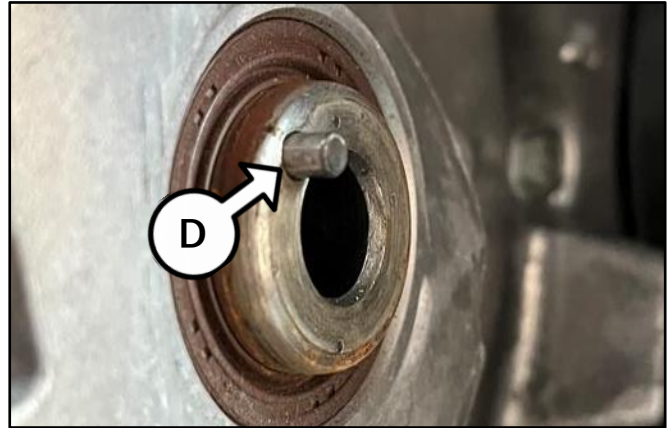
4. Insert the new dowel pin (D) on the crankshaft end.

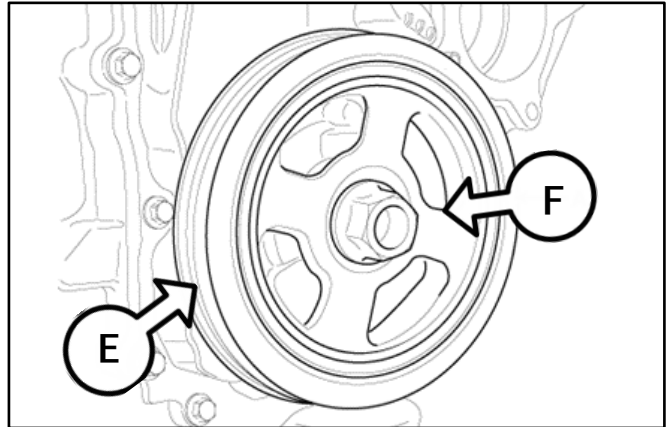
5. Install the new crankshaft pulley (E).

6. Install the new crankshaft bolt (F).

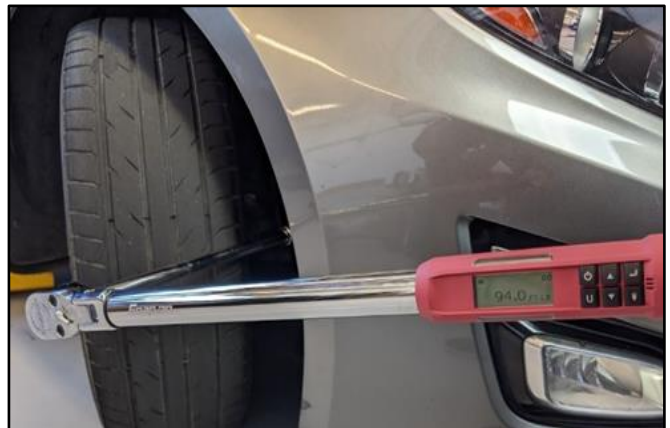
8. Perform engine rotational torque inspection using a torque wrench and set it to 94 ft. lb.

- If engine rotational torque is less than 94 ft. lb., (OK) proceed to step 9 to perform a compression test.
- If engine rotational torque is greater than 94 ft. lb., (NG), then the engine will require to be replaced. **DSA-B Dealers: MUST** create a Techline case (PWA) and include photos/video of the damage.

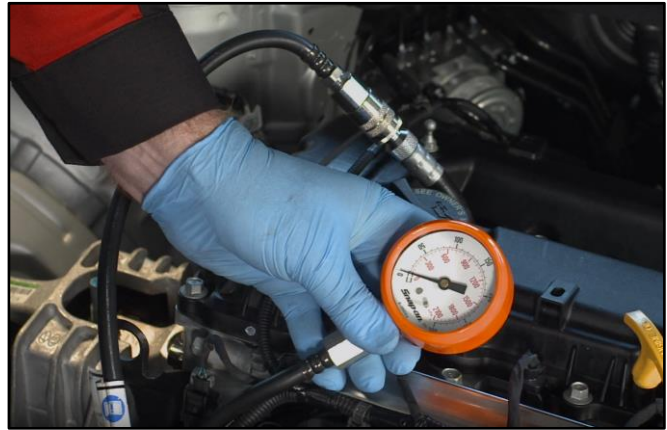
9. Perform a compression test by referring to “Engine Mechanical System → Compression Test” in the applicable Shop Manual on KGIS.
  - If compression test results are within specification (**OK**), proceed to step 10.
  - If compression test results are not within specification (**NG**), then the engine will require to be replaced. DSA-B Dealers: MUST create a Techline case (PWA) and include photos/video of the damage.
