## A/C Compressor Shaft Seal Leak

### AFFECTED VEHICLES

Year	Model	Trim	VIN Range
2019–20	Pilot	Elite, Touring, Black	ALL
2021	Pilot	ALL	ALL
2019–21	Passport	ALL	ALL
2020–21	Ridgeline	ALL	ALL

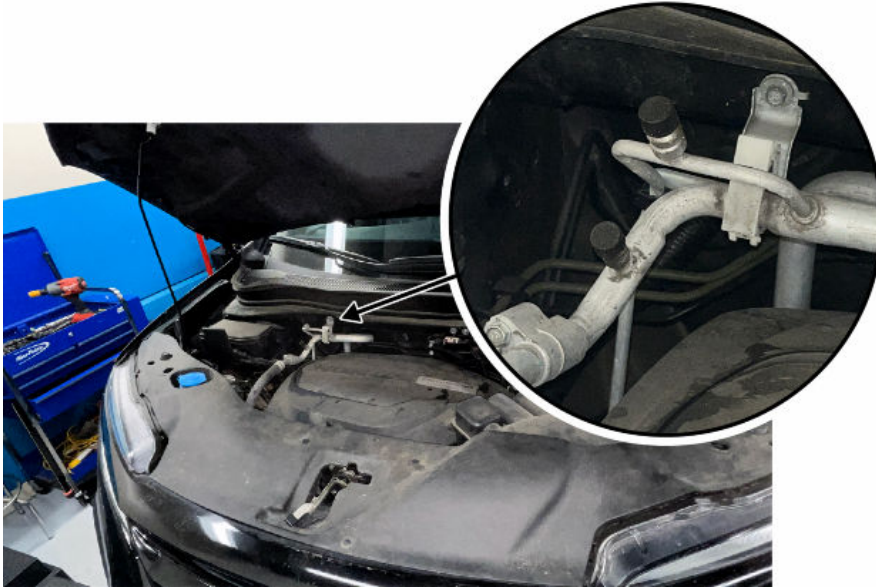
1. Connect an A/C recover/recycle/recharge machine to the high-pressure service port and the low-pressure service port following the equipment manufacturer's instructions.

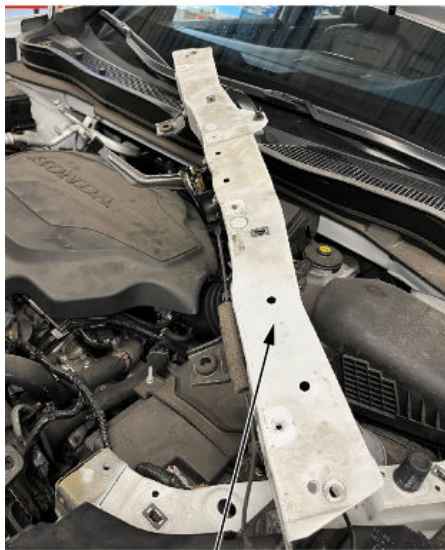
**FRONT  
BULKHEAD**

6. Unbolt the front bulkhead and move it aside, then remove the front center upper beam B.

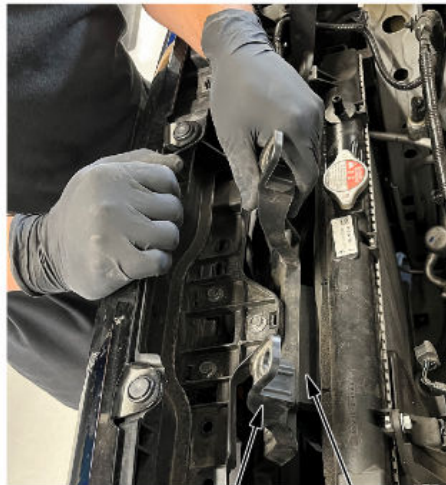
**FRONT CENTER  
UPPER BEAM B**      **LIP**

NOTE: You may need to move the front center upper beam B back and forth to clear the center lip from the radiator to remove it.

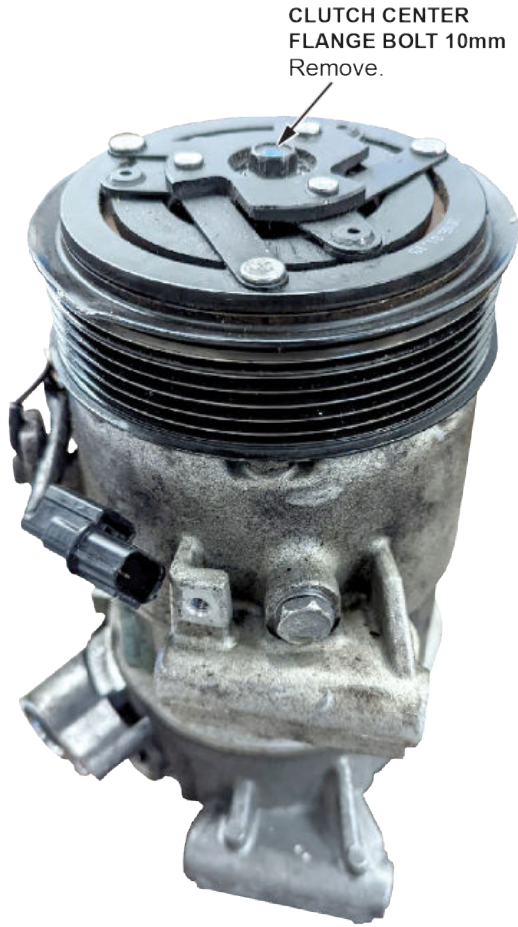
11. If the clutch has not been removed from the previous step, remove the center hub bolt while holding the armature plate with the A/C clutch holder.

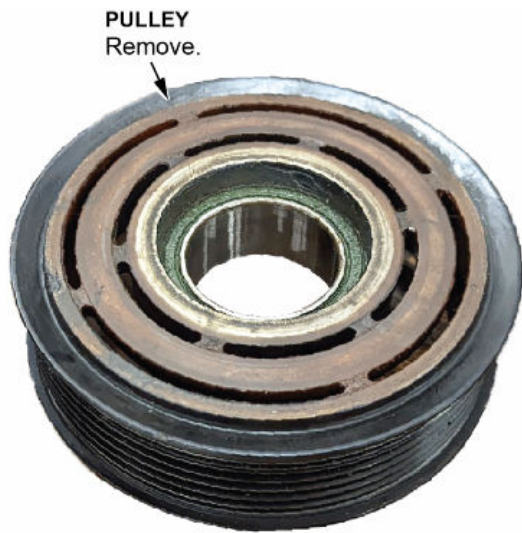
15. Remove the pulley.

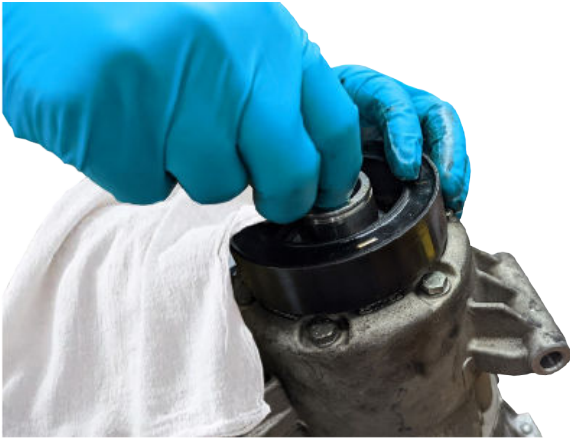
17. Thoroughly clean the bore and shaft with a lint free cloth.

NOTE: Do not use compressed air. The bore needs to be very clean as to prevent debris from entering the compressor once the seal is removed. Failure to remove all debris will result in future failure.

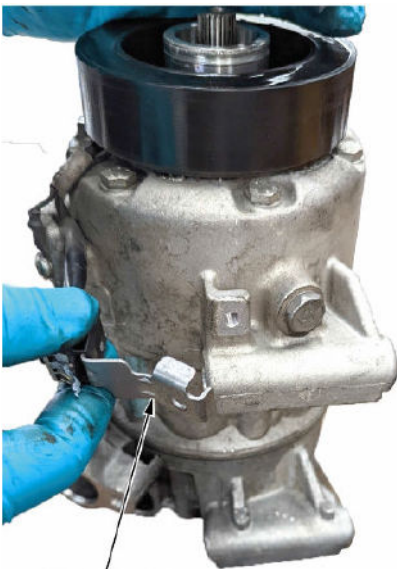
**SIDE BRACKET**  
Remove.

18. Remove the side bracket.

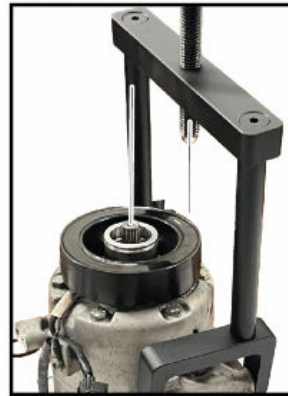
19. Place the press tool onto the A/C compressor and insert the holding pins (2). Make sure the press tool installs where the press shaft should align with compressor shaft. The press tool will only align correctly in one orientation. The pins must go all the way through.

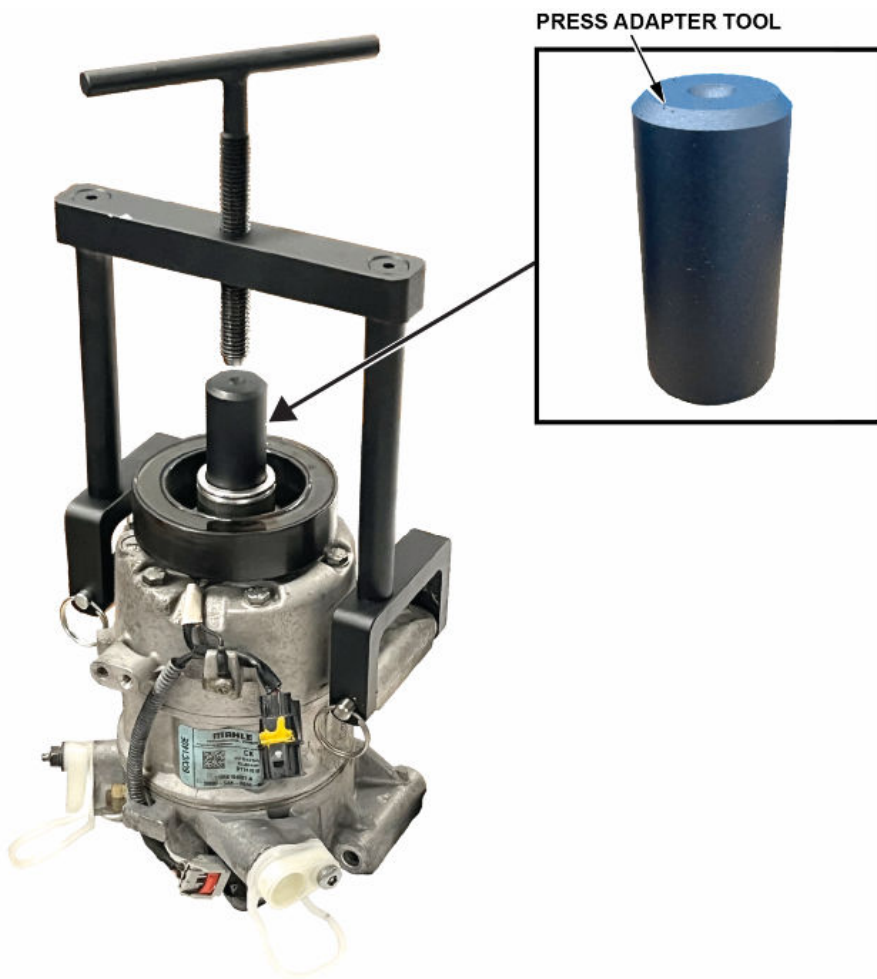
20. Add the press adapter tool.

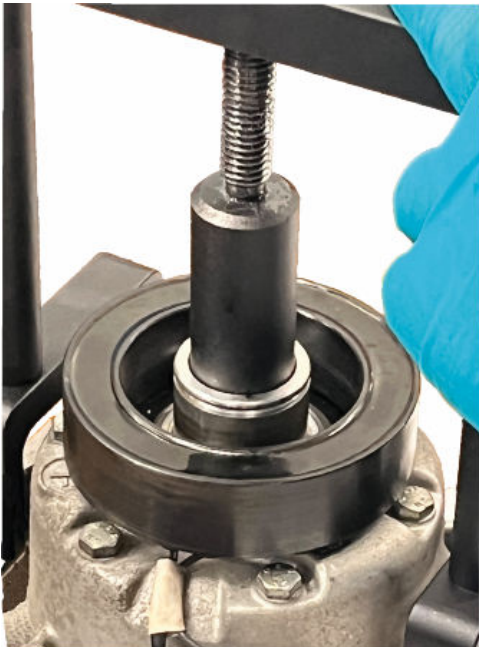
22. Tighten the press until there is no clearance, then **3/4 turn (270°)**.

- The purpose of this step is to break the compressor shaft seal loose.
- Turning the handle more than 3/4 turn (270 degrees) can damage the tool and seal making it difficult to remove the compressor shaft seal.

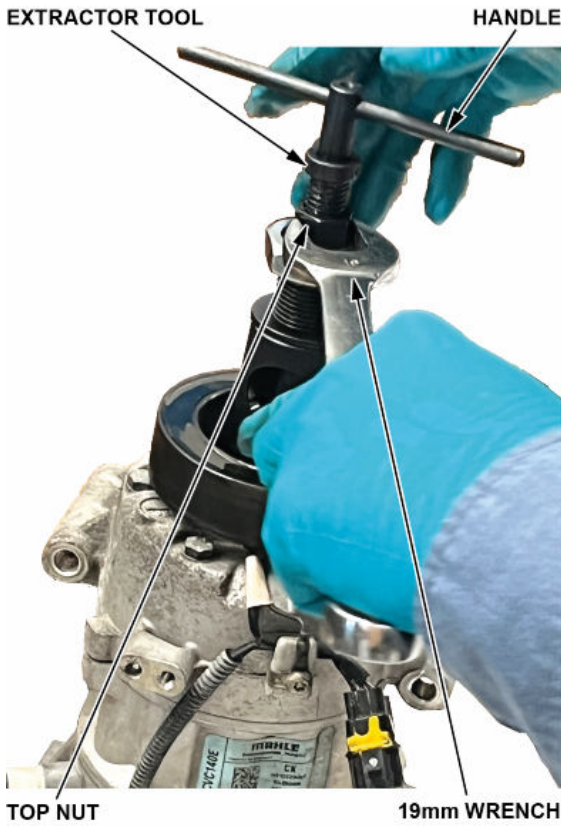
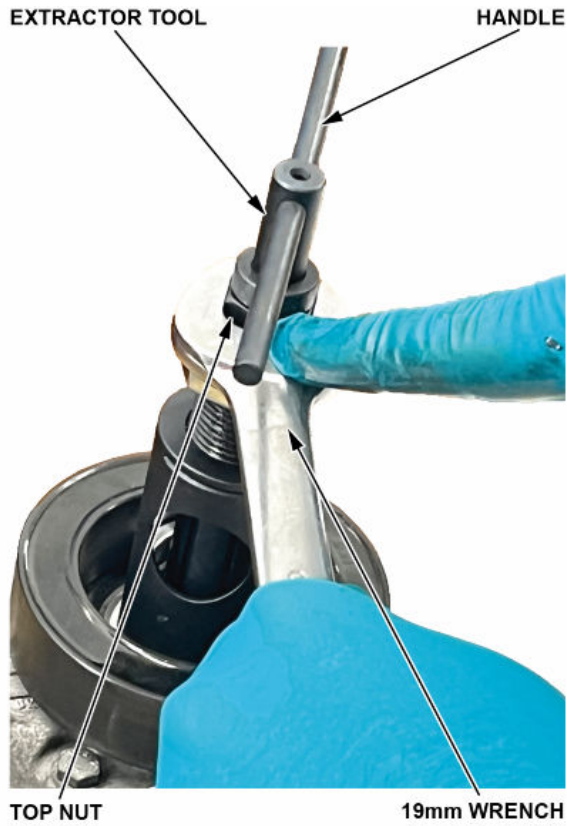
26. Stabilize the extractor tool using a **19 mm** wrench on the top. Then, turn the handle clockwise until the resistance is felt. Make sure that the space between the **19 mm** wrench and the bottom portion of the extractor tool is minimal.

NOTE: To confirm the extractor is engaged, hold the extractor tool and lift the compressor up.

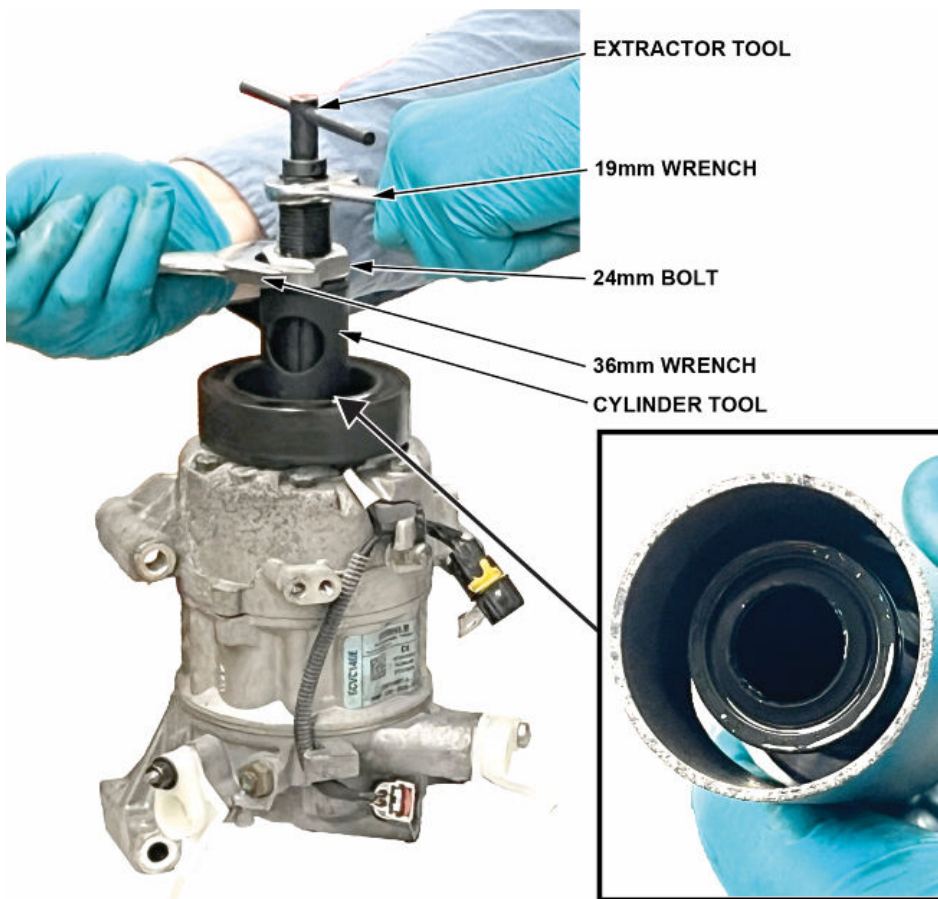
28. With the **19 mm** wrench in place, lower the **24 mm** nut down until it reaches the cylinder. Slowly and carefully adjust until the extractor tool comes out freely with the seal.

- Resistance will be felt while lowering **24 mm** nut and will cease once the seal is extracted.
- If the seal does not come out on the first step, repeat the process starting at step 13.

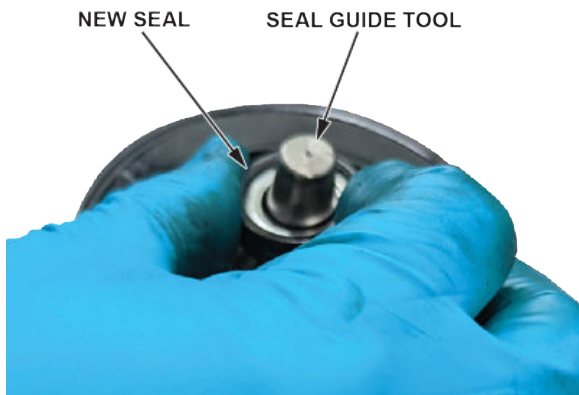
33. Insert the new seal onto the seal guide tool.

NOTE: The seal is directional and must be placed with the metal side upward.

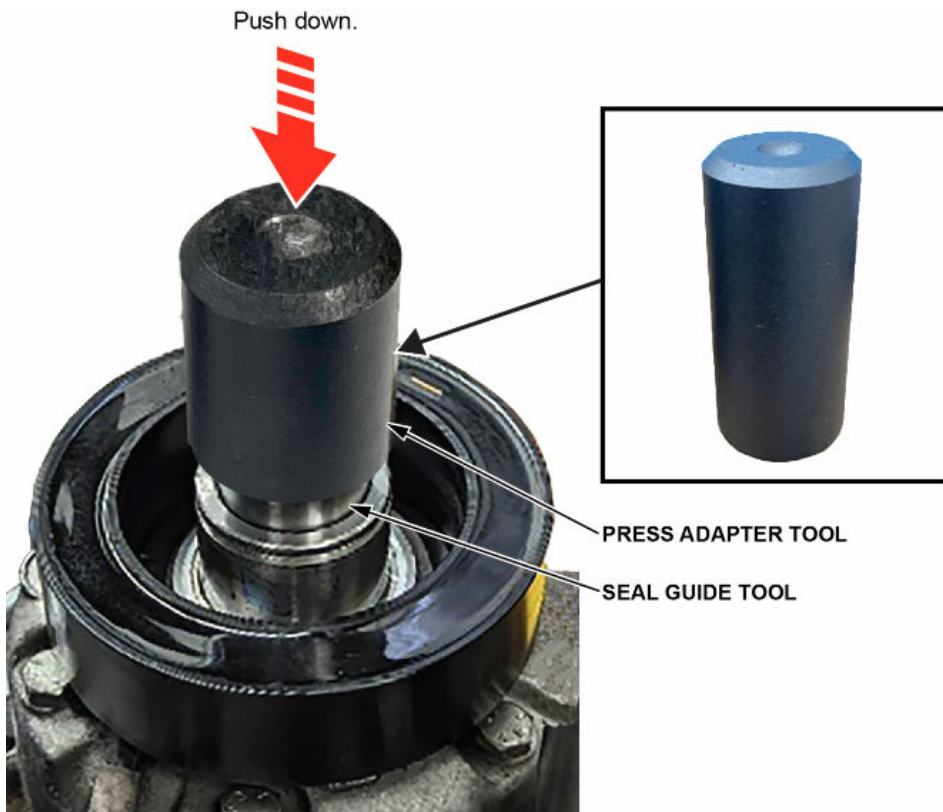
34. Insert the press adapter tool over the seal guide.

35. By hand, press down to seat the new seal about **5 mm** below the top edge of the bore and remove the press adapter.

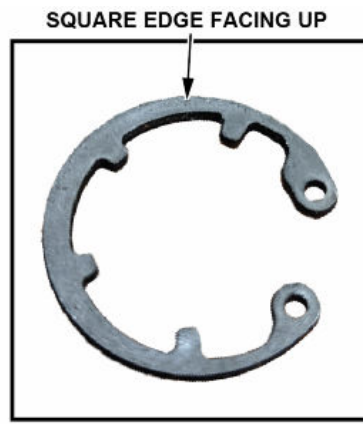
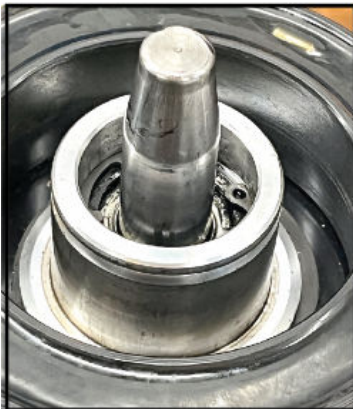
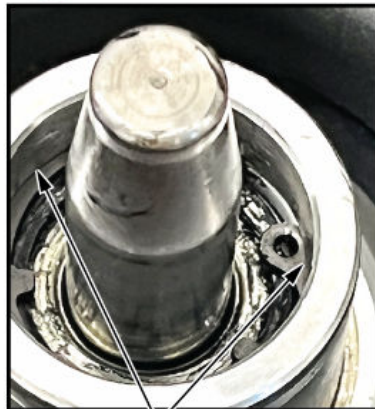
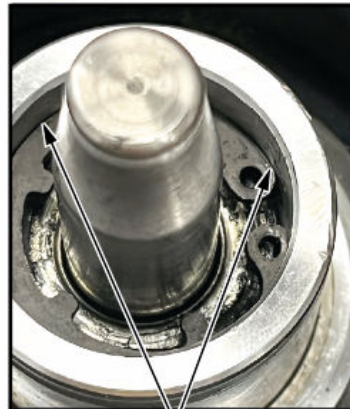
36. Insert the seal C-ring with the teeth's rounded side pointing down into the bore.
