June 30, 2023

Version 1

2019-20 MDX A/C Compressor Shaft Seal Leak

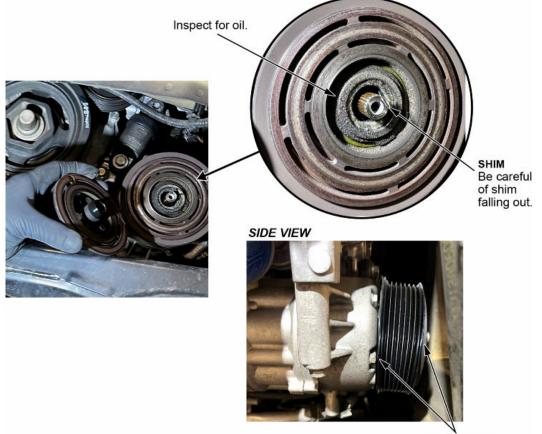
Inspect for oil.

Examples of dry and oily clutch assemblies.

Rotor	Hub	Rotor	Hub
Dry	Dry	Oily	Oily
			١
		0

- If no oil is noticed, leave the compressor on the vehicle. Remove the center hub bolt while holding the armature plate with the A/C clutch holder and remove the hub/armature plate from the compressor. Then, inspect both for oil. NOTE:
 - If oil is present on the hub/armature plate, then proceed to the repair procedure.
 - If no oil is present, then proceed to step 7.

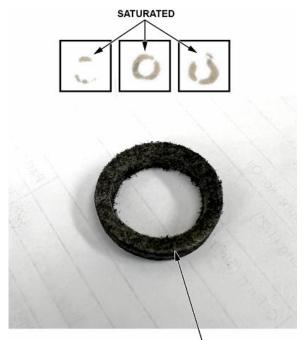
Observe for excess oil.

6. Remove the felt washer from the compressor and gently place it on a clean sheet of paper.

NOTE: If oil transfers from the felt washer to the paper after **10 seconds**, then proceed to the repair procedure. If not, then proceed to step 8.

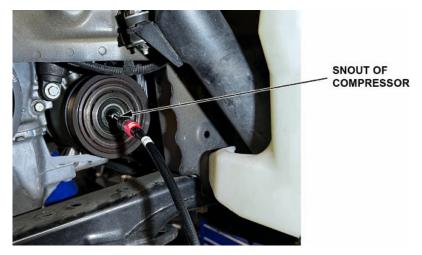
7. Using a calibrated sniffer, check for a leak.

- Use a sniffer for at least **5 minutes** around the snout of the compressor.
- An A/C compressor that has not been engaged will yield better results. The longer the A/C compressor has not been run, the better chance you will have at detecting a leak.
- A higher vehicle temperature produces more accurate results.
- If a leak is detected, then proceed to the repair procedure.

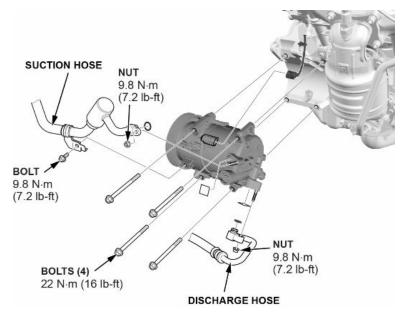
9. Disconnect the discharge and suction hose.

NOTE: Use the port plugs in the seal assembly kit to immediately seal the ports after disconnection. This avoids moisture and dust contamination from entering the A/C compressor. Installing an A/C compressor into a contaminated system can result in premature A/C compressor failure.

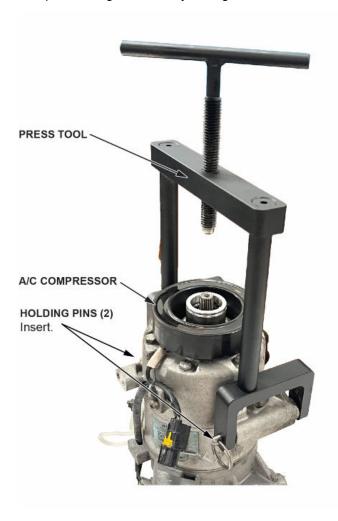
19. Place the press tool onto the A/C compressor and insert the holding pins (2). Make sure the press tool installs where the press shaft should align with compressor shaft. The press tool will only align correctly in one orientation. The pins must go all the way through.

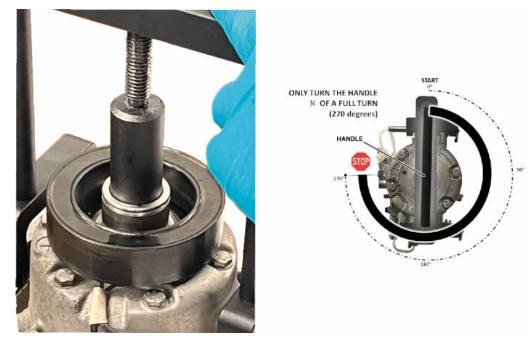
22. Tighten the press until there is no clearance, then 3/4 turn (270°).

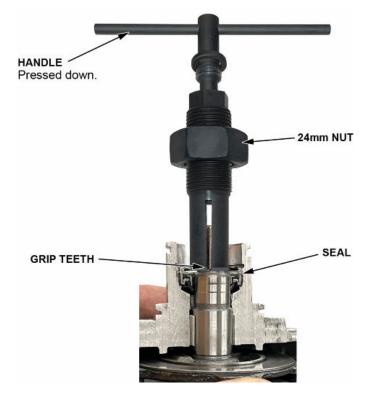
25. Insert the extractor tool, and make sure the **24 mm** nut is positioned towards the top. Look into the cylinder window to align the extractor tool onto the flange and press the handle fully down to grab the seal.

NOTE: The 24 mm nut will use a 36 mm wrench.

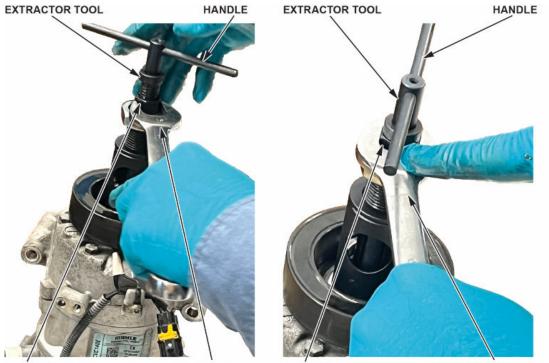
26. Stabilize the extractor tool using a **19 mm** wrench on the top. Then, turn the handle clockwise until the resistance is felt. Make sure that the space between the **19 mm** wrench and the bottom portion of the extractor tool is minimal.

19mm WRENCH

NOTE: To confirm the extractor is engaged, hold the extractor tool and lift the compressor up.

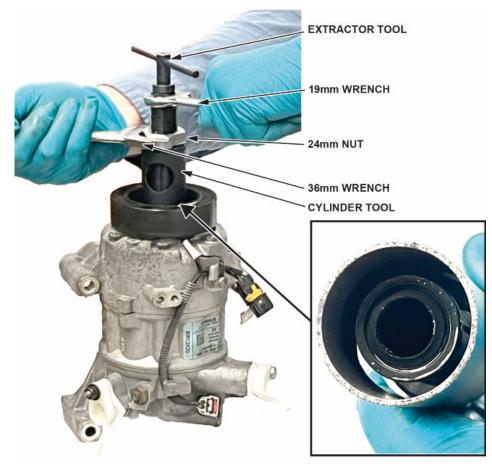
28. With the **19 mm** wrench in place, lower the **24 mm** nut down until it reaches the cylinder. Slowly and carefully adjust until the extractor tool comes out freely with the seal.

- Resistance will be felt while lowering **24 mm** nut and will cease once the seal is extracted.
- If the seal does not come out on the first step, repeat the process starting at step 13.

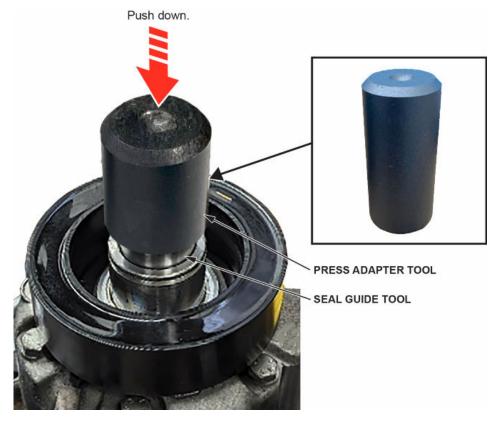
NEW SEAL SEAL GUIDE TOOL

35. By hand, press down to seat the new seal about **5 mm** below the top edge of the bore and remove the press adapter.

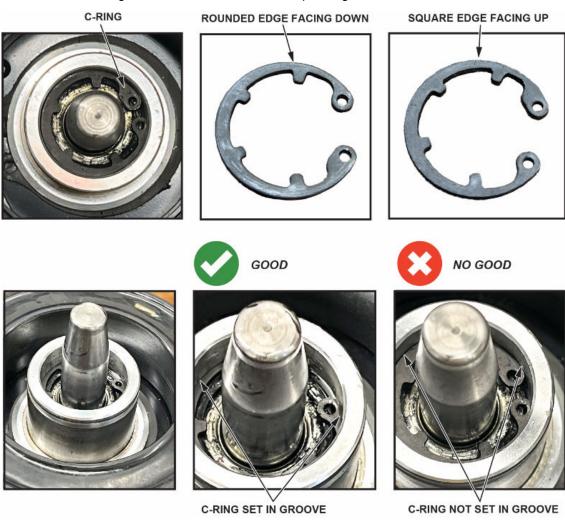
36. Insert the seal C-ring with the teeth's rounded side pointing down into the bore.

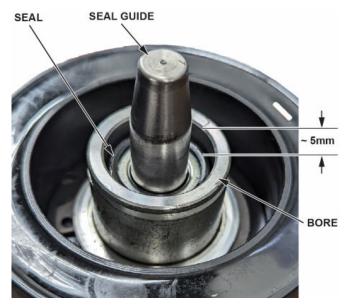
38. Tighten the press by rotating the handle clockwise until it reaches the adapter tool. Slowly and carefully continue to rotate the handle clockwise until the seal is pressed down roughly **10 mm** below the bore.

NOTE: Tighten the press until the C-Clip is installed into the clip groove. There will be a sound or vibration felt when the C-clip is fully set.
