**SUBJECT: RECOMMENDED NEW VEHICLE DEMONSTRATION / DELIVERY HOLD
Customer Satisfaction Program 22B39
Certain 2022 Maverick HEVs
Maverick No-start Condition**

CERTAIN 2022 MODEL YEAR MAVERICK VEHICLES EQUIPPED WITH A 2.5L FULL HYBRID ELECTRIC VEHICLE POWERTRAIN — HARNESS LAYOVER

SERVICE PROCEDURE

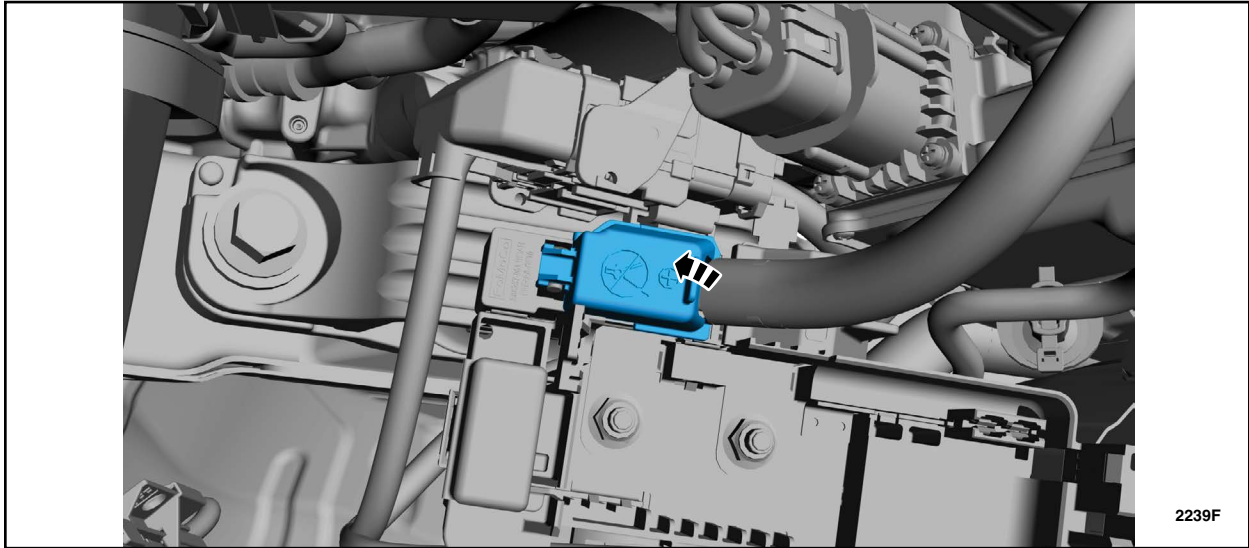
FIGURE 6

10. Remove the power cable terminal cover. See Figure 6.

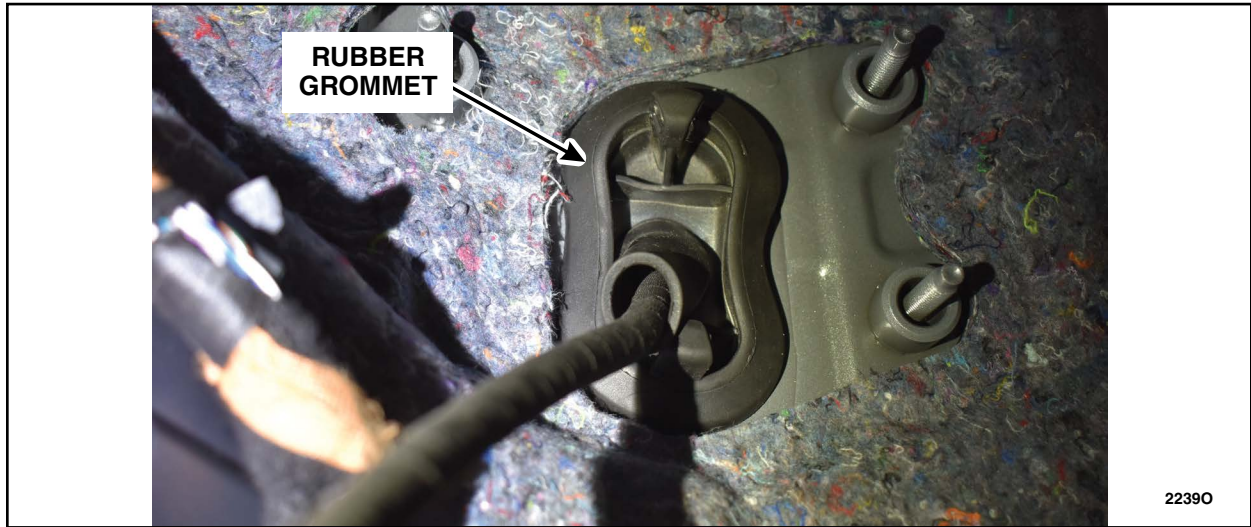
FIGURE 14

20. Remove and discard the grommet. Insert the new wire harness, short side, into this port until it is stopped by the rubber grommet that is installed on the wire harness. See Figure 14.

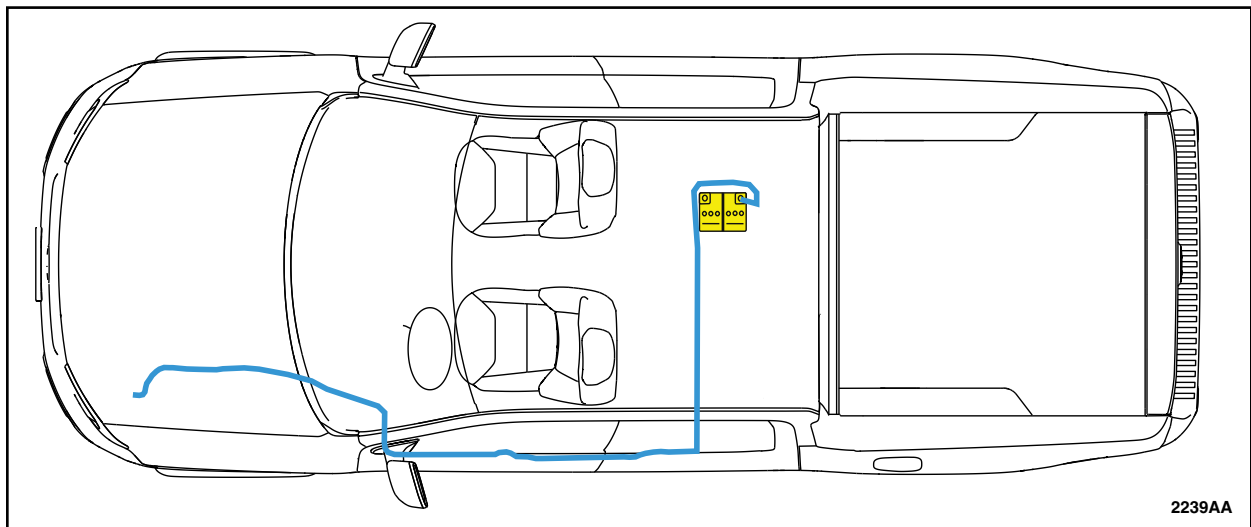
FIGURE 15

See Figure 15 below for the full routing path of the harness.

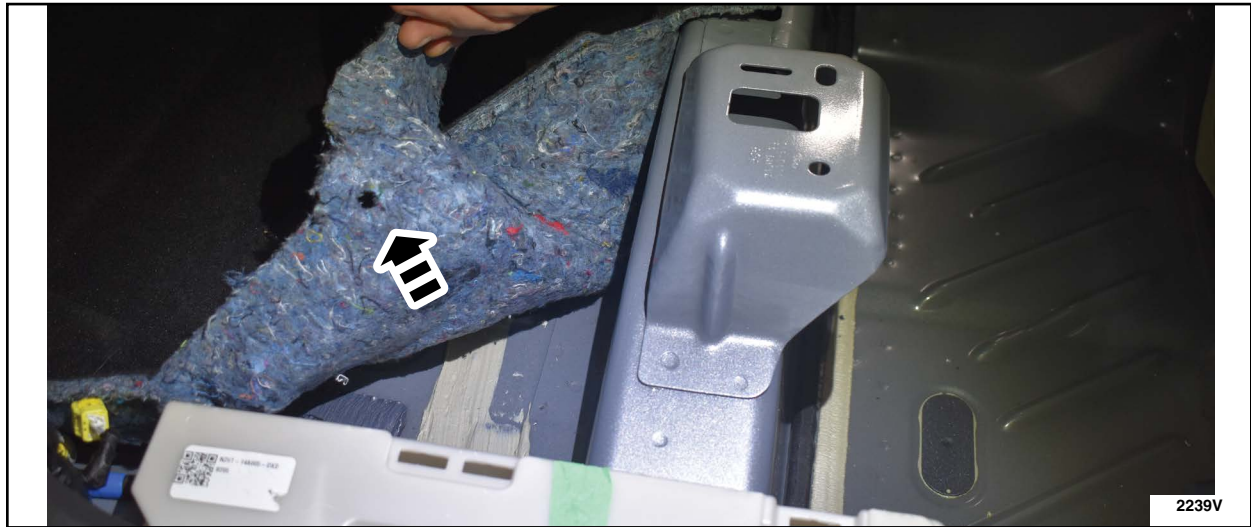
FIGURE 20

25. Position the carpet aside. See Figure 20.

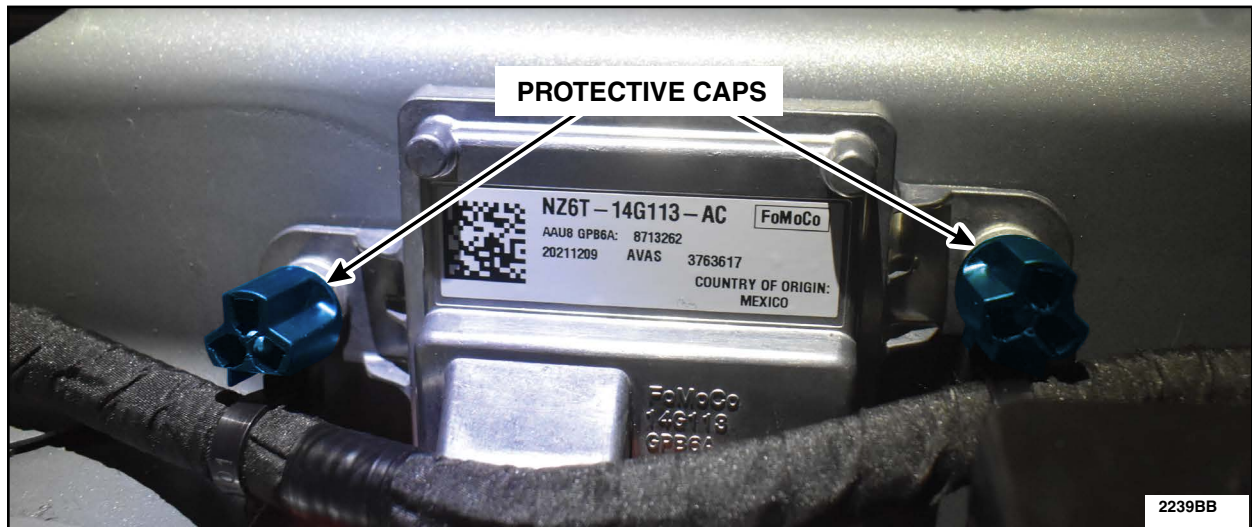
FIGURE 23

28. Install the protective caps while routing the harness. See Figure 23.

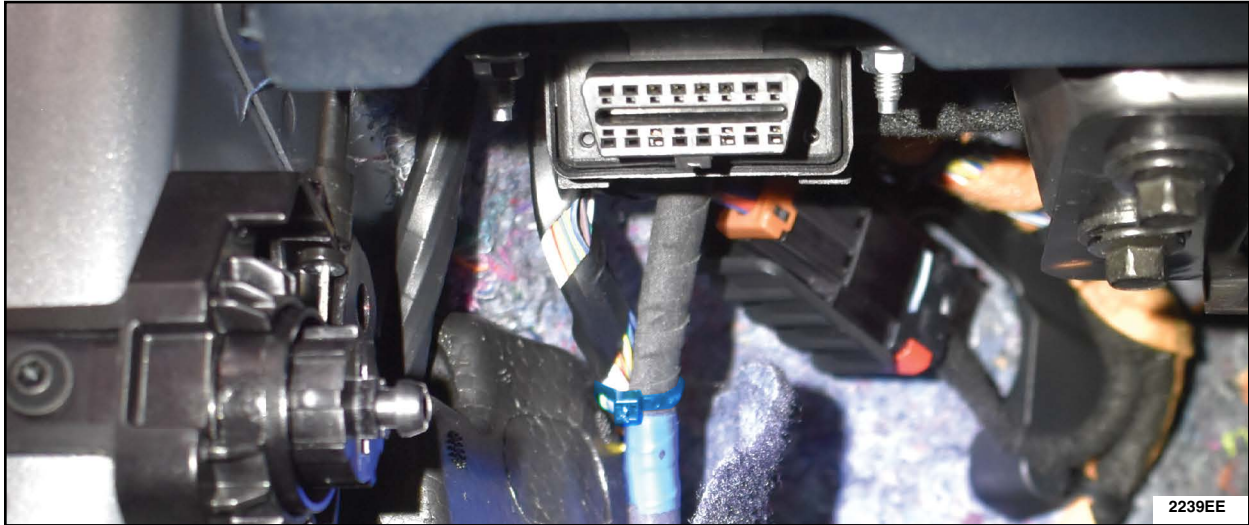
FIGURE 28

33. If there is any excess wire harness left, secure using zip ties underneath the dash area.
See Figure 28.

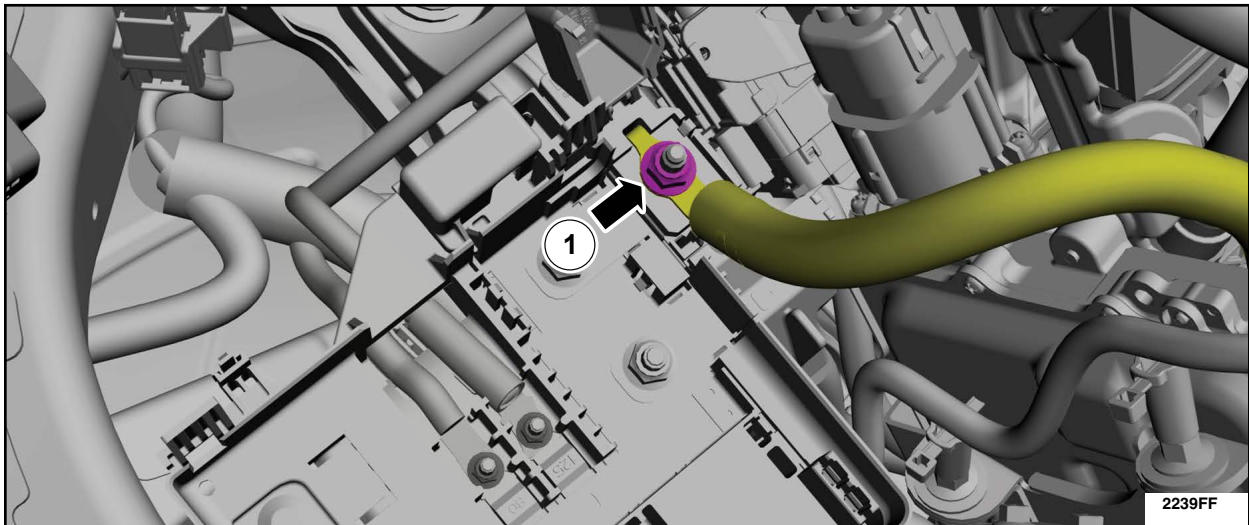
FIGURE 29

34. Secure the new harness to the terminal.
Torque: 106 lb.in (12 Nm)
