SAFETY RECALL BULLETIN

SUBJECT:	No:	SR-15-007REV			
RAIDER DRIVER S	DATE:	June 2023			
SAFETY RECALL C	MODEL: 2006-09 Raider				
CIRCULATE TO:	[X] GENERAL MANAGER	[X] PARTS MANAGER		[X] TECHNICIAN	
[X] SERVICE ADVISOR	[X] SERVICE MANAGER	[X] WARRANTY PROCESSOR [X] SALES MANAGER		[X] SALES MANAGER

This bulletin supersedes SR-15-007 issued June 2015, to update the Inflator Returns section. Revisions are indicated by: ◀

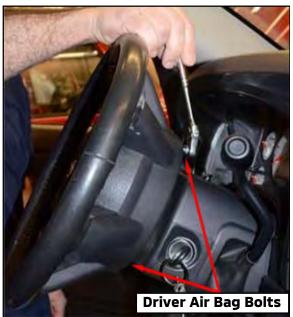
1. Record the radio station presets. Disconnect the negative (-) battery cable (10mm) and insulate the cable end with electrical tape.

MARNINGWait at least two minutes after disconnecting the battery cable before doing any further work to prevent accidental air bag deployment.

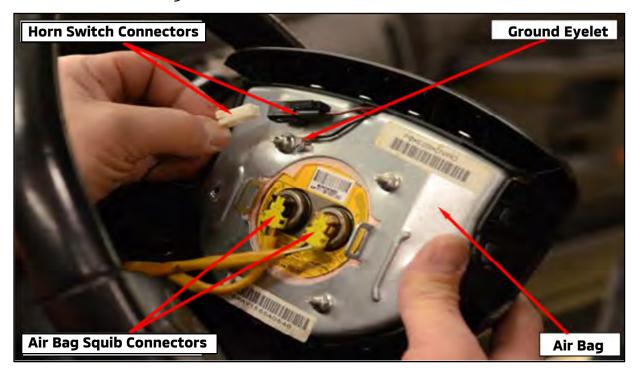
2. From the steering wheel's underside, remove the (2) 10mm bolts that secure the driver side frontal air bag to the steering wheel armature.

NOTE: Rotate the steering wheel so that the bolts are at the top of the steering column as shown in the illustration.

3. Carefully pull the driver side frontal air bag far enough away from the steering wheel to access the air bag's backside

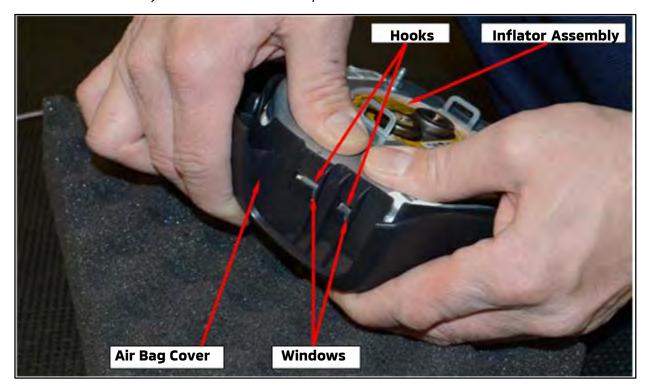
11. Remove the air bag cover starting with the left side by pressing down on the inflator assembly until the hooks unsnap from the windows.

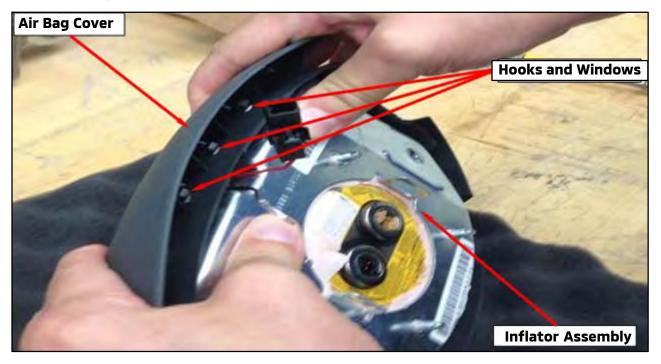
12. Unsnap the top hooks by pressing down on the inflator assembly until the hooks unsnap from the air bag cover windows.

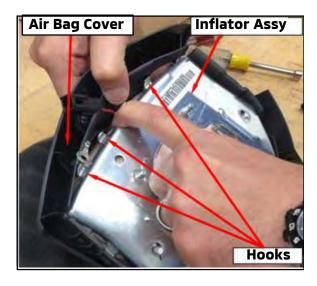
13. Unsnap the right side hooks by pressing down on the inflator assembly until the hooks unsnap from the air bag cover.

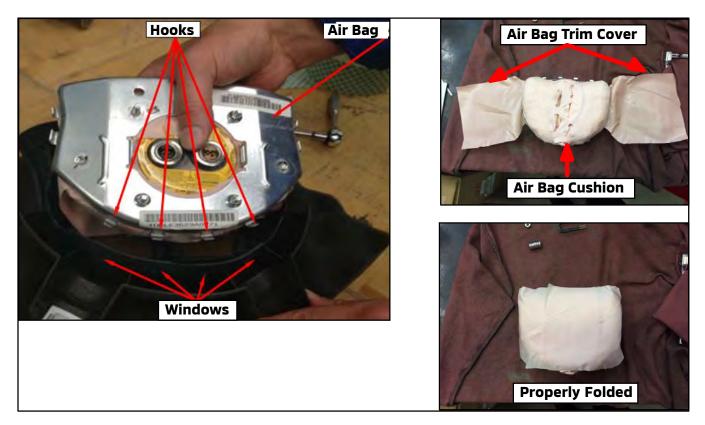
16. Install the new air bag to the air bag cover by first inserting the bottom hooks into the windows.

NOTE: Ensure the driver side frontal air bag trim cover is properly folded over the air bag cushion during installation and remains folded.

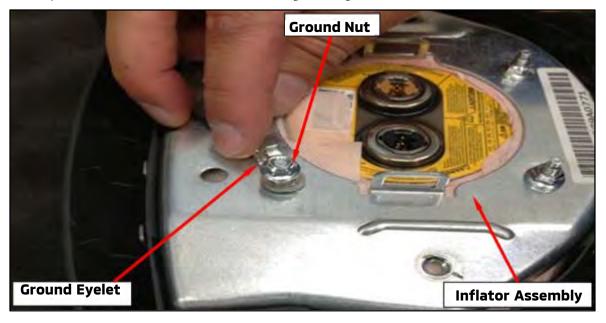
19. Install the ground outlet on the upper right stud. Install the new ground nut provided with the replacement driver side frontal air bag and tighten to 26 in-lbs (3 N-m).

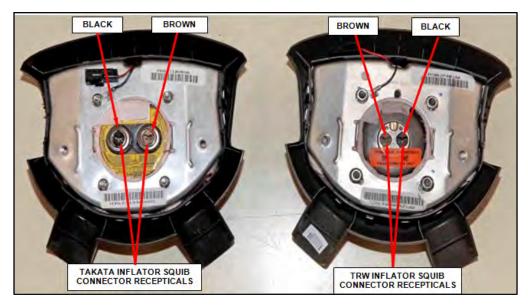
22. Connect the two airbag squib connectors to the air bag inflator assembly connector receptacles bypressing straight in on the connector. Be certain to engage each keyed and color -coded connector to the matching connector receptacle. Be certain that each connector is fully engaged in its receptacle by listening carefully for a distinct, audible click as the connector latches snap into place.

NOTE: The squib connector receptacle locations on the driver side front air bag inflators are switched between the original Takata inflator and the TRW replacement inflator kits. Squib connectors are keyed and color coded for error proofing.
