SAFETY RECALL BULLETIN

DRIVER SIDE TAKATA NADI INFLATOR	
SAFETY RECALL CAMPAIGN - REVISED

No: **SR-20-001REV3**

DATE: June 2023

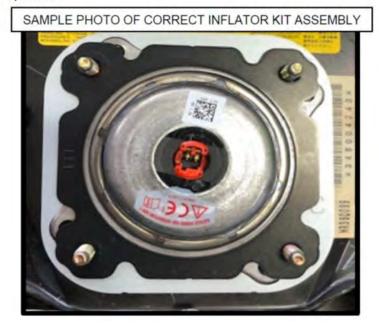
All claims must include a photo of the new countermeasure Inflator kit after assembly—the photo must be posted to the Photos Required Condition (PRC) system in the "RECALL PHOTO/DOCS SUPPORT" category. The photo must clearly show the countermeasure Inflator kit assembled correctly.
