Technical product information

Topic	Coolant leaking from the mechanical coolant pump - Low coolant level warning - Engine overheating - DTC's evident
Market area	Australia E04 Bentley rest Asia and Australia (6E04),China 796 VW Import Comp. Ltd (Vico), Beijing (6796),Germany E02 Bentley rest Europe (6E02),Japan E03 Bentley Japan (6E03),Korea, (South) E08 Bentley South Korea (6E08),United Arab Emirates E06 Bentley Middle East and Africa (6E06),United Kingdom E01 Bentley UK (6E01),United States E05 Bentley USA and rest America (6E05)
Brand	Bentley
Transaction No.	2065919/8
Level	EH
Status	Approval
Release date

W12 Bentayga - New Continental GT/GTC - New Flying Spur

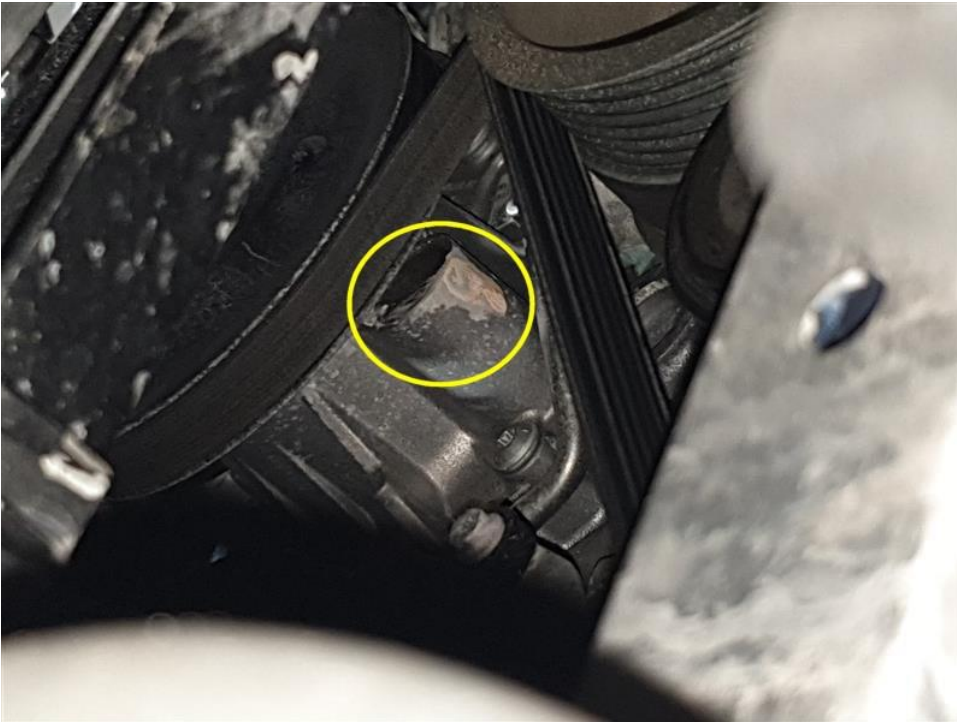
Figure 2

Refer to the video located within the Bentley Hub reference [TPI 2065919/-](#) this video shows an example of a coolant pump with no leak although there is a small coolant witness mark evident (Figure 2) in this scenario the coolant witness mark should be cleaned off (using a suitable cleaning agent) to the condition shown in Figure 3
