# Service Bulletin

Bulletin No.: 23-NA-073

**Subject: Evaporative DTCs P0442, P0446, P0455 or P0449, Caused by Dust Intrusion into the Evaporative Canister and Canister Vent Solenoid**

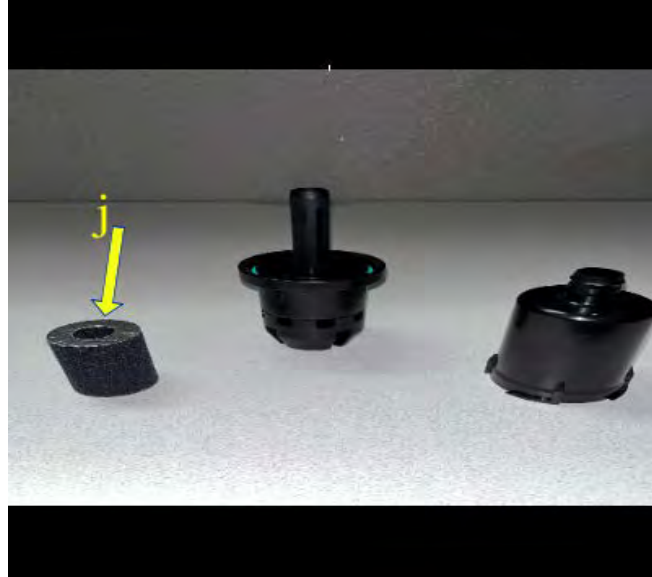
6325318

**Note:** The retro-fit to add the filter is described in the Service Procedure below. For the retro-fit, the filter assembly P/N (with the 3 parts shown above) will need to be utilized. If a vehicle has already undergone the retro-fit and the vehicle returns after a period of time with the Condition reappearing, the repair can be the filter (1).
