TIGER 900 AFTERMARKET PROTECTION BARS - FRAME DAMAGE

TOL NOTICE (US&CA) – May 18, 2023 TOL Ref. # 24332-SVC

TIGER 900 AFTERMARKET PROTECTION BARS – FRAME DAMAGE

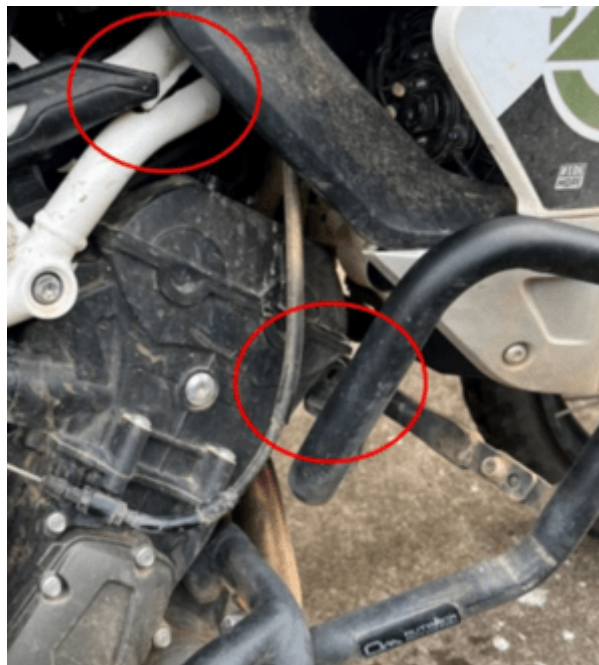
Triumph has seen a small number of Tiger 900s that have suffered main frame damage following fitment of unapproved aftermarket upper protection bars.

In all such cases of this frame damage, the protection bars have been mounted to the front cylinder head mounting point on the frame. This is a critical structural joint between the engine and frame, and any weakening of this joint – for example through incorrect fitment, a weak fixing or low torque, will lead to overload and cracking of the frame rails.

This damage is the result of fitment of unapproved parts and, as such, is not covered by warranty. **Any related warranty claims will be rejected.** As is common with other unapproved components, Triumph strongly recommends that protection bars that fit to the front cylinder head mount are not fitted.

Please note we only recommend Triumph's Genuine Upper Protection Bar Kit, Part # A9780275.
