Technical Service Bulletin

01 MIL on, DTC P040100 is stored in the ECM - TDI

01 23 60 2064398/1 July 7, 2023.

Model(s)	Year	VIN Range	Vehicle-Specific Equipment
A3 Sportback	2010 - 2013	Not Applicable	TDI

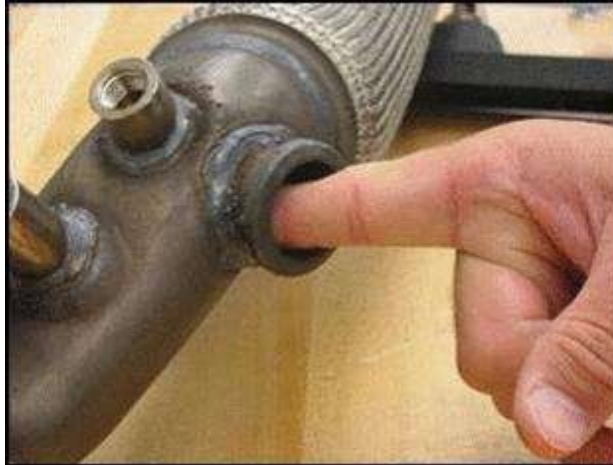
1. Remove the EGR filter from the Diesel Particulate Filter (DPF) and swipe the inside of the exhaust pipe at the EGR filter connection point using a clean cloth or your finger.

Figure 1. Checking for carbon.

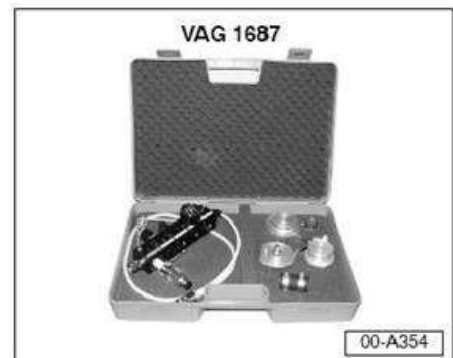
1. The charge air pressure system can be checked using the VAG 1687. Charge air system tester along with the VAG1687/10 adapter as follows:

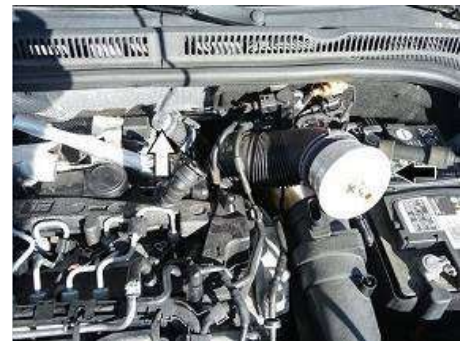
3. Special tool VAG 1687/10 pressure adapter, installing.

- Separate intake hose from the Mass Airflow Sensor assembly (MAF).
- Insert VAG 1687/10 pressure adapter in intake hose -black arrow- using existing clamp (as shown).
- Remove crankcase ventilation valve or tube from intake hose at -white arrow-.
- Plug hose with appropriate metal plug and hose clamps supplied with VAG 1687 special tool kit at -white arrow-.

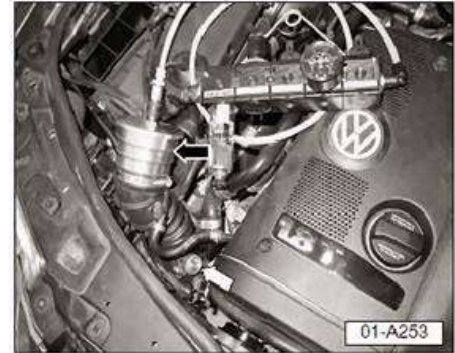
Special tool KLI9210 (EVAP system leak detector)

- Install optional fitting KLI 9210/50 on hose of special tool KLI9210.
- Connect KLI9210 to VAG 1687/1 adapter (KLI 9210 is shown attached to VAG1687/1 at arrow on 1.8L Turbo).

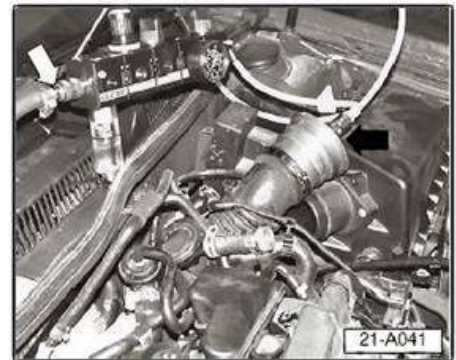
Special tool VAG 1687 connecting to pressure adapter 1687/10

- VAG 1687 is shown connected to VAG 1687/10 (black arrow).
- Shop air supply connected to VAG 1687 at (white arrow).
- Perform pressure test.
