GROUP	MODEL
Subsequent Repair Action	2014-2016MY Optima (TF HEV) w/2.4L MPI
NUMBER	DATE
PI2104Y/Z	July 2023

SUBJECT: **ENGINE REPLACEMENT INSTRUCTIONS
FOR DTC P1326 (PI2104Y/Z)**

This bulletin provides information related to the Technical Service Bulletin previously published in (PI2104) titled "Knock Sensor Detection System - ECU Logic Improvement" for 2014-2016MY Optima (TF HEV) vehicles equipped with Theta 2.4L MPI engine, produced from December 11, 2013 through July 22, 2015. Specifically, this bulletin provides instructions on which procedures to follow if, after installation of the KSDS, any one of the subject vehicles below return to the dealer with Diagnostic Trouble Code (DTC) P1326 (Knock Signal Range/Performance).

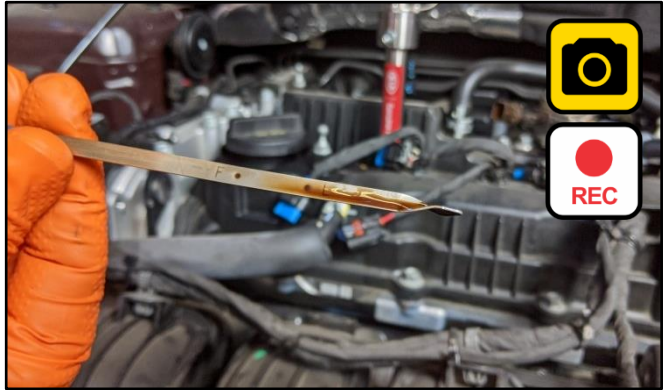
1. Start video showing vehicle and move in towards the dash VIN tag.
2. Measure and record oil dip stick level.
3. Note oil dip stick reading on the RO.
4. Take a picture of the oil reading on dipstick.
5. Inspect the inner/bottom of the oil cap and inside oil filler opening.

Record/Note findings: Oil sludge, varnish, burnt oil smell condition(s) found.

If oil lacquering, oil sludge or oil varnish is present, then the engine is therefore suspect to maintenance neglect. Review of the vehicle's maintenance history is required.

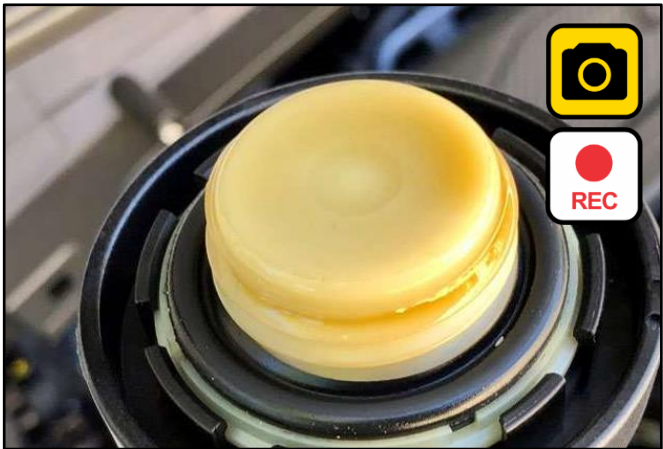
6. Inspect the inner/bottom of the oil cap and inside oil filler opening.

Record/Note findings: Oil sludge, varnish, burnt oil smell condition(s) found.

7. Take a picture of both, the bottom of the oil cap and oil filler opening.

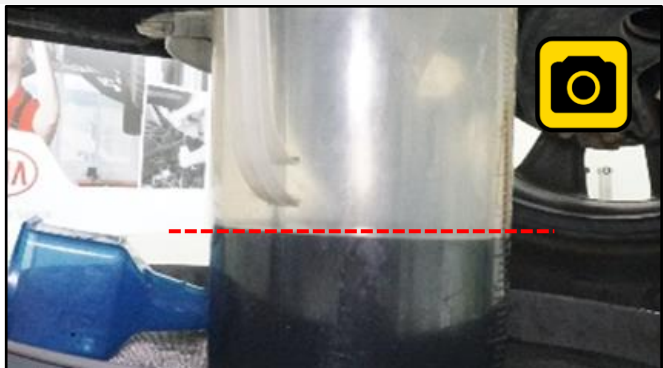
Oil Level Measurement: (Flowcharts B & C → PWA Request)

1. Remove oil filler cap, remove oil drain plug and drain oil into the supplied measuring container SST067BUCK and check oil level.
2. Record oil level reading on the RO.
3. Take photo of the drained oil container using KDS and attach to warranty claim PWA request.

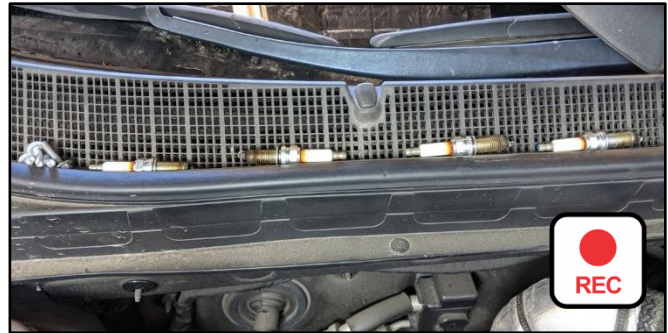
2. Show the removed spark plugs.

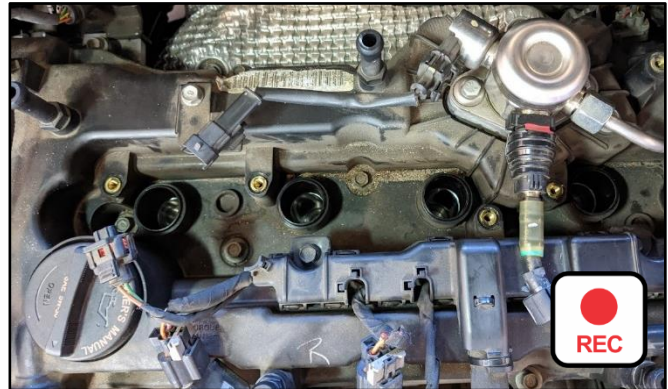
3. Show the empty spark plug holes from the engine.

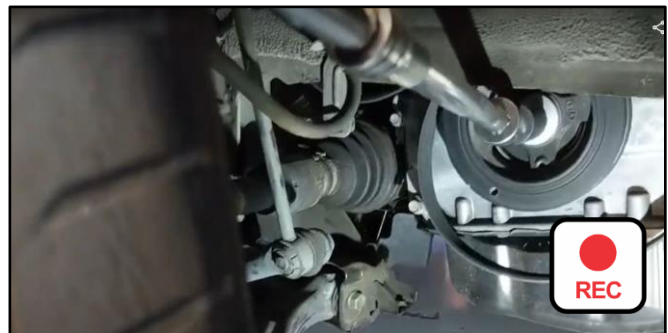
5. Show the removed drive belt and attached torque wrench to crank bolt.

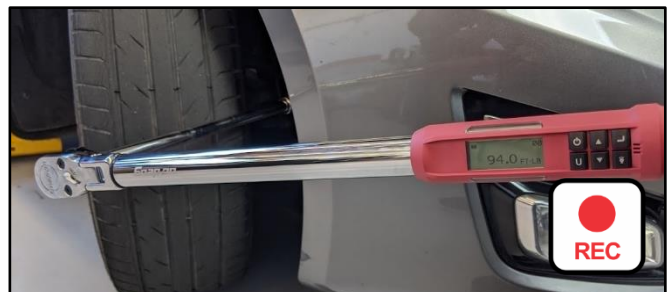
6. Show the engine being cranked and torque specification exceeding 94 lb.ft. torque.
