Technical Service Bulletin (TSB)  
Check Strap Webbing Kit on Driver's Side Front Door

<b>REFERENCE:</b>	<b>TSB:</b> 23-055-23 <b>GROUP</b> 23 - Body	<b>Date:</b>	May 13, 2023	<b>REVISION:</b>	23-019-22
<b>VEHICLES AFFECTED:</b>	2014-2020 (VF) RAM ProMaster			<b>MARKET APPLICABILITY:</b>	
				<input checked="" type="checkbox"/> NA	<input checked="" type="checkbox"/> MEA
				<input type="checkbox"/> SA	<input type="checkbox"/> IAP
				<input type="checkbox"/> EE	<input type="checkbox"/> CH
<b>CUSTOMER SYMPTOM:</b>	The repair eliminates the over swing when opening the driver's side door.				
<b>CAUSE:</b>	Installing webbing kit on the front left driver's door.

This bulletin involves installing a webbing kit on the front left driver's door for the door check strap.

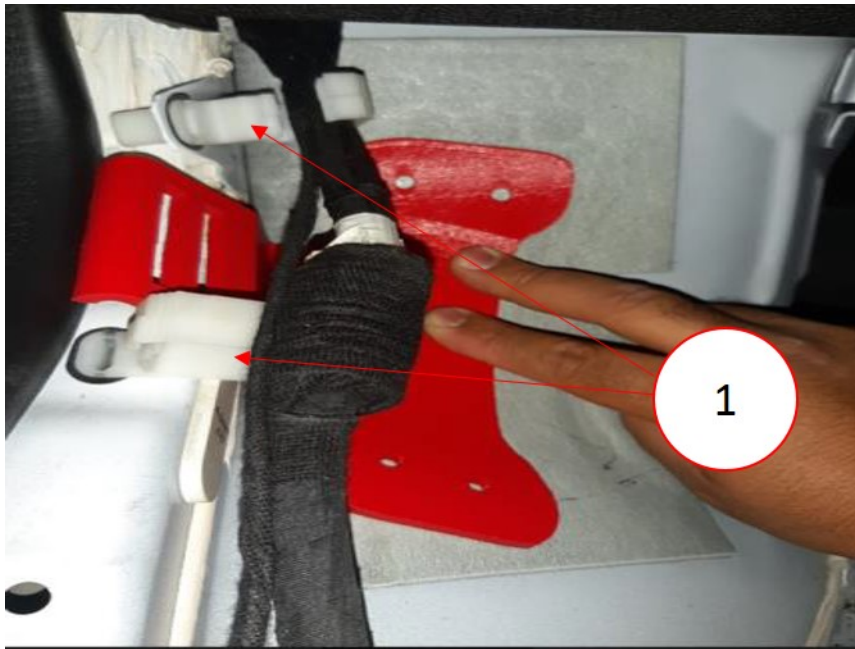
Fig. 1

**NOTE:** The check strap bracket has to be positioned between the slot in the sill and the slot in the shock tower. Both are used by the electrical harnesses (Fig. 1) .

Check Strap Bracket Location Between Harness

- Carpet. Refer to the detailed service procedures available in DealerCONNECT> Service Library under: Service Info>23 - Body / Interior / Carpet / Removal.
  - Sill front covers. Refer to the detailed service procedures available in DealerCONNECT> Service Library under: Service Info>23 - Body / Interior / Plate, Scuff, Front Door Sill / Removal.
  - Harness clip.
    - Carefully open 4 white clips shown in images.
    - Release locking mechanism with a thin, flat-headed screwdriver.
2. Secure the harnesses.
    - Insert all harnesses into a 25 mm (1 in) diameter convolute.
    - Spot tape (3 turns) the START and END of convolute.
    - Fully wrap tape the length of convolute.
  3. Place the check strap bracket on the floor (Fig. 1) . Since it follows shock tower's surface, it will be self centered (Fig. 1) .

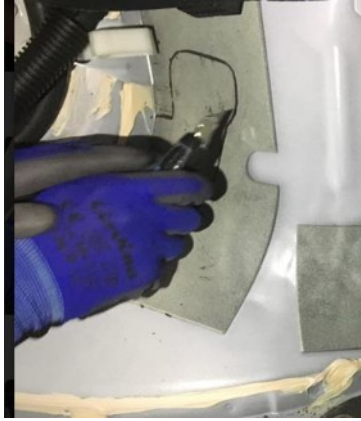
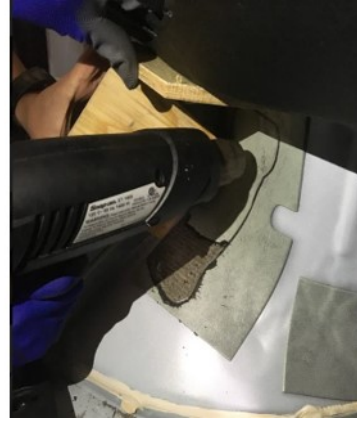
Fig. 2

Marking, Scribing and Heat Gun

4. Use the check strap bracket as a template. Once you make sure the check strap bracket fits the shock tower's geometry, mark its perimeter (Fig. 2) .
5. Using a utility knife or equivalent tool, scribe the perimeter of the check strap bracket/template into the deadener material (Fig. 2) .
6. Remove the Body Control Module (BCM) and bracket to avoid any heat buildup. Refer to the detailed service procedures available in DealerCONNECT> Service Library under: Service Info> 08 - Electrical / 8E - Electronic Control Modules / Module, Body Control (BCM) / Removal.
7. Using a heat gun, heat the central portion of the deadener material (Fig. 2) .

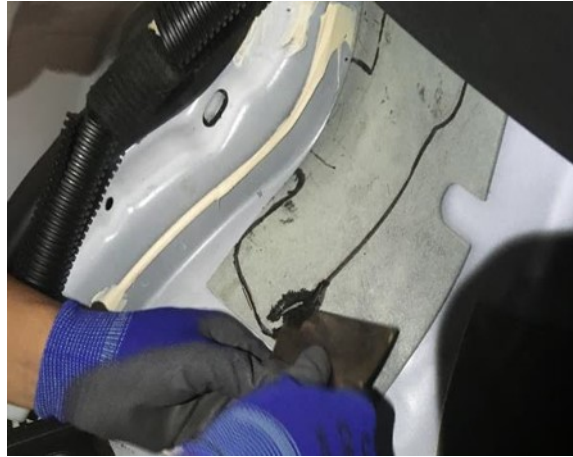
**Fig. 3**  
**Deadner Material to be Removed**

- Using the scraper remove the deadener material carefully. Do not use a hammer/mallet as this may damage the panel (Fig. 3) .

**NOTE: Confirm that there are no deadener remains on the panel inside the bracket perimeter.**

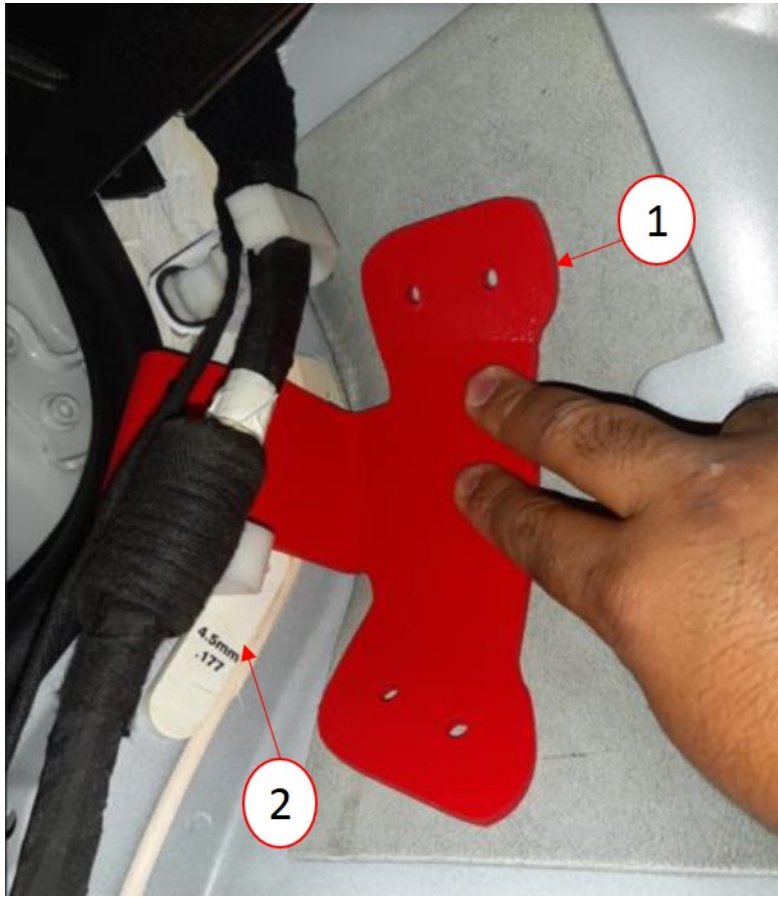
**Fig. 4**  
**Gauge**

9. Place the webbing check strap/bracket into position and confirm that the bracket rests face to face on the surface of the panel (Fig. 4) .
- Reconfirm that the 4.7 mm (.18 in) separation with the sill trim, before marking the holes (Fig. 4) .

- 1 - Bracket  
2 - Gauge
-

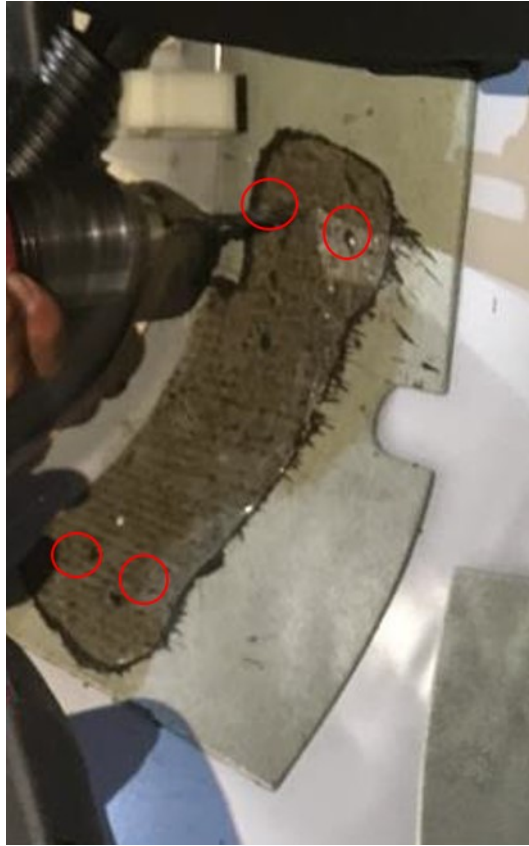
**Fig. 5**  
**Bracket Hole Locations**

10. Using the bracket as reference, mark the hole centers. Punch each center with a center punching tool, or use a center drill bit (Fig. 5) .
11. Drill thru the shock tower reinforcement, using an M6 drill bit. Use a stopper to avoid damaging suspension components on the outside of the vehicle (Fig. 5) .

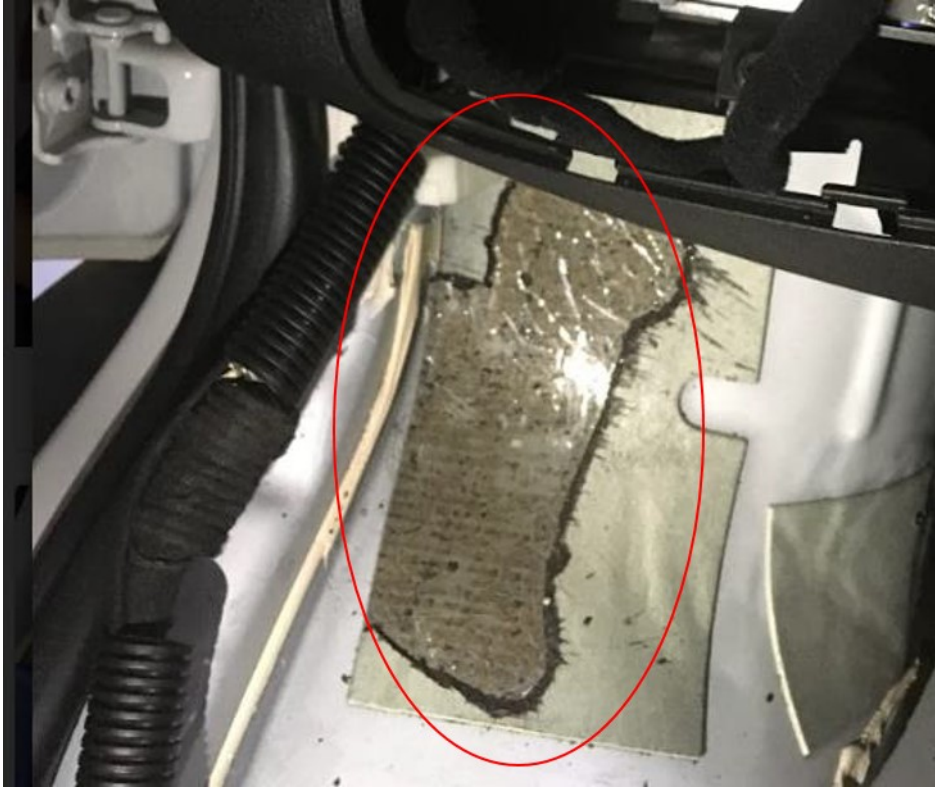
**Fig. 6**  
**Rust Inhibitor**

12. From the external side of the shock reinforcement, and using a scraper, remove a 1.5 cm X 1.5 cm (0.6 in x 0.6 in) square of anti-chipping material at each hole location.
13. From inside the vehicle prep for applying rust inhibitor sealer primer to the area where the perimeter was cut out of the deadener patch and the drilled bolt holes in the body (Fig. 6) .

**NOTE: Let the rust inhibitor sealer primer dry for 10 minutes.**

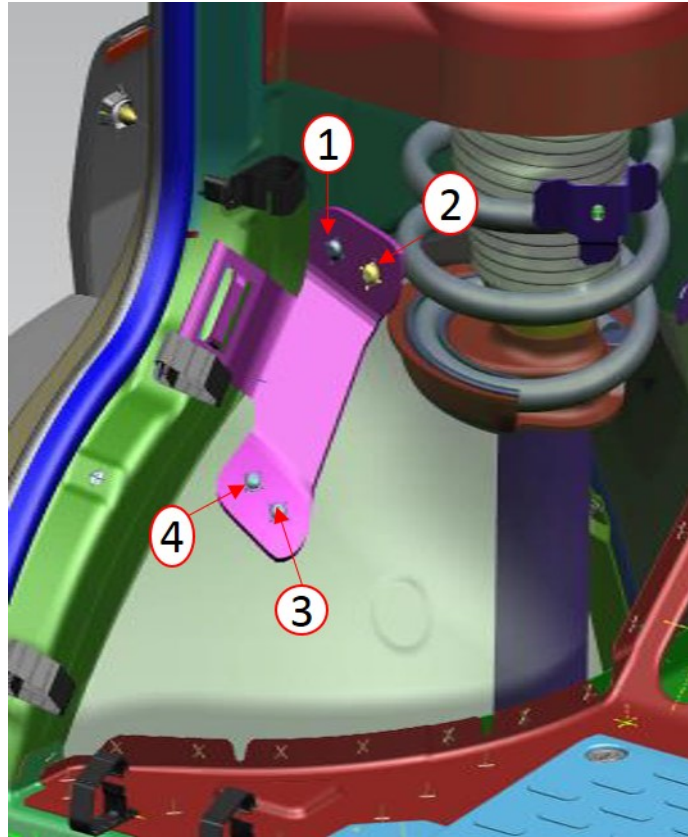
Fig. 7

15. Position webbing check strap bracket in location (Fig. 7) .
16. Install the four M6 bolts. Loctite® has already been applied to the bolts.
17. Install and tighten the four M6 nuts. Tighten to 9 N·m (79 in.lbs.) in a (1-3-2-4) pattern starting at the top left (Fig. 7) .

## Tightening Sequence (1-3-2-4)

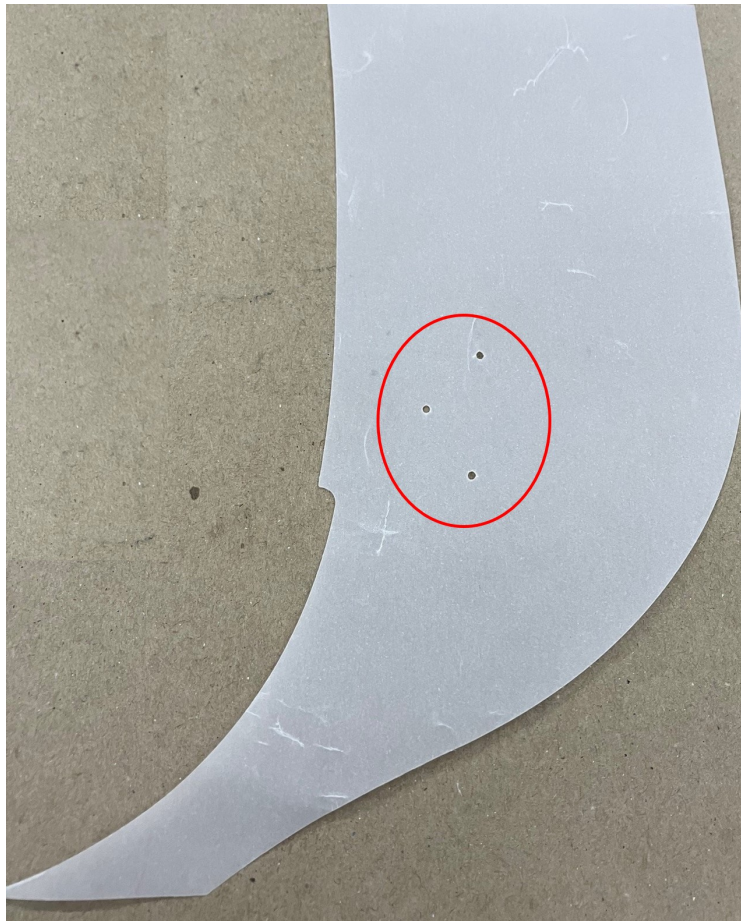
**Fig. 8**  
**Template**

- 22. **\*\*Use the door template to the contour of the door panel and the outer door contour (Fig. 8) .\*\***
- 23. Mark the hole centers according to the template (Fig. 8) .

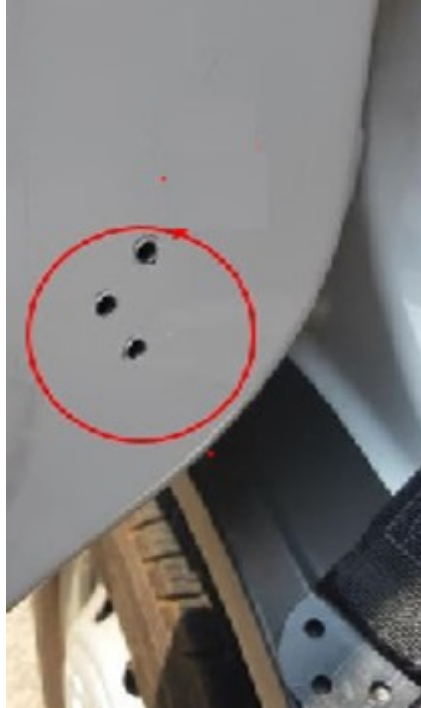
**Fig. 9**  
**Drilled Locations**

24. Drill thru the door sheet metal, using an M6 drill bit. Use a stopper to avoid damaging outer panel of the door (Fig. 9) .
25. Apply a rust inhibitor sealer primer where the holes where drilled (Fig. 9) .

**NOTE: Let the rust inhibitor sealer primer dry during 10 minutes prior to proceeding to the next steps.**

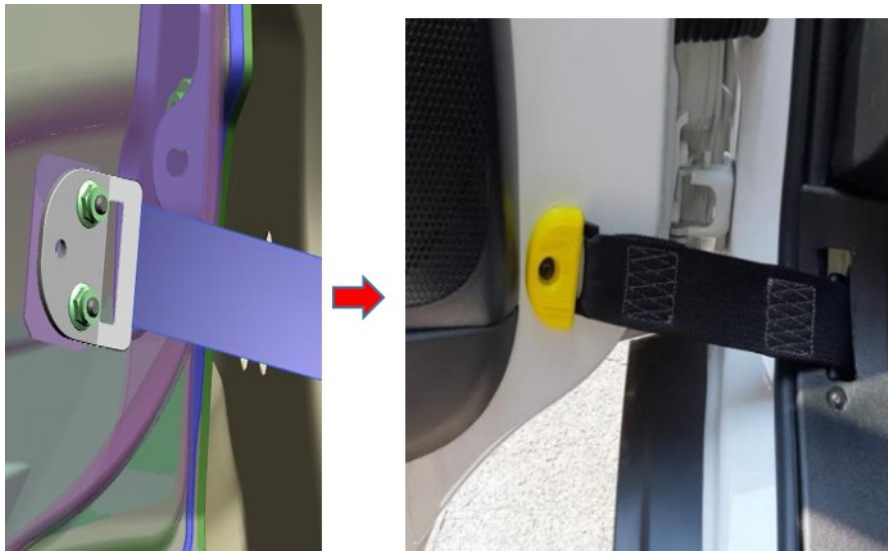
Fig. 10

26. Install the webbing check strap through the door sill trim and install door sill trim into position.
27. Position webbing check strap bracket into location (Fig. 10) .

28. Install the tapping plate bracket inside the door.
29. Install and tighten the two of the three M6 bolts (Loctite<sup>®</sup> has already been applied to the bolts) to the tapping plate bracket and the door. Tighten to 9 N·m (79 in. lbs.) (Fig. 10) .

32. Install door trim cap and the other M6 bolts (Loctite<sup>®</sup> has already been applied to the bolts) to the tapping plate bracket and the door. Tighten to 9 N·m (79 in. lbs.)(Fig. 10) .

**Webbing Check Strap Installation**
