REFERENCE:	TSB: 23-054-23 GROUP 23 - Body	Date:	May 13, 2023	REVISION:	23-040-22
VEHICLES AFFECTED:	2021 - **2023** (M1) Jeep Compass This bulletin applies to vehicles built on or after March 01, 2022 (MDH 0301XX) and on or before **April 21, 2023 (MDH 0421XX)** equipped with Branco Polar Paint (Sales Code PWA).	MARKET APPLICABILITY:			
CUSTOMER SYMPTOM:	The customers may complain about paint peeling on the front bumper on vehicles with polar white color paint.				
CAUSE:	Peeling paint in specific areas on the front bumper.

REPAIR SUMMARY:

This bulletin involves repainting the area of the front bumper that is peeling.

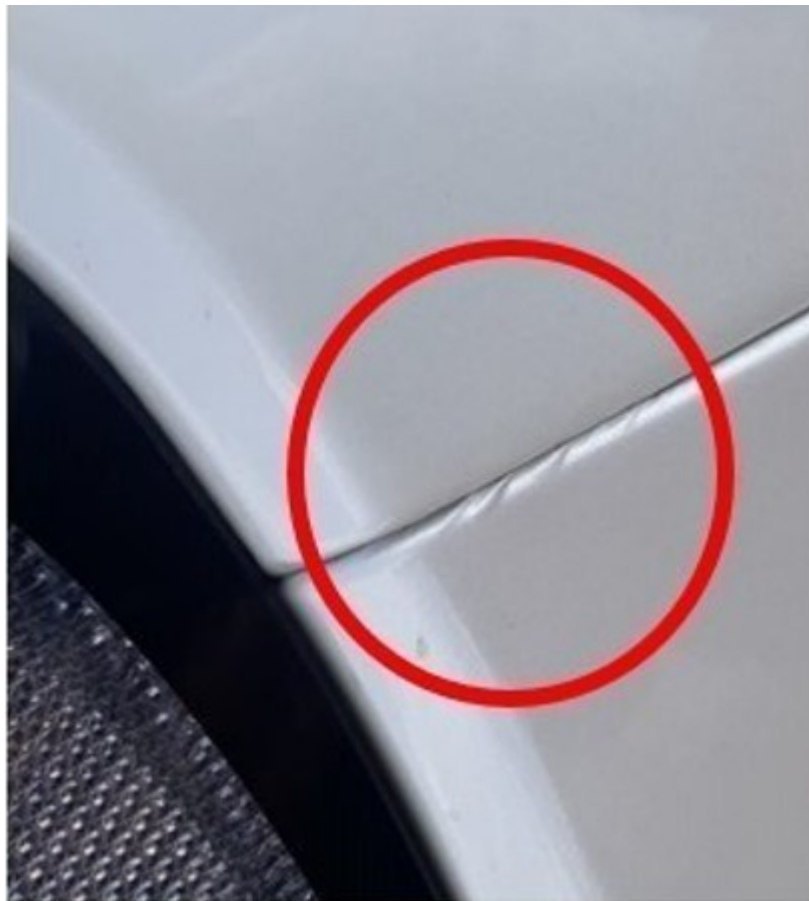
Fig. 1
Paint Peeling

1. Check for paint peeling between front bumper and fenders (Fig. 1) .

2. Is there peeling between the front bumper and the fenders (Fig. 1) ?
 - YES>>> Proceed to [Step 1](#) of the Repair Procedure.
 - NO>>> This bulletin has been completed, use inspect LOP (23-60-01-13) to close the active RSU.

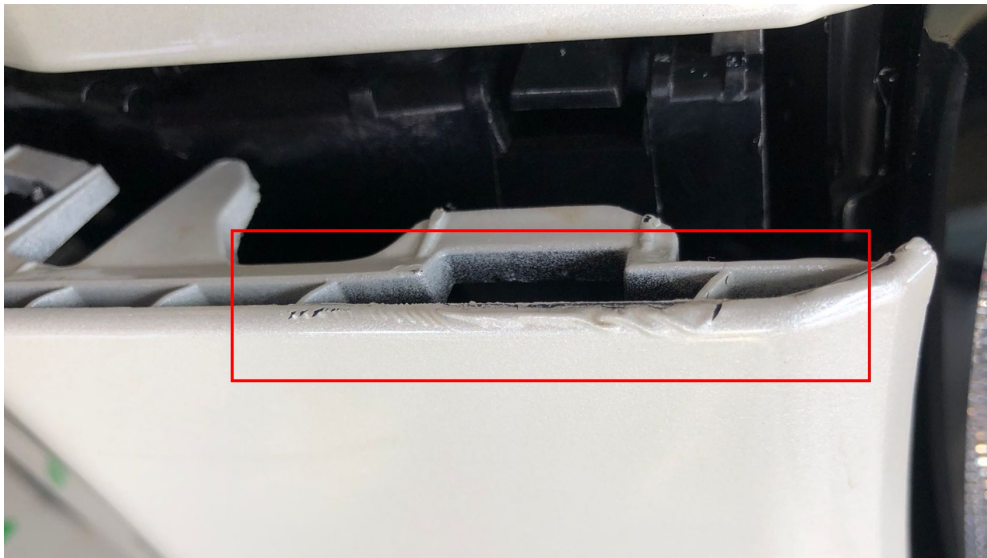
Fig. 3
Peeling Paint to be Sanded

2. Identify the peeling area on the front bumper (Fig. 3) .
