<b>REFERENCE:</b>	<b>TSB:</b> 23-047-23 <b>GROUP</b> 23 - Body	<b>Date:</b>	May 18, 2023	<b>REVISION:</b>	23-006-22 REV. C
<b>VEHICLES AFFECTED:</b>	<b>2022 (WS) Grand Wagoneer/Wagoneer</b> This bulletin applies to vehicles built on or after <b>**October 27, 2021 (MDH 1027XX)</b> and on or before <b>August 26, 2022 (MDH 0826XX)**</b> equipped with Heated Front Seats (Sales Code JPM).	<b>MARKET APPLICABILITY:</b>			
<b>CUSTOMER SYMPTOM:</b>	Front row heated seats (driver and/or passenger) will not stay on and shuts itself off in less than <b>**10**</b> minutes while occupied. (Customers will not experience a Malfunction Indicator Lamp (MIL) illumination or Diagnostic Trouble Codes (DTCs) for this symptom/condition).				
<b>CAUSE:</b>	HVAC module update.

This bulletin involves possibly updating the HVAC module with the latest software, checking the operation of the front heated seats and repairing as required.

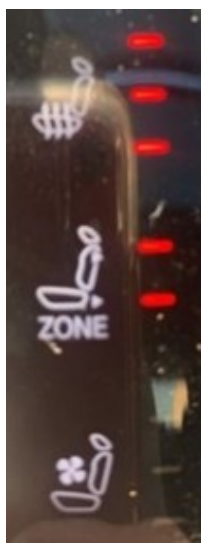
Fig. 1

Heated Seat Buttons With Red Indicators

6. Turn on the cushion and back seat heat by pushing the heat seat logo until three red indicator bars (high setting) are shown ([Fig. 1](#)) .
7. Ensure both cushion and back heat seat are both on by pushing the seat zone button until two red indicator bars are shown ([Fig. 1](#)) .

9. Did all the red indicator bars on the heated seat buttons (Fig. 1) stay activated after \*\*10\*\* minutes?
- YES>>> This bulletin has been completed. Use LOPs \*(18-50-10-AM)\* or (18-50-10-AH) depending on build dates, to close the active RSU.
  - NO>>> One or more red indicator bars turned off before 10 minutes proceed to [Step 10](#).
