STAR ONLINE PUBLICATION

Case Number: S2323000044

Symptom/Vehicle Issue: Rear Door High Closing Effort.

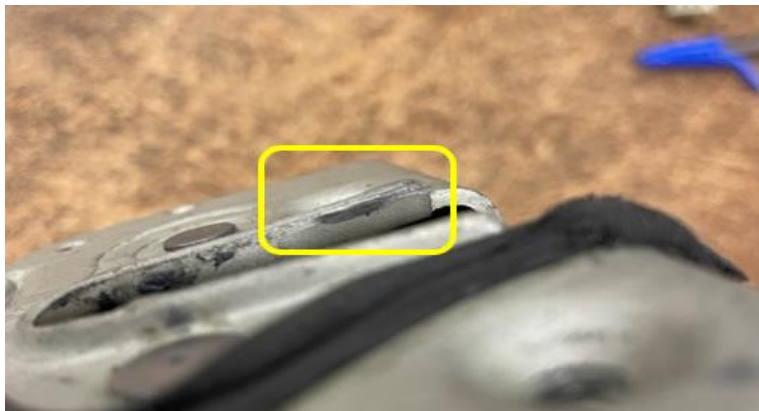
Discussion: Rear door latch parts returns to the Quality Engineering Center exhibit no failures when installed on a test vehicle. Latches do show wear marks on the fish mouth of the latch indicating the striker was contacting the latch instead of being centered (Fig 1). Review of the claims information links the replacement of the latches to a customer complaint of high closing effort. When diagnosing a vehicle with this complaint, first start with verifying door fitment, gap and flush. Refer to Service Library 23 - Body / Doors - Rear / STRIKER, Door Latch / Removal and Installation for striker information and 23 - Body / Body Structure / Gap and Flush / Specifications for information on door adjustments.

Fig 1.
Wear on door latch edge from striker contact.
