Subject		Market
Appearance concerns with Radio/Navigation Screen		USA
Service Category	Section	
Audio/Visual/Telematics	Navigation/Multi Info Display	
Applicability		
MY22 - MY24 NX MY23 - MY24 RX

2023-2024	RX350H	2024	RX450H
2022-2024	NX250	2022-2024	NX350H
2023-2024	RX500H	2022-2024	NX350
2022-2024	NX450H+	2023-2024	RX350

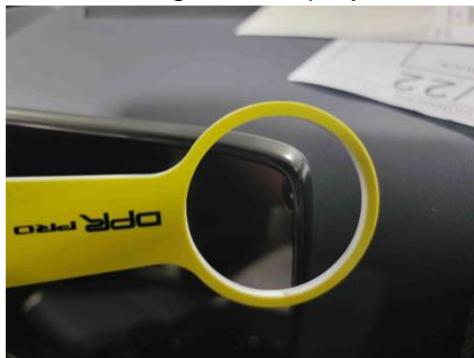
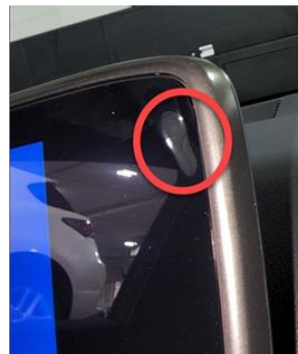
Some customers and technicians have reported the presence of bubbling, scratching, peeling or imperfections on the navigation display screen (see examples below).

The conditions mentioned above are due to a thin protective plastic film installed (see image below) on the display screen in new vehicles. It is not the screen itself that has those conditions. While this film will not interfere with normal operation of the display screen, it is intended to be removed during PDI. If any of these conditions are present on the film, please ensure to remove it.
