HYUNDAI Technical Service Bulletin	GROUP AUTOMATIC TRANSMISSION	NUMBER 23-AT-009H
	DATE JULY 2023	MODEL SANTA FE (TMA) SONATA (DN8A)
SUBJECT: AUTOMATIC TRANSAXLE (8-SPEED DCT) POSITION SENSOR DTC P070500, P070512, P070514, P07051C, P070600, P070661 & P070696 DIAGNOSIS

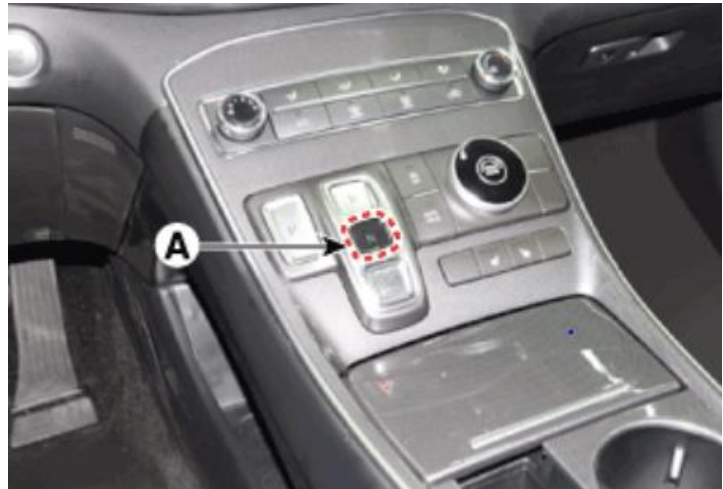
7. Push the start/stop button (SSB) two times to turn the ignition ON. Set the parking brake or place wheel chocks to prevent vehicle movement. Press the brake pedal and press the Neutral button (A) for several seconds until the cluster displays “N”. Turn the ignition off.

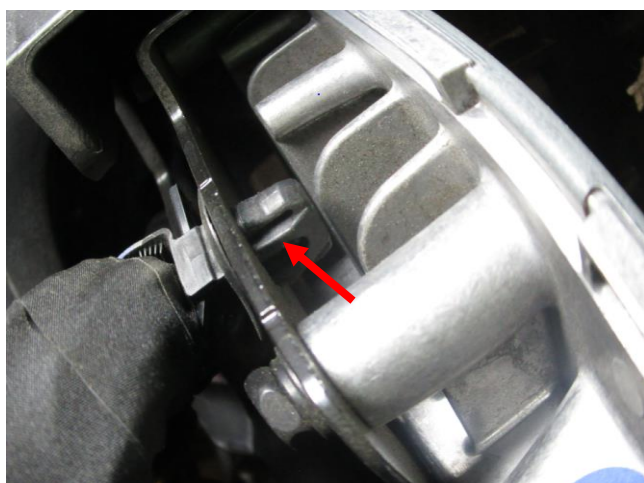
10. For some models:

Use pliers to pinch the tab and disconnect the harness from the ECM bracket.

Move the ECM bracket out of the way to access the position sensor.

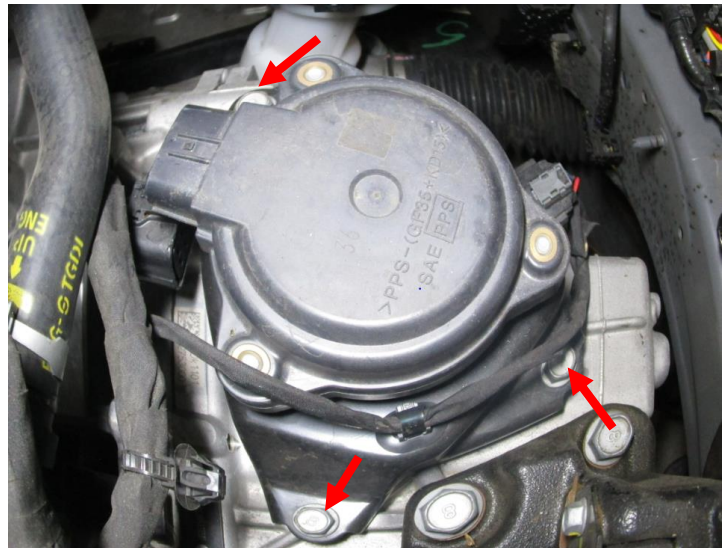
16. Reinstall the SBW actuator.
Install 3 bolts and torque to specification.
Torque: 15~19 lb-ft, 2~3 kgf.m, 21~26 N.m
Reconnect the connector.
