# **HYUNDAI** Technical Service Bulletin

GROUP	NUMBER		
CAMPAIGN	23-01-058H		
DATE	MODEL(S)		
JULY 2023	Accent (RB)

UNDERBODY CORROSION PREVENTATIVE SERVICE (SERVICE CAMPAIGN 992)

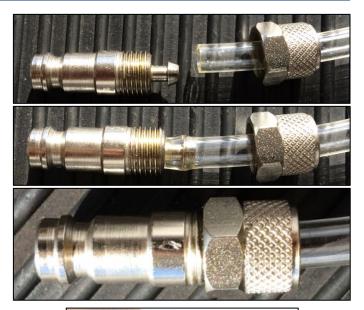
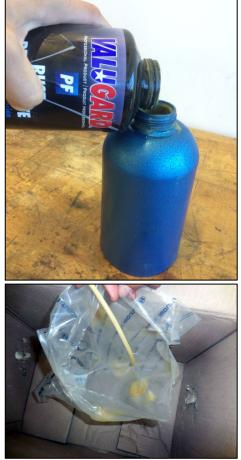
Set air supply pressure to 70 psi.

Prime the wax spray gun to increase the flow when the mist is no longer visible.

To optimize the priming process, cover the nozzle with a rag and spray until the flow has increased.

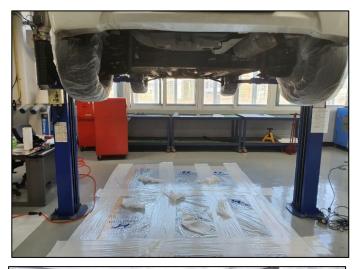
1. Lift the vehicle on a hoist.

Apply a plastic vinyl sheet on the floor.

If equipped, remove plastic undercovers to gain access to the front sub-frame, brake, and fuel tubes.

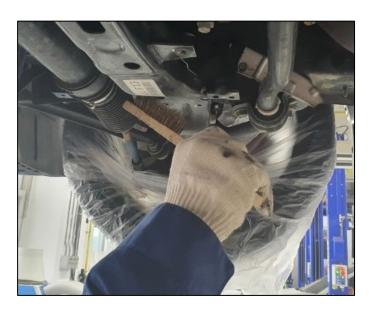
- 3. Use a wire brush to remove debris from:
  - Front sub-frame
  - Front lower arms
  - Rear CTBA

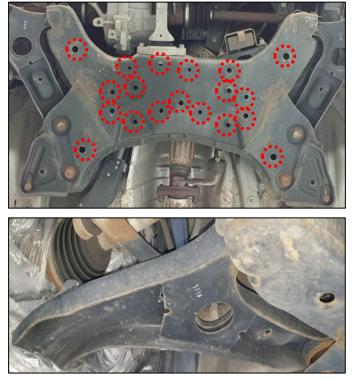
Front Underbody

- Front sub-frame
- Front lower arms

There is no internal cavity in the front lower arms. Blow air on the exterior surface to remove remaining debris.

- 5. Remove the remaining debris by inserting an air nozzle into the interior cavity of the sub-frames, control arms, and rear CTBA. Then blow air in multiple directions.

Use the marked areas as a guideline to insert the nozzle. Additional access might be possible to remove more debris.

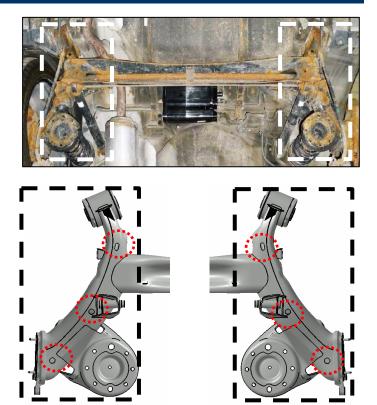
Rear Underbody

• Rear CTBA

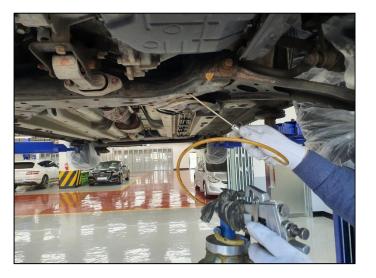
1. Use the marked areas as a guideline to insert the cavity wax nozzle. Additional access into the internal cavity of the components might be possible.

Wipe the excess wax off the exterior surfaces of the components.

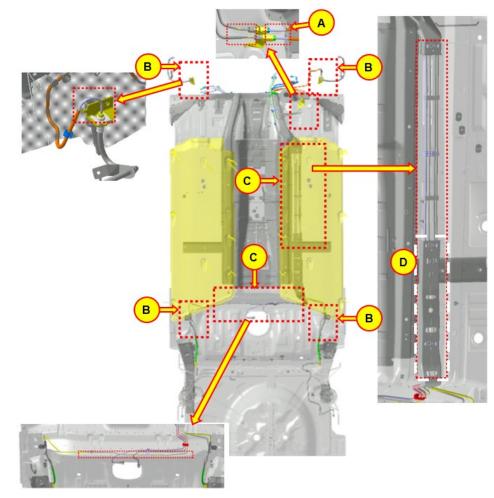
- 2. Additional brake and fuel tube brackets and connectors:
  - Brake tube 2-way connector (A)
  - Brake tube mounts (B)
  - Rear brake and fuel tubes within the area marked in (C)
  - Areas marked in the boxes next to (D)

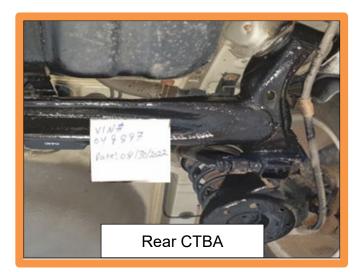
Using STUI, take clear photos of the following components after the undercoating is applied with the last 6 digits of the VIN and the date of repair on a piece of paper. See examples shown to the right.

- 1. Front sub-frame
- 2. Left front lower control arm
- 3. <u>*Right*</u> front lower control arm
- 4. Rear CTBA
