Technical Service Bulletin

GROUP**BODY ELECTRICAL****NUMBER****23-BE-011G****DATE****JULY 2023****MODEL(S)****G70 (IK)****SUBJECT:**

BLOWER MOTOR MULTI-FUSE & FUSE BOX INSPECTION,
AND FRONT WIRING REPLACEMENT
(WARRANTY EXTENSION Z02G)

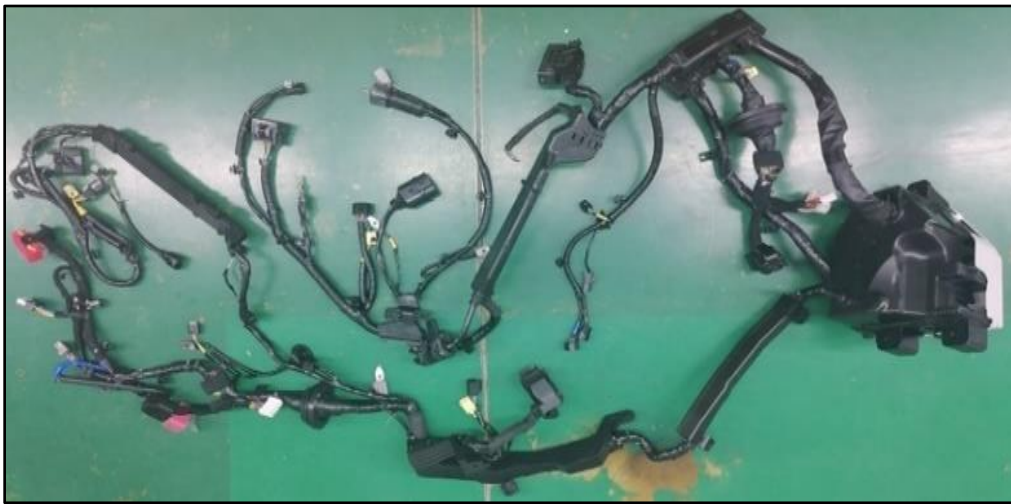
Front Wiring

Description: The warranty coverage for repairs and replacement of the front wiring on certain 2019MY G70 (IK) vehicles has been extended to 10 years or 120,000 miles from the date of original retail delivery or date of first use, whichever occurs first, and is valid for original and subsequent owners. Some vehicles may have an inoperative blower motor (not blowing). This may be caused by damage or deterioration of the blower motor multi-fuse and fuse box. Follow the procedures in this bulletin to inspect for damage or deterioration and, if necessary, replace the blower motor front wiring.

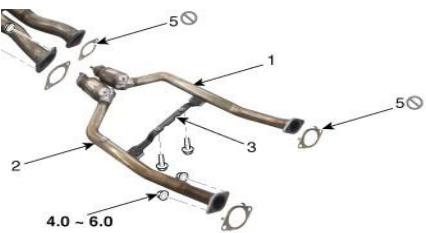
3 each
		Rear Nuts: 49339-3M000		3 each
	Front Muffler Gasket	Single: 28751-3J000	<div>Dual Muffler</div>

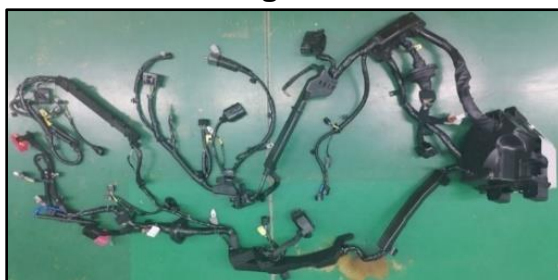
Figure:

Part Name	No.	Part Number	Part Name	No.	Part Number
Front Wiring Assembly	1	912A3-G9160	Front Wiring Assembly	23	91203-G9651
	2	912A3-G9161		24	91203-G9721
	3	912A3-G9171		25	91203-G9731
	4	912A3-G9240		26	91203-G9771
	5	912A3-G9280		27	912B1-G9371
	6	912A3-G9281		28	912B1-G9400
	7	912A3-G9840		29	912B1-G9401
	8	91203-G9761		30	912B1-G9370
	9	91205-G9761		31	912B1-G9411
	10	912A3-G9320		32	912B1-G9420
	11	912A3-G9321		33	912B1-G9421
	12	912A3-G9170		34	912B1-G9431
	13	912A3-G9241		35	912B1-G9481
	14	912A3-G9250		36	912B1-G9490
	15	912A3-G9251		37	912B1-G9491
	16	912A3-G9290		38	912A3-G9331
	17	912A3-G9291		39	91212-G9171
	18	912A3-G9330		40	91212-G9181
	19	912B1-G9360		41	91212-G9291
	20	912B1-G9361		42	91212-G9311
	21	912B1-G9410		43	91212-G9321
	22	91203-G9641		44	91212-G9331

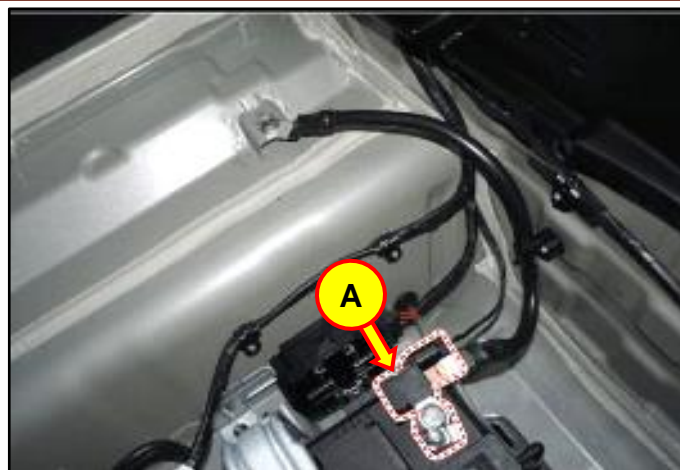
Open the trunk of the vehicle and disconnect the negative (–) battery terminal (A).

lb-ft	6.5
lb-in	78
N.m	8.9
