BODY/CHASSIS

LOADSPACE COVER DAMAGED/SAGGING

Defender

- 20-23MY Defender

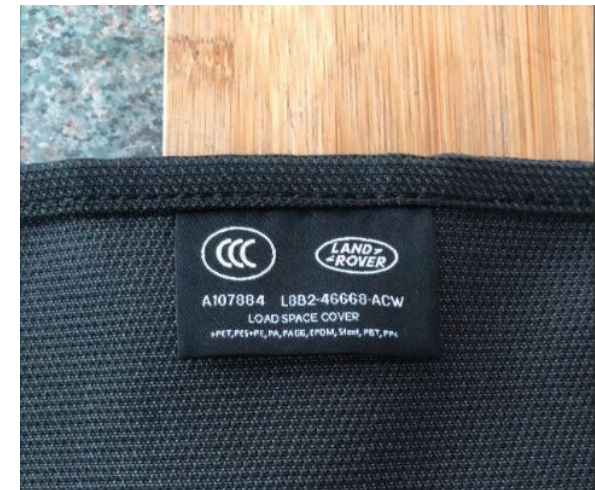
- This may be caused by incorrect installation of the loadspace cover. The cover must be installed orientated with the label on the underside of the fitted cover.

- **SSM 76011** has been published to address this concern, providing a clear graphic for correct installation guidance.
