## Front Spotlight Electrical Update

| <b>Bulletin #(s):</b> | 23-101 | <b>Make(s):</b> | Jayco & Entegra Coach |

| <b>Incident:</b> | Current on the spotlight is pulling higher amps than acceptable causing issues with Firefly. |

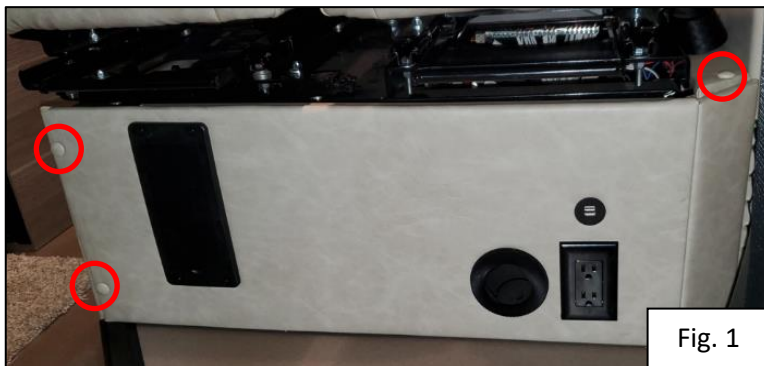
Fig. 1

1. Remove the Driver Seat
  - A. Cut the zip ties securing the OEM seat wire harness.
  - B. Using an E12 Torx Socket, remove the (4) fasteners securing the seat.
  - C. Remove the seat from the unit.
2. Remove the buttons and the fasteners from the Mid-Seat Access Cover.  
(Figure 1)

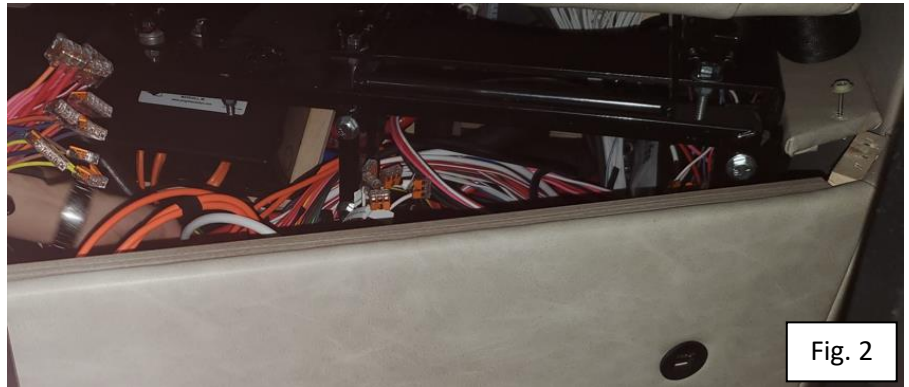
Fig. 2

3. Pull the Mid-Seat Access Cover forward to gain full access. (Figure 2)

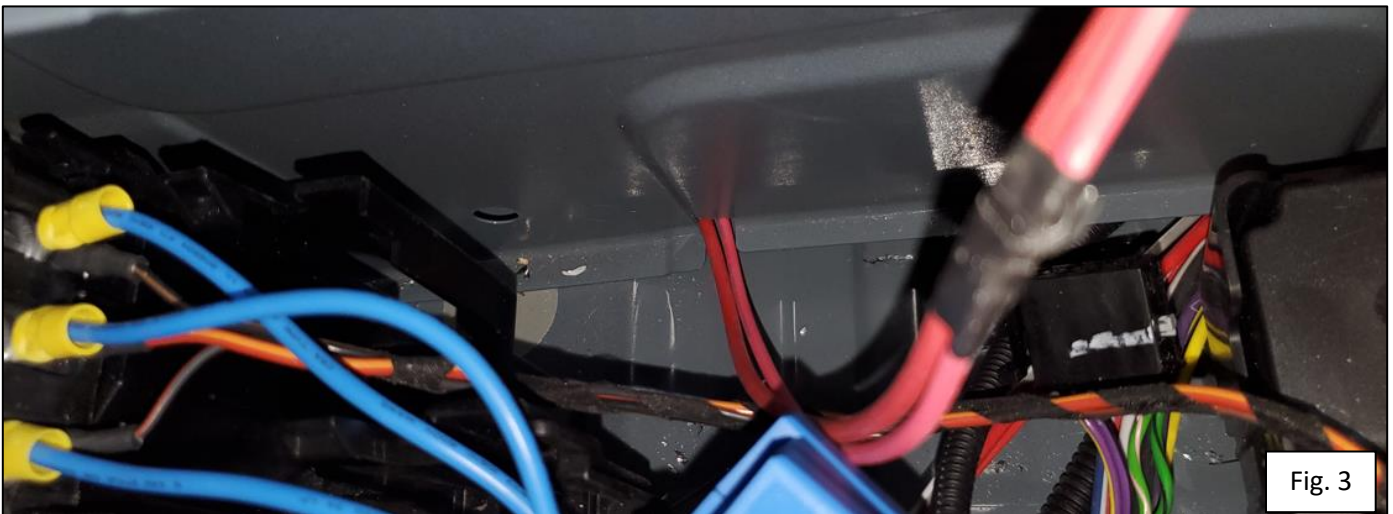
Fig. 3

4. Route the Pink and Red wires from the relay harness jumper (Figure 3)
  - A. Locate the outer support block on the step assembly.
  - B. Route the Pink and Red wires from the Mid-Ship seat area to the driver seat base.

- C. Reaching down inside the OEM seat base to the pass-thru opening, locate the wires and pull through
5. Remove the cover plate installed over the (3) OEM mounting studs.
6. With a ratchet, extension and 10mm socket, remove the mounting nut from the center stud. (Figure 4)

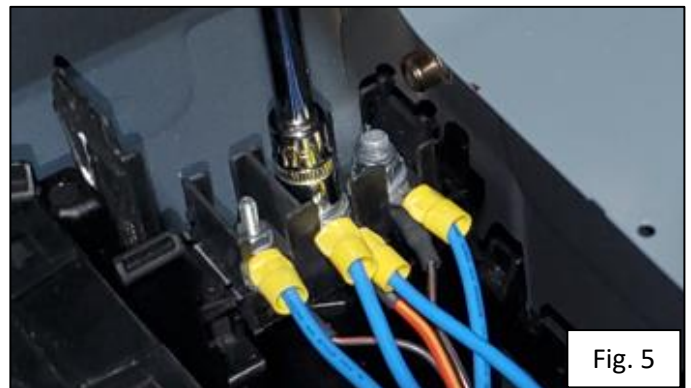
Fig. 5

7. Add a 15A inline fuse holder to the center stud and tighten. (Figure 5)

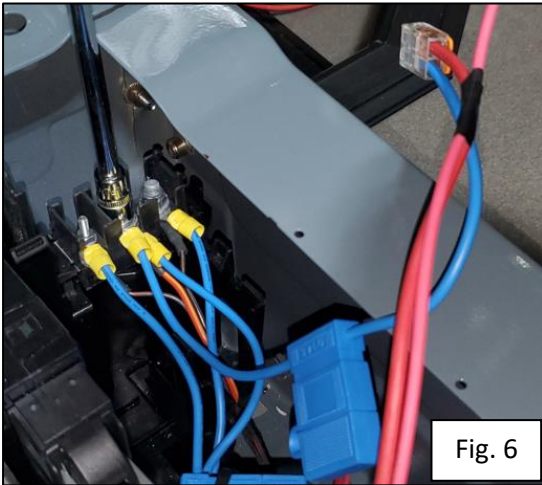
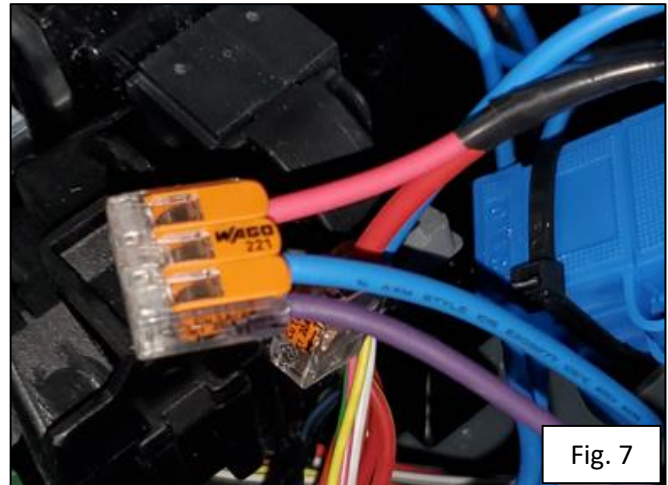
8. Re-install the cover plate.
9. Using wire strippers, strip the pink and red wires.
10. Electrical connections at OEM Seat Base.
  - A. Connect the 12GA Red wire to the 15A Inline fuse in a Double WAGO. (Figure 6)
  - B. Remove the Double WAGO from the Purple and Blue inline fuse holder which is mounted to the rear stud. Connect the 14GA Pink wire to the Purple and Blue inline fuse holder in a Triple WAGO. (Figure 7)

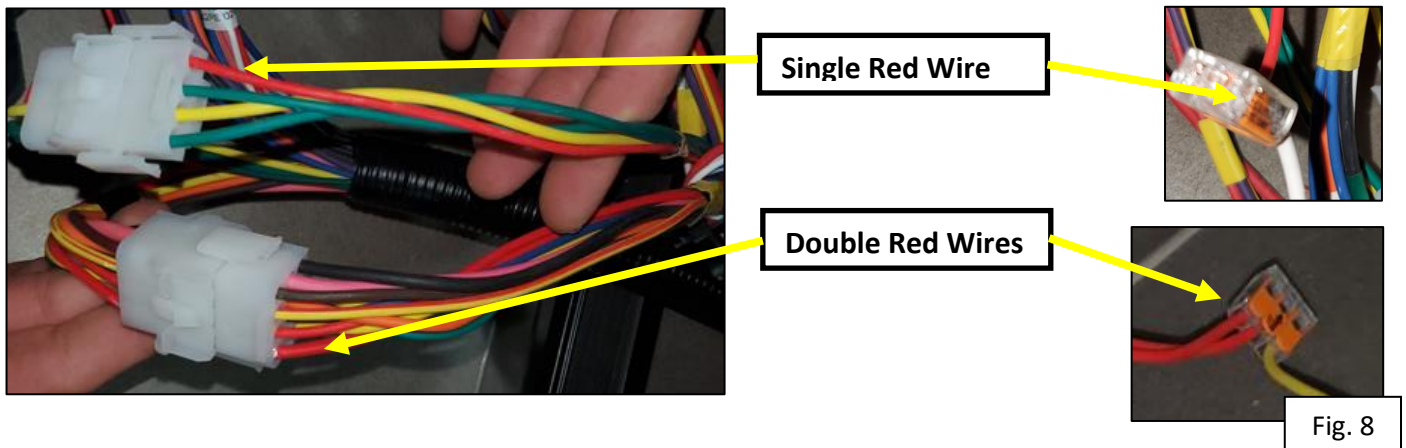
11. Electrical connections at the Mid-Ship Seat Base.
  - A. Locate the connectors at the G12. (Figure 8)
  - B. Cut the Red wire before the 4-pin plug (harness side with Yellow tape) and connect with 14GA White wire (from relay harness assembly) in a Double WAGO.
  - C. Cut the double Red wires before the 12-pin plug (harness side with Yellow tape) and connect with 12GA Yellow wire (from relay harness assembly) in a Triple WAGO.

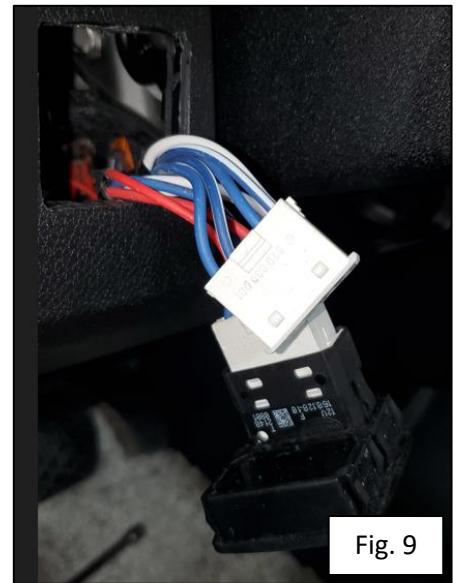
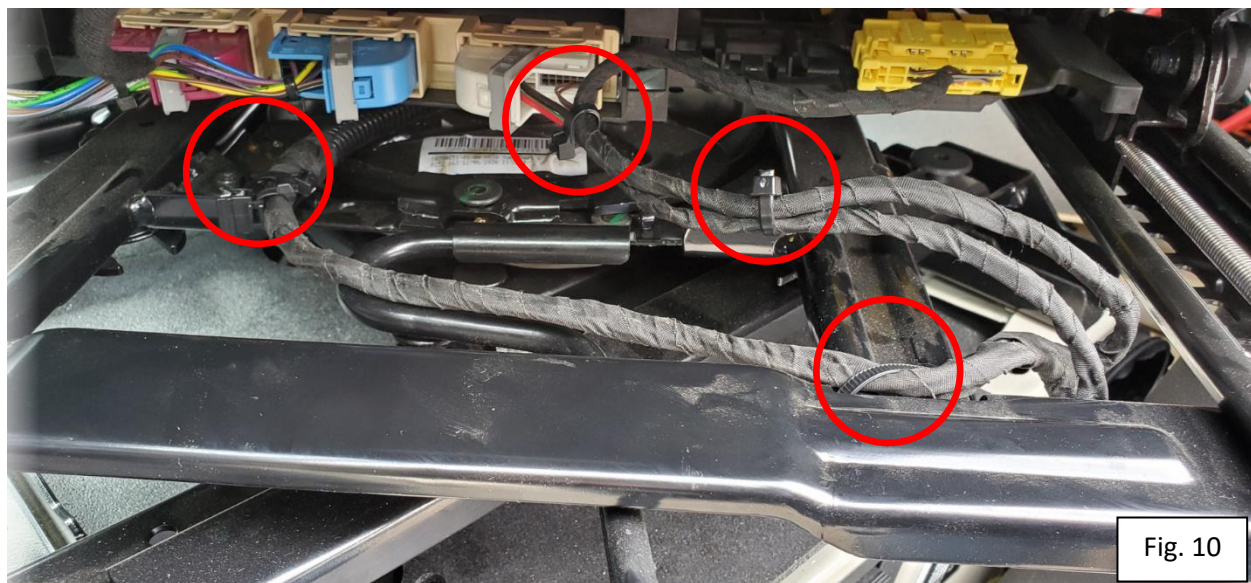
21. Double check OEM seat harness are secure at the four OEM locations. (Figure 10)

**Note:** Seat Bolts should be finger started to prevent cross-threading.
20. OEM seat harness must route through the rear foam isolator to allow seat to swivel freely without harness concerns.
