Technical Service Bulletin

Subject: WHITE STAINS FROM UNDER OUTER MIRROR BASE	Bulletin No.: 09-014/23
	Last Issued : 07/13/2023

DESCRIPTION

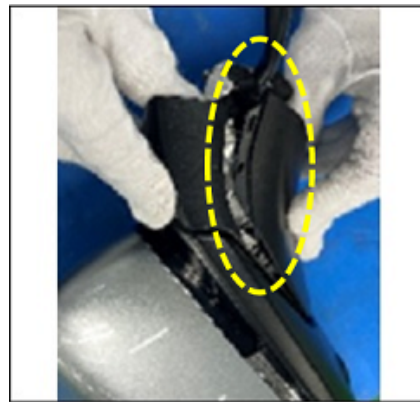
Detail of the removal of the base cover (lower)

Removal of (3)

Removal of (4)

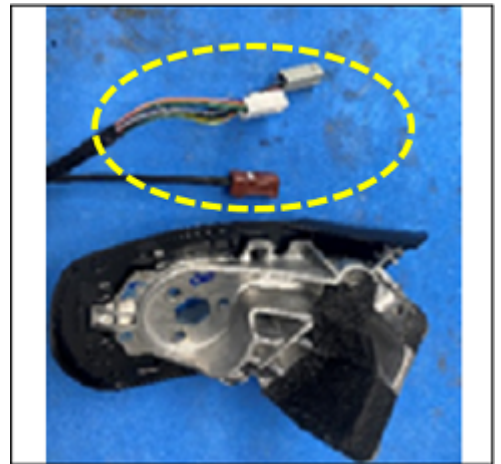
f. Remove the harnesses (1), (2), and (3) from the inner base.

NOTE: Removal order - 1st: White (1), 2nd: Gray (2), 3rd: Brown (3)

- (1) Connector: White
- (2) Connector: Gray
- (3) Connector: Brown

Finished to pull out

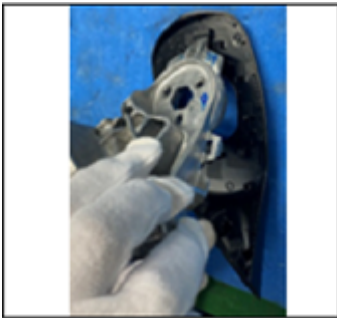
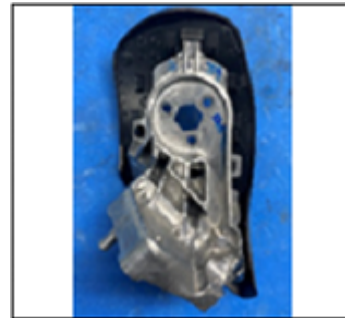
h. Pass the harnesses through the inner base with the base cover (upper).

NOTE: Pass the harnesses through the inner base in the reverse order of pulling them out.

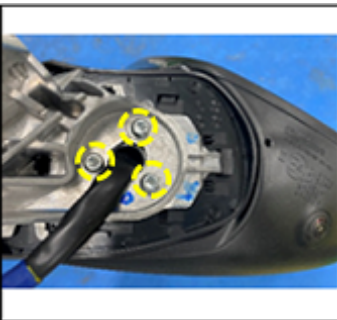
i. Screw the inner base to the outer mirror base.

Specified tightening torque: 4.4±0.7 ft-lb (6.0±1.0 Nm)

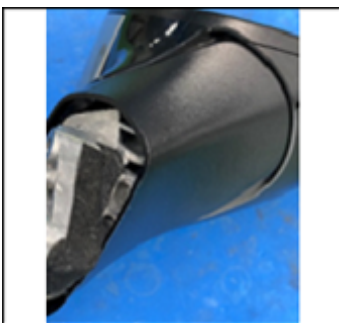
l. Align the outer edges of the base cover (upper) and the base cover (lower) and assemble them so that there are no gaps.

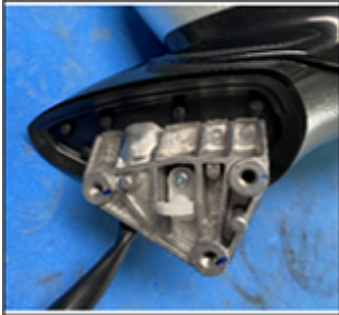
m. Assemble the seal rubber and the clip to the outer mirror base so that the seal rubber fits properly.

Specified tightening torque of the seal-rubber fastening screws: 11 ± 1.7 in-lb (1.25 ± 0.2 Nm)

- Reuse the seal rubber, the clip, and the screws fastening the seal rubber, which are removed at step 2.
- The seal rubber should not be curled and/or deformed.
