<b>Subject:</b>  REAR MOUNT CAMERA IMAGE NOT CLEAR/NO IMAGE ON SCREEN	<b>Bulletin No.:</b> 09-031/20
	<b>Last Issued :</b> 09/21/2020

2014-2018 Mazda3 5-door HB  
2016-2019 CX-3

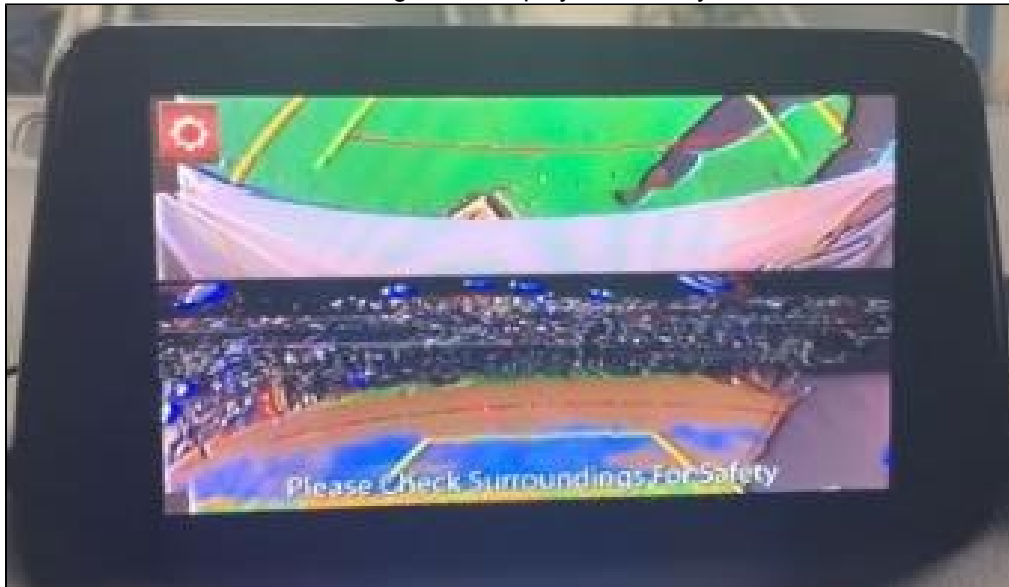
Some vehicles may exhibit a distorted image or no image from the rear mount camera when shifted into reverse. Due to friction, the coating of camera socket terminals may wear out, creating high electrical resistance.

**NOTE:** The icons and the messages are displayed normally.

Customers having this concern should have their vehicle repaired using the following repair procedure.
