# Service Memorandum

## SM 23-01: High Motor Temp Caused By Heater Valve In The Off Position

- EV BBCV-T3 product manufactured between January 1, 2018 through February 1, 2022

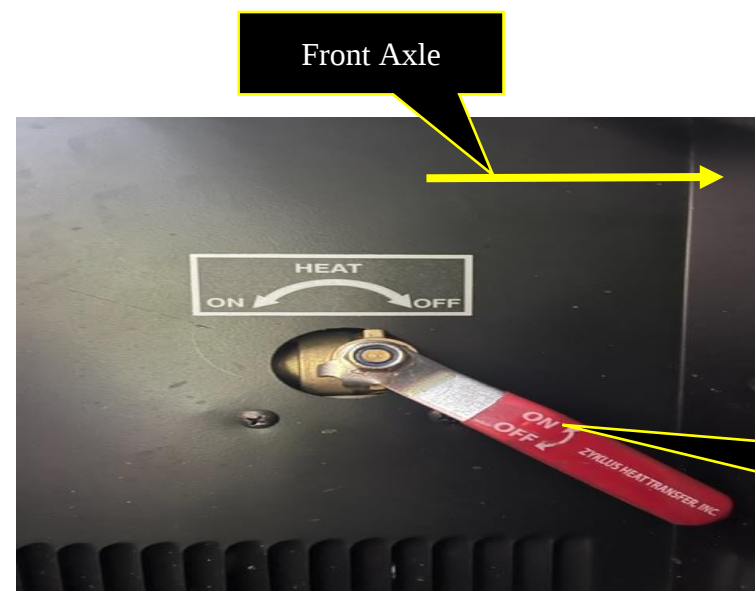
- For type C bus: The manual coolant valve is in the OFF position. The coolant valve is located on the left side of the driver's seat.
- For type D bus: The temperature knob on the OEM heater control panel is in the max cold position. The knob is located on the vehicle dashboard.

- For type C bus: Turn the manual coolant valve to the ON position and test drive bus.
- For type D bus: Turn the temperature knob to the max hot position and test drive bus.
