GROUP	MODEL
Service Campaign	2023MY Telluride (ON)
NUMBER	DATE
SC274	August 2023

## VOLUNTARY SERVICE CAMPAIGN

### POSITIVE BATTERY TERMINAL NUT RE-TIGHTENING (SC274)

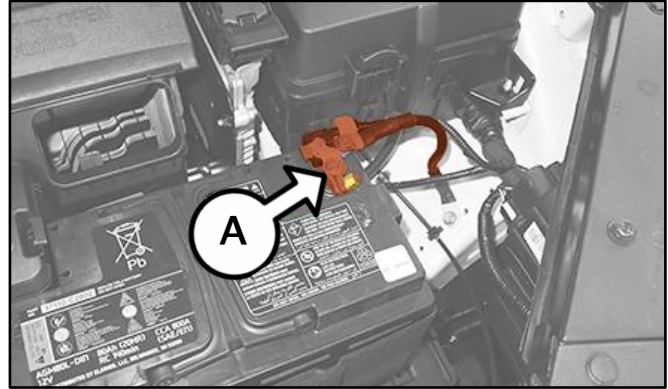
1. Open the hood and disconnect the battery negative (-) terminal (A).

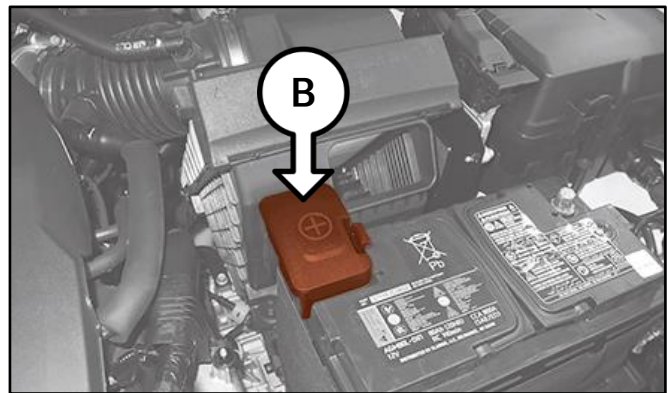
2. Detach/open the battery positive (+) terminal cover (B).

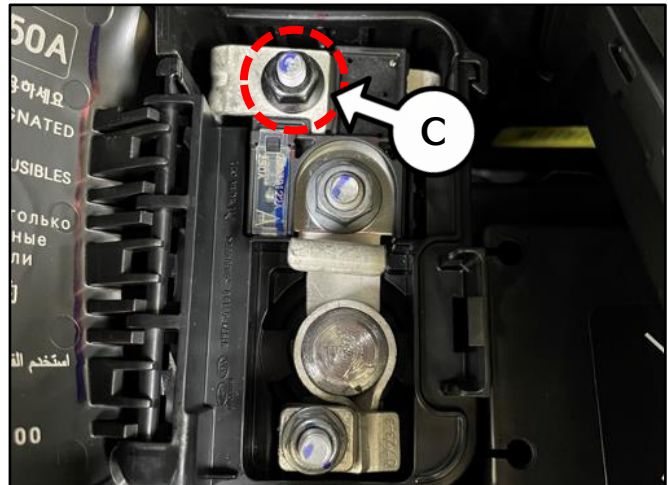
3. Confirm that the positive (+) terminal nut (C) shown is secured and tightened to specification:

Tightening torque for nut (C):  
86.8 - 104.1 lb.in. (9.8 - 11.8 N.m)
