STAR ONLINE PUBLICATION

Case Number: S232400009

Symptom/Vehicle Issue: Driver Side Vents Blow Warm/Cool Air On When Using AC.

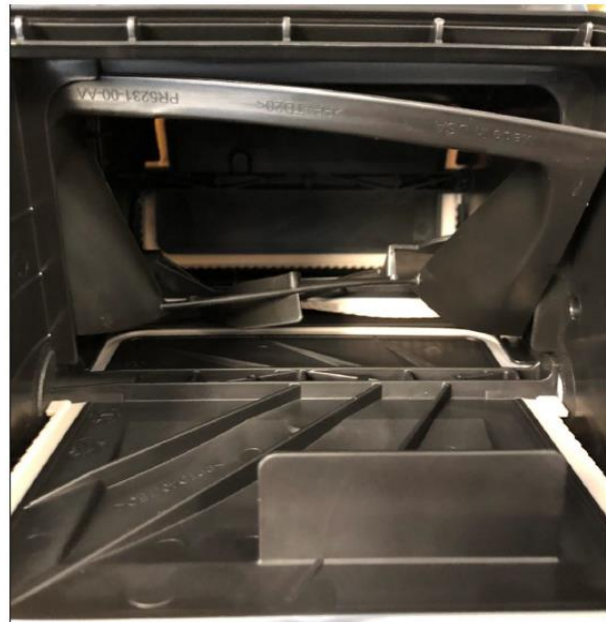
Discussion: Inspect drivers side temp door for full range of movement. When manually moving the door from the actuator location, if it is felt to only be moving partially or has resistance, the HVAC assembly needs to be removed and inspected for internal box binding. The distribution channel may come in contact with the temp door and prevent full range of motion.

The reference image is an example of how the distribution housing can enter the doors range of motion and prevent proper operation.

The housing will need to be replaced, prior to replacement ensure the new housing does not have this condition.
