## STAR ONLINE PUBLICATION

**Case Number:** S2323000020 Rev. A

**Symptom/Vehicle Issue:** Power Side Steps Reverse, Stop In Motion, And/Or Do Not Deploy Or Stow

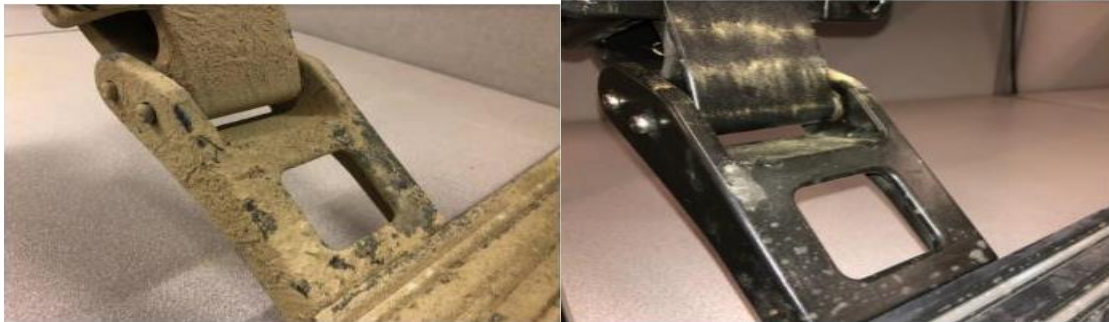
Fig 1  
Before and after pressurized water cleaning

2. Inspect the pivots and linkage of the PSS. If there is dirt/debris buildup, clean between the links and bushing ends/tracks using high-pressure water. The use of a car wash wand is best to prevent excessive water pressure from damaging nearby components. See Fig 1

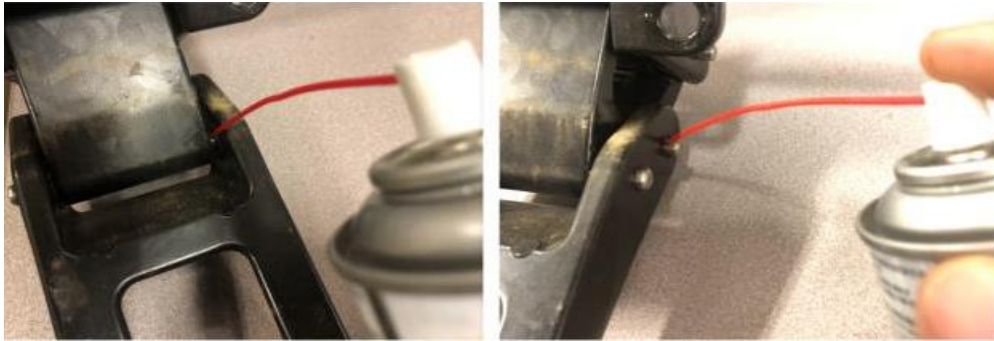
Fig 2

Pivot points (16 per side step)

3. Use a Penetrating spray like MP-50 MOPAR Rust Prevention Lubricant 04549626AD and continue to clean the bushing/pivot locations of both running boards. This will help remove any embedded corrosion/debris that pressure washing may not have removed. If any leftover corrosion/debris is present after using the penetrating spray, perform step 2 again followed by step 3 until corrosion/debris is completely removed from the pivots.
4. Use compressed air to dry the surfaces and remove further debris from the pivots and linkage.
5. Once clean and dry, cycle (extend and retract) the PSS 5 to 10 times to verify operation.
6. Apply MOPAR Spray White Lithium Grease 04318066AE to the pivot points (Fig 2 and 3). Remove excess lubricant with a shop towel. Deploy and retract the PSS 5 to 10 times.
