STAR ONLINE PUBLICATION

Case Number: S2323000035 Rev. A

Symptom/Vehicle Issue: Installing Rear License Plate, License Plate Not Completely Visible as Expected

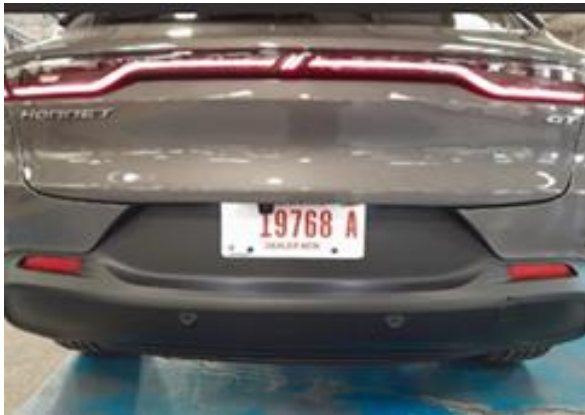
Technician Observation: The license plate does not display in full as expected.

Plate Installed Incorrectly - Too High

Discussion: License plate installation for North America market vehicles requires a license plate bracket. Rear plate bracket 68607295AA and 3 self-tapping screws 68113529AA should be in the vehicle upon delivery from transport. See Pg 1 and 2.

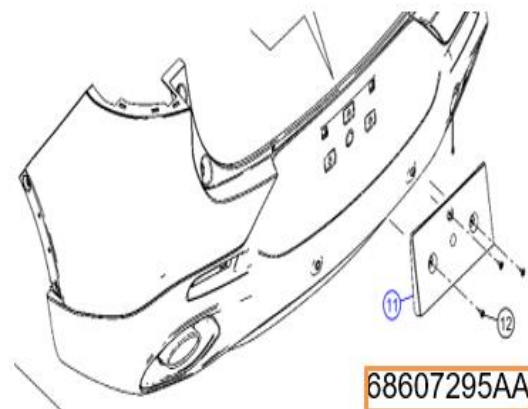
Plate Bracket and Screws
