CUSTOMER SATISFACTION NOTIFICATION

Incorrect Grille Insert Color

Reference: 51A

2022 - 2023 (JL) Jeep Wrangler

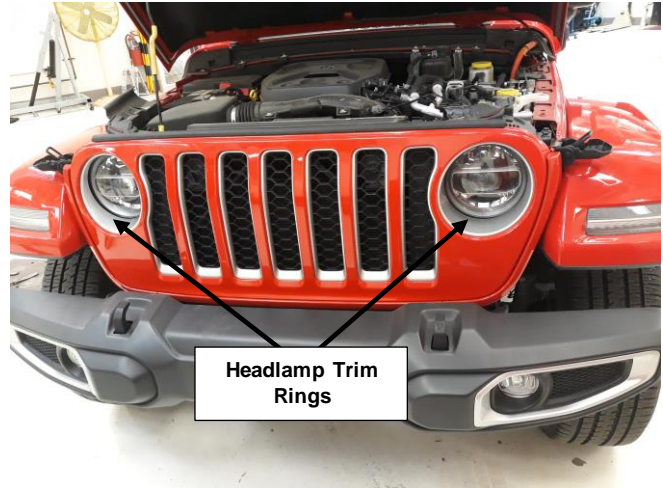
Figure 1 – Grille Insert

1. Visually inspect the headlamp trim rings color (Figure 1).

- Are the headlamp trim rings black in color?

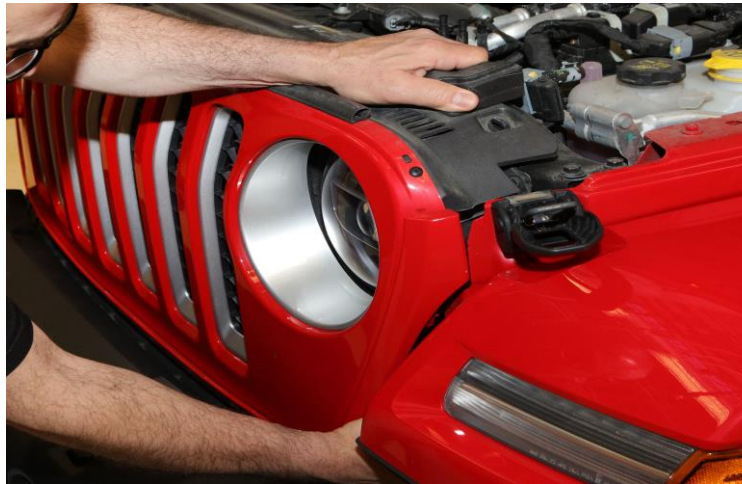
Figure 3 – Grille Removal

4. Grasp the lower portion of the grille and carefully pull out to release the lower clips (Figure 3).
5. Separate and remove the grille.
