Keystone RV Company

SERVICE ADVISORY # 23-445

Arcadia Rear Wall

It has been determined that on certain rear living room models the rear wall is attached at the roof, and sidewalls, but may not be properly attached to the floor. The following procedure describes how to properly attach the floor to the rear wall.

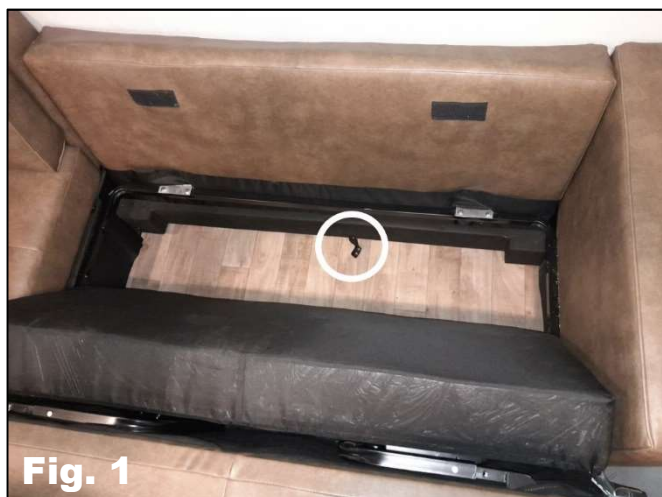
Fig. 1

Move the rear sofa away from the wall. It will be attached using nylon straps and screws. On L-shaped sofas, the rear piece will need to be removed, then the corner, and so on. See Figure 1.

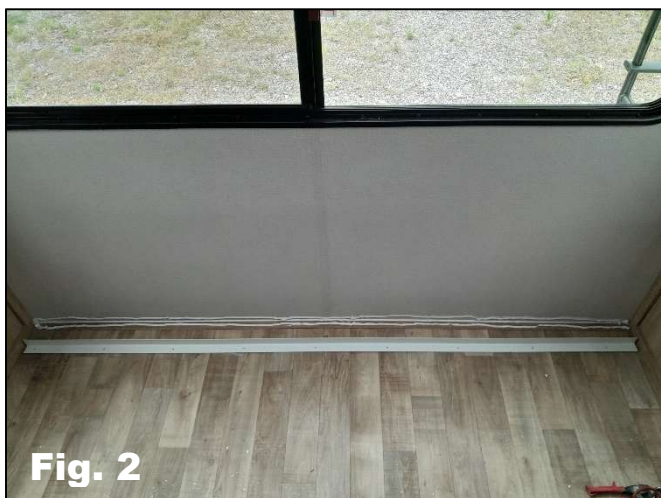
Using silicone adhesive or construction adhesive and #10 x 1" screws every 8" to 10", attach the angle to the rear wall first and then to the floor. The construction adhesive should completely seal where the rear wall and floor meet to prevent being able to see daylight. Figures 2 & 3.
