Service Action

Code: 60E2

Subject	Front Sunroof Drain Cleaning & Modification – USA ONLY								
Release Date	August 22, 2023								
REVISION SUMMARY	<ul style="list-style-type: none"> • Reopening this service action for unrepaired vehicles in order to support a class action settlement. • Updated expiration date for this service action to 02/22/2024 								
Affected Vehicles	<table border="1"> <thead> <tr> <th>Country</th> <th>Beginning Model Year</th> <th>Ending Model Year</th> <th>Vehicle</th> </tr> </thead> <tbody> <tr> <td>USA</td> <td>2018</td> <td>2019</td> <td>ATLAS</td> </tr> </tbody> </table> <p><i>Check Campaigns/Actions screen in Elsa on the day of repair to verify that a VIN qualifies for repair under this action. Elsa is the <u>only</u> valid campaign inquiry & verification source.</i></p> <ul style="list-style-type: none"> ✓ Campaign status must show “open.” ✓ If Elsa shows other open action(s), inform your customer so that the work can also be completed at the same time the vehicle is in the workshop for this campaign. 	Country	Beginning Model Year	Ending Model Year	Vehicle	USA	2018	2019	ATLAS
Country	Beginning Model Year	Ending Model Year	Vehicle						
USA	2018

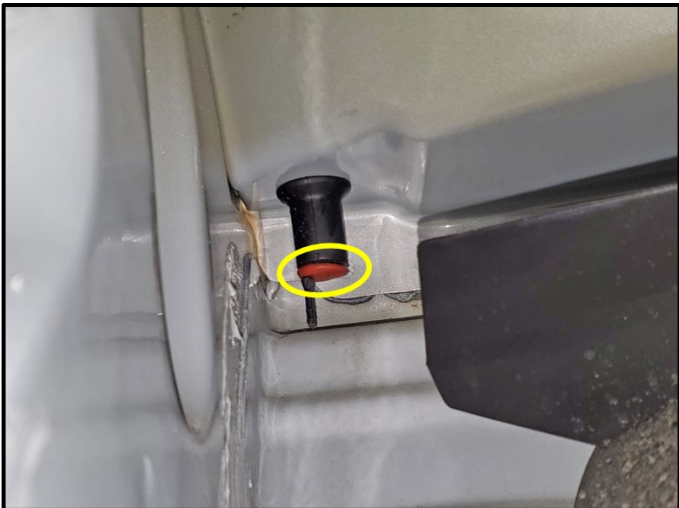
- Remove flaps from left front and right front sunroof drains.

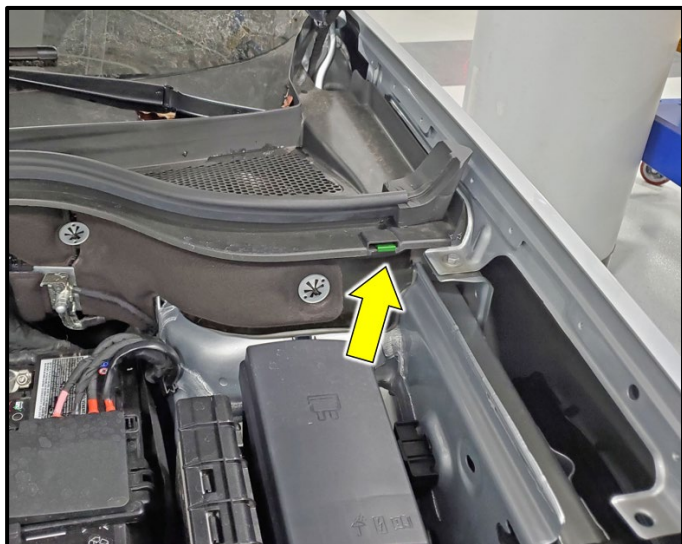
Remove plenum chamber cover clips:

- Remove the outer most plenum chamber cover clip <arrow> on the left and right plenum chamber covers.

Left side shown. Procedure for right side is similar.

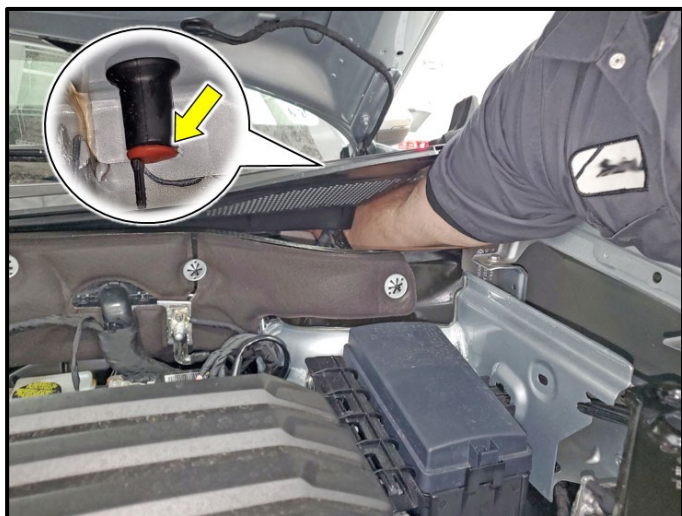
Removing sunroof drain flap:

- Carefully lift the plenum chamber cover approximately 15 cm.
- Reach in along the outer edge of the plenum chamber (between the wiper transmission and the plenum chamber on the left side).
- Carefully remove the red sunroof drain flap <arrow> downward off the sunroof drain.
- Repeat on the opposite side.

When working during extreme temperatures, it is recommended that the vehicle be allowed to acclimate inside the shop to avoid temperature-related component damage/breakage. Damage to plenum chamber covers will not be covered under this action.

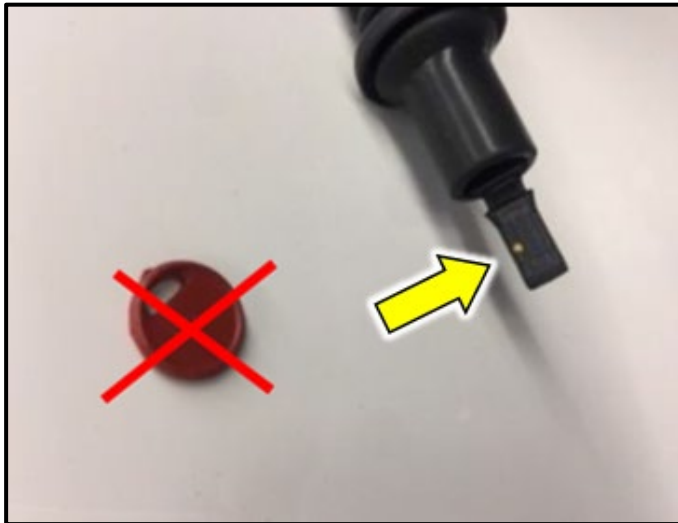
DO NOT remove the sunroof drain from the vehicle. The tab <arrow> on the sunroof drain remains on the sunroof drain. The red flap can be discarded.

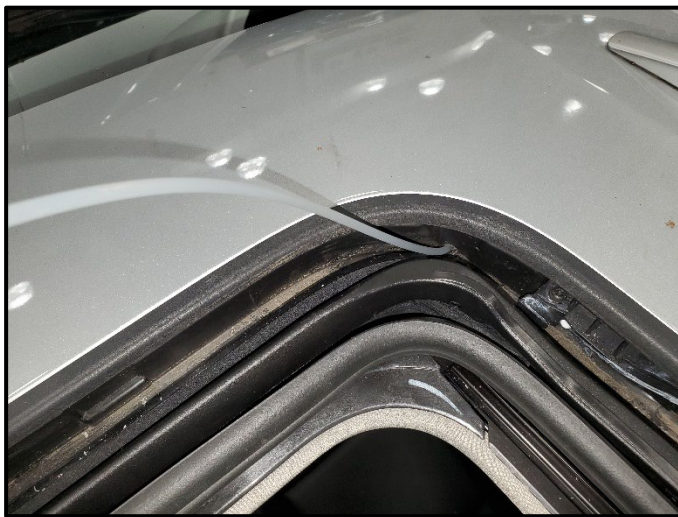
Clean the sunroof drains:

- Clean both front sunroof drains using the -VAS6620- (or equivalent).

DO NOT use extra force if resistance is encountered when using the -VAS6620-. Doing so could result in damaging the sunroof drain or disengaging the sunroof drain from the sunroof. Damage to the sunroof drain or time to reattach the sunroof drains to the sunroof will not be covered under this action.

The -VAS6620- will exit the sunroof drain tube in the plenum chamber after approximately 120 cm.

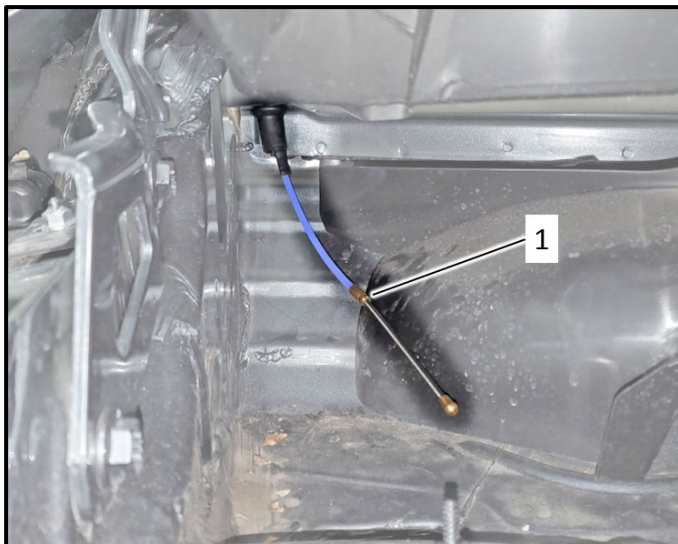
If the -VAS6620- cannot be removed out of the sunroof drain, the end of the tool <1> can be unscrewed and the tool can then be easily removed.

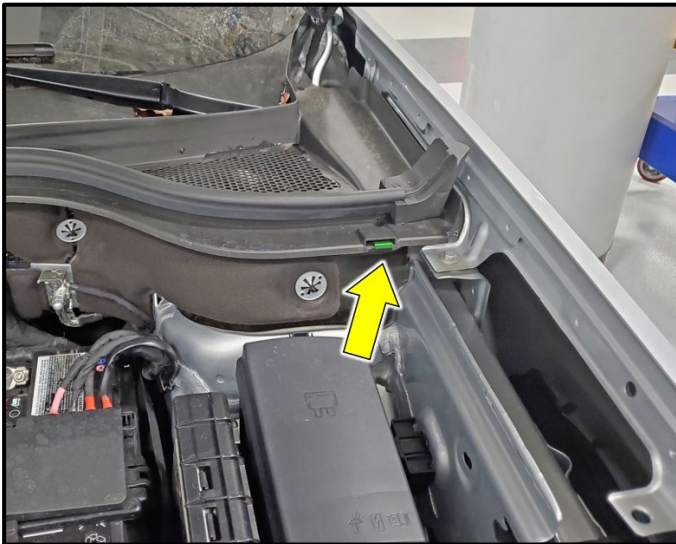
Reinstall the plenum chamber covers:

- Installation is the reverse order of removal.
- Ensure all seals are in place.
