Technical Service Bulletin

60 Water entry into cabin from the sunroof area

60 23 67 2056944/9 August 23, 2023. Supersedes Technical Service Bulletin Group 60 number 21-56 dated October 28, 2021 for reasons listed below.

Model(s)	Year	VIN Range	Vehicle-Specific Equipment
Q3, and Q8	2019 – 2021	All	Not Applicable
e-tron quattro	2019 2021		
e-tron Sportback quattro, SQ8, and RS Q8	2020 – 2021

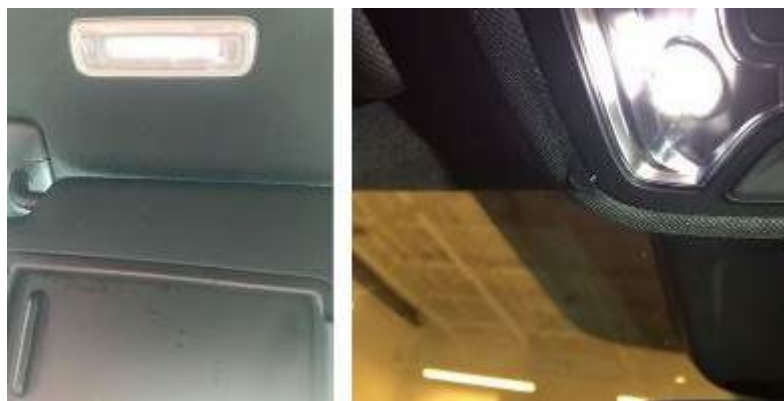
- There is a water drip from the headliner area (figure 1).

Figure 1. Water intrusion near the headliner.

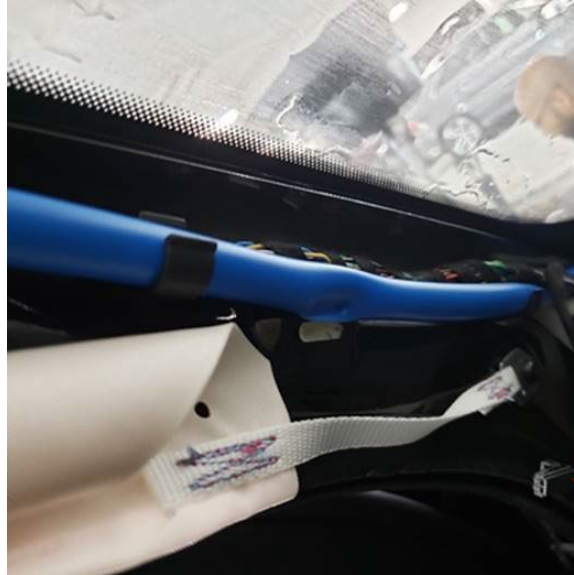
Using the VAS6620 Sunroof Drain Snake follow the cleaning procedure for the sunroof water drain hoses as described in ElsaPro. Any possible obstruction other than debris cleared by this procedure will be apparent after this check such as a kinked or pinched drain hose (Figure 3).

Figure 3. Sunroof drain hose pinched by the pillar trim.

Ensure that any water in the sunroof frame drainage areas flows freely after the cleaning procedure. If any obstruction is due to a pinched or kinked drain hose the damaged drain hose(s) or valve(s) must be replaced.

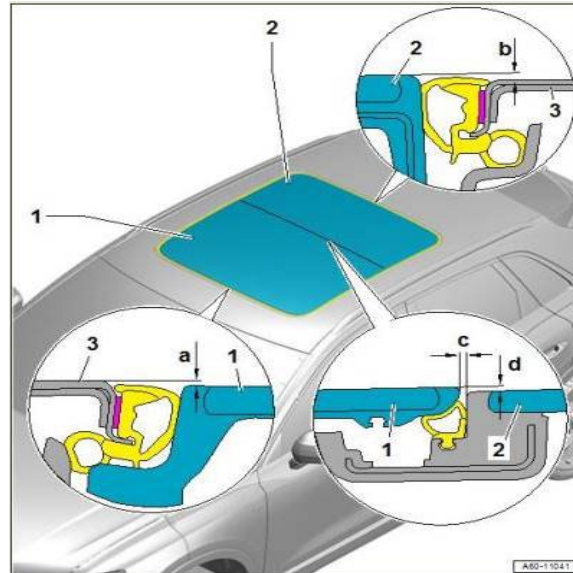
Check all adjustment axes of the sunroof glass panels for poor adjustment (Figure 5).

Figure 5. Front and rear glass panel adjustment.

If after all dimensional measurements are made on the sunroof glass panels an issue is found make the necessary adjustments to the sunroof glass panels.

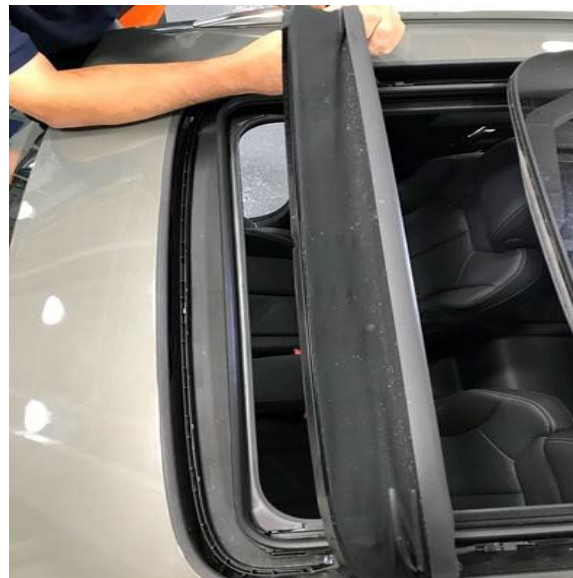
When the vehicle is exposed to water (rain, car wash, or standing water on the roof panel) either with the vehicle stationary or driving it is possible for water to enter the sunroof frame, breach the normal water drainage channeling, and leak into the cabin area, particularly if the sunroof is opened or vented when the vehicle is wet.

Any possible water drip may not appear until after a driving period when the water travels to the underside of the headliner area during the normal course of driving (Figures 6-8). This may occur due to a slow migration of water along the wind deflector hinge arms and potential water entry into the stowage area for the wind deflector. This stowage area does not provide water drainage away from the vehicle.

Figure 6. Front sunroof opening with the drainage exposed.

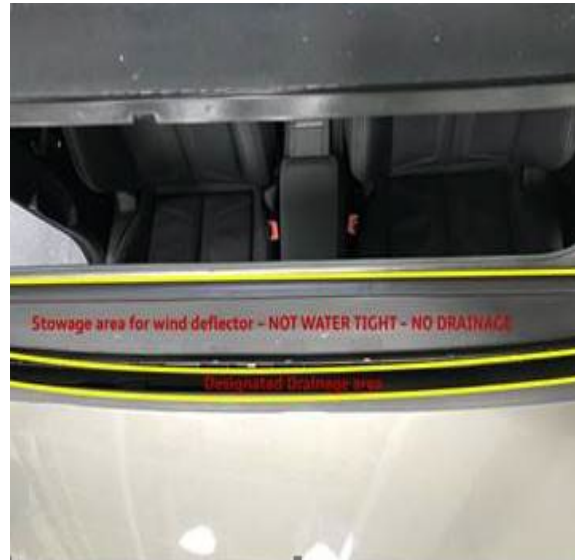
Figure 7. Areas of sunroof opening water elimination capabilities.

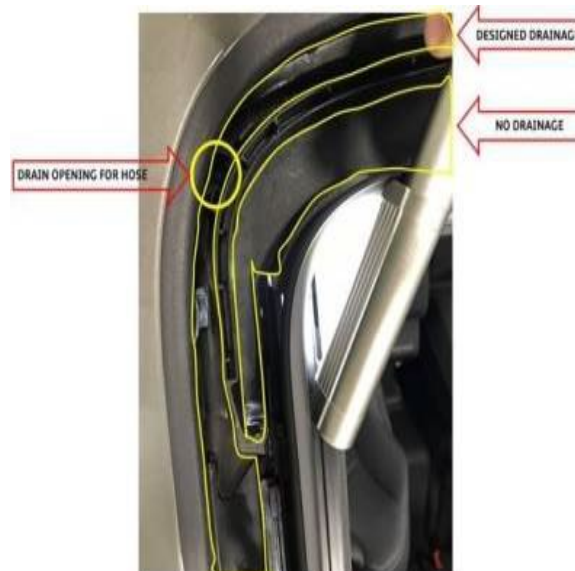
Figure 8. Sunroof water channeling diagram.

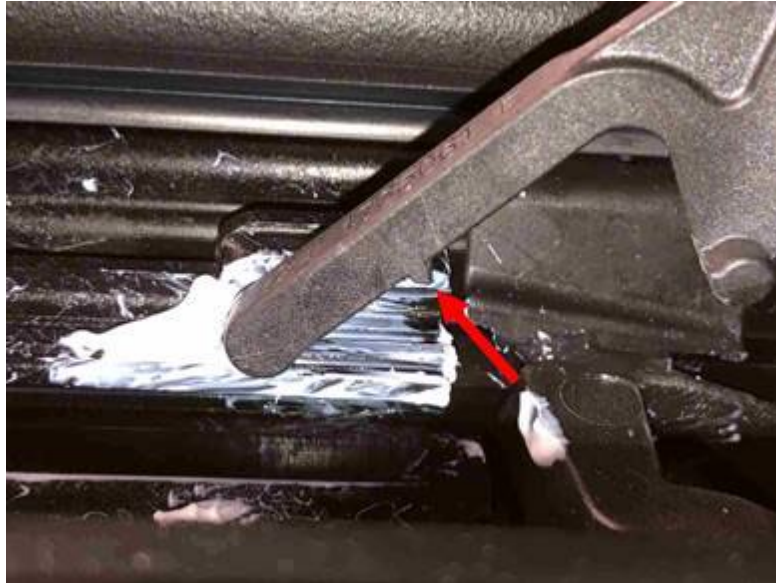
Figure 10. Tabs cast into the redesigned wind deflector.

6. There has been a design change to the wind deflector to enhance the water flow and drainage in the event the wind deflector gets wet. Inspect the area of the wind deflector shown (Figure 10). The redesigned wind deflector has small tabs cast into the deflector structure on both sides. If the wind deflector does not have these tabs replace the wind deflector. Make certain that the replacement wind deflector contains these tabs before installation. With the redesigned wind deflector installed, proceed as follows.

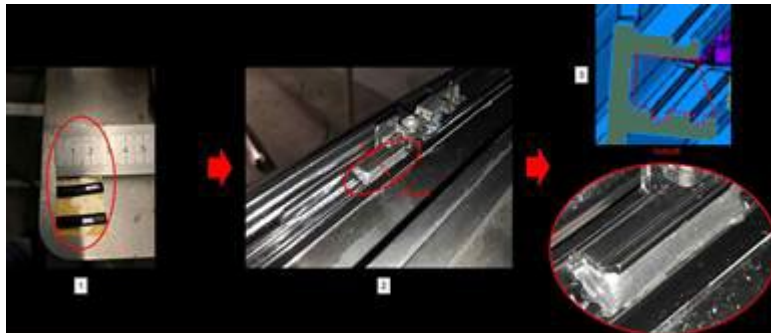
Figure 12. Preparation and application of butyl cord.

8. Cut two 25mm strips of AKL 450 005 05 Butyl adhesive/sealing cord. Firmly press each strip into the groove shown (Figure 12). Both channels shown in the cut away must be completely filled with the butyl cord.

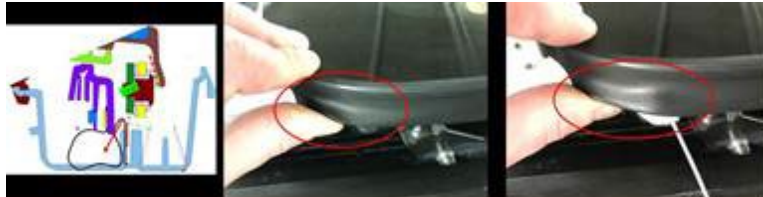
Figure 15. Area of glass panel 'skirt' where bonding agent is to be applied.

11. Apply D 355 205 A2 Bonding Agent using a primer applicator D 009 500 25 (or equivalent). Allow bonding agent to thoroughly dry (Figure 15).

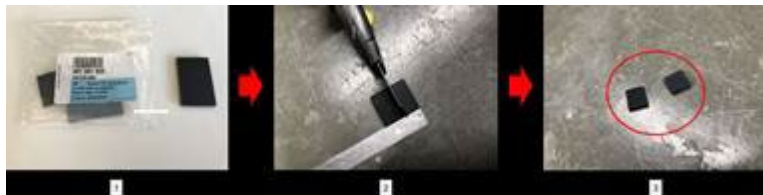
Figure 16. Preparing 2 – 10mm x 10mm pads of 251 201 525 packing.

12. Using 251 201 525 packing cut 2 x 10mm x 10mm pads (Figure 16).

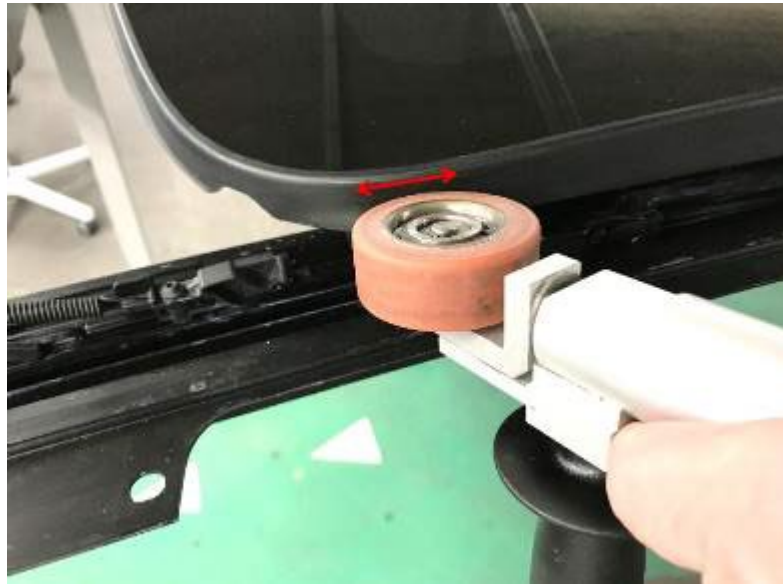
Figure 18. Applying pressure to bonded area with 3356 roller (or equivalent).

14. Using a 3356 roller tool (or equivalent), apply firm pressure (~50 Nm) to the newly adhered pads to enhance the strength of adhesion (Figure 18).
