**Document ID:** IK0800080

**Title: J1939 Data Link Troubleshooting**

**Applies To: All Models with 250k Baud Data Link (Black 9-Pin Diagnostic Connector); Overview information for 500k Baud Data Link**

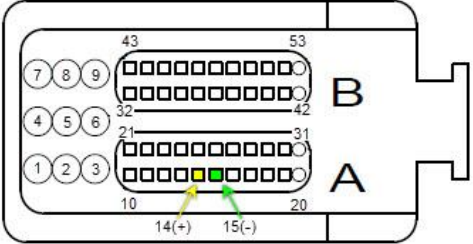
| Engine DCU - Doser Control Unit <ul style="list-style-type: none"> <li>MaxxForce DT / 9 / 10 (EPA 10)</li> <li>N9 / N10 (EPA 10)</li> </ul> | 6340 | | 14(+) | 15(-) | |
