Title: Luggage Rack Upholstery Repair

Applies To: Bus with interior luggage racks

This document will guide the user through repairing the detached upholstery on interior luggage racks bumper pads.

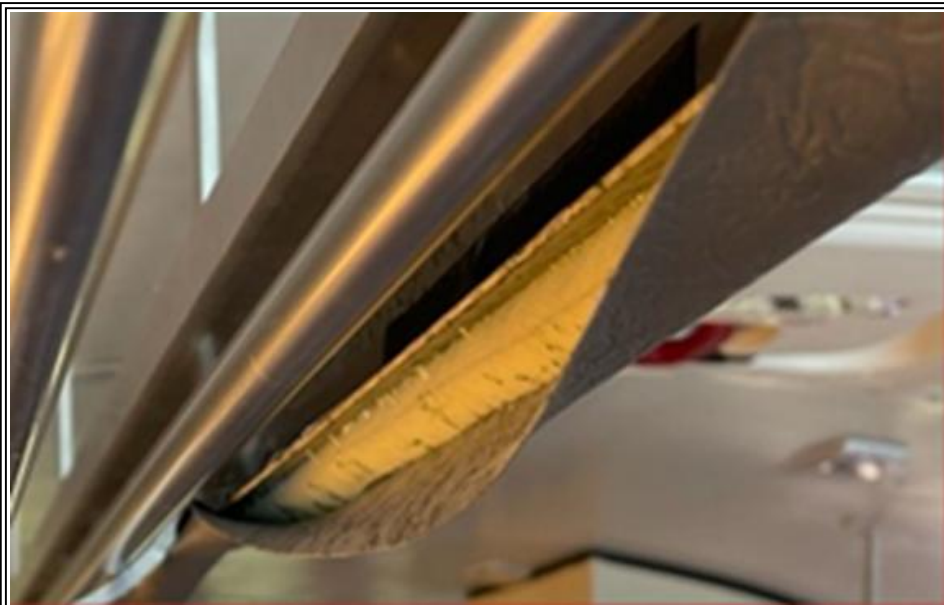
Figure 1: Upholstery not adhering

The upholstery will start separating at the edges of the padding and hangs loose from metal backing plate.

Step	Action	Decision
#	<p>DIAGNOSTIC:</p> <p>Is your luggage rack upholstery separating from the pad as shown in Figure 1?</p>	<p>Yes. Proceed to Repair Steps.</p>
		<p>No. This iKnow does not apply.</p>

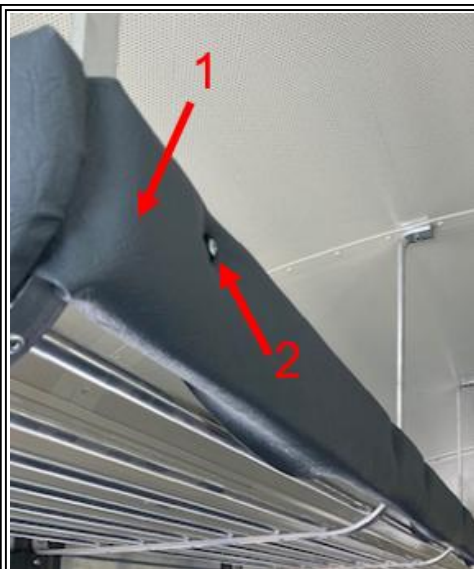
Figure 2: Luggage Rack Bumper Pad

Item 1: Bumper Pad
Item 2: Mounting Screw

1. Remove the luggage rack bumper pad by removing the mounting screws, see Figure 2. Retain screws for later usage.
2. Lay the removed padding assembly outside facing down as shown in Figure 3 below.
3. In the area where the upholstery has separated, peel back tape (Item 2, Figure 3) to expose the metal backing plate (Item 3, Figure 3).

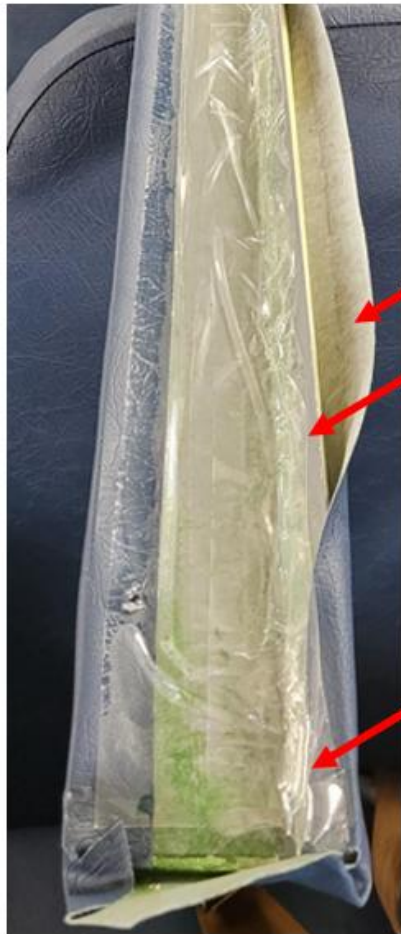
Figure 3: Bumper Pad Assembly

Item 1: Upholstery

Item 2: Tape

Item 3: Metal Backing Plate

1. Apply a bead of Loctite 401 to the metal backing plate flange/edge (Item 3, Figure 3). Recommend only doing approximately 12" sections at a time as the adhesive will cure quickly.
2. Take the loose upholstery edge and press it into the adhesive bead. Apply pressure for approximately 30 seconds.
Note: Using a small roller will help wet out the adhesive, and a ruler or straightedge may help apply pressure across the upholstery.
3. Repeat step 2 for the entire length of the bumper pad.
4. Once repairs are complete to the bumper pad assembly, it can be reattached to the luggage rack using the screws retained from Removal Step 1.
