# HYUNDAI Technical Service Bulletin

GROUP <b>ENGINE</b>	NUMBER <b>23-EM-003H</b>
DATE <b>AUGUST 2023</b>	MODEL(S) <b>PALISADE (LX2)</b>

**SUBJECT:** RADIATOR COOLANT LEAK REPAIR

**Description:** Certain 2020-2022MY Palisade (LX2) vehicles may exhibit a slight coolant leak at the radiator. Follow the procedure outlined in this bulletin to inspect and replace the radiator to correct the condition, if necessary.

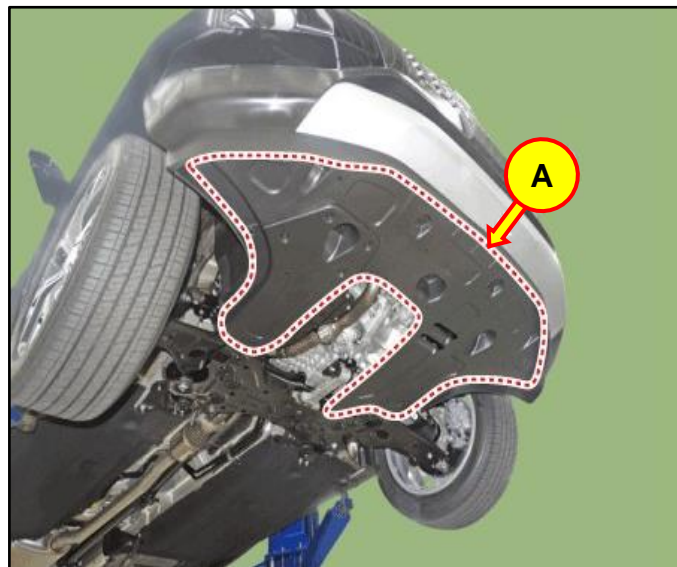
Lift up the vehicle and remove the engine room undercover (A).

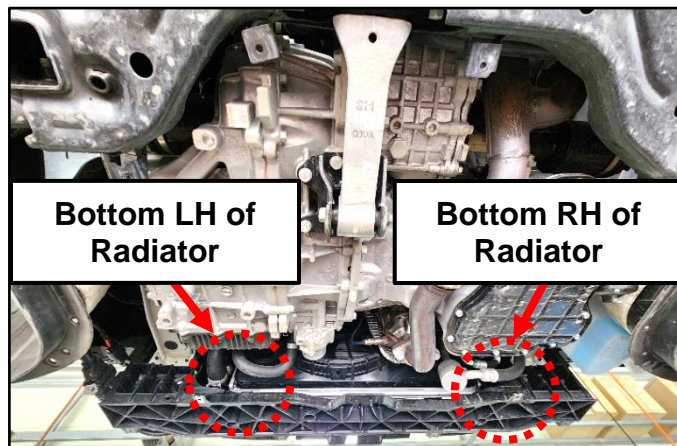
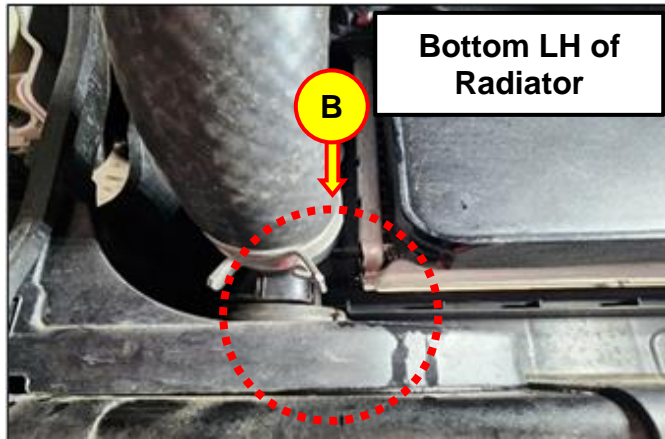
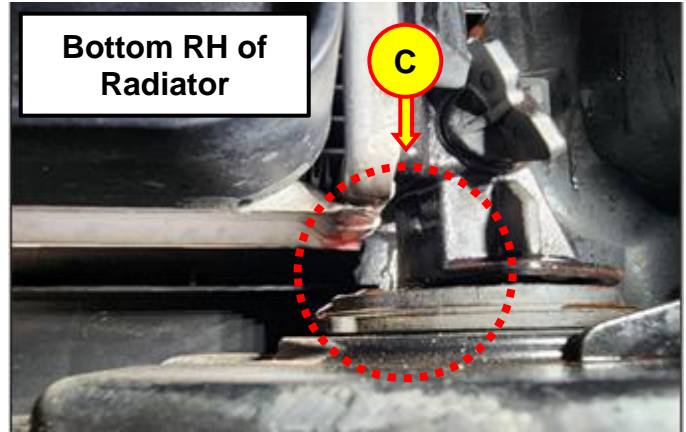
- Check the bottom LH (B) and RH (C) of the radiator for a coolant leak.

- If there is **NO** coolant leak, then **STOP**. Do not continue with this service procedure.
- If a coolant leaking condition is found at any of the indicated areas, then follow the next steps to take STUI photo(s) and complete the repair.

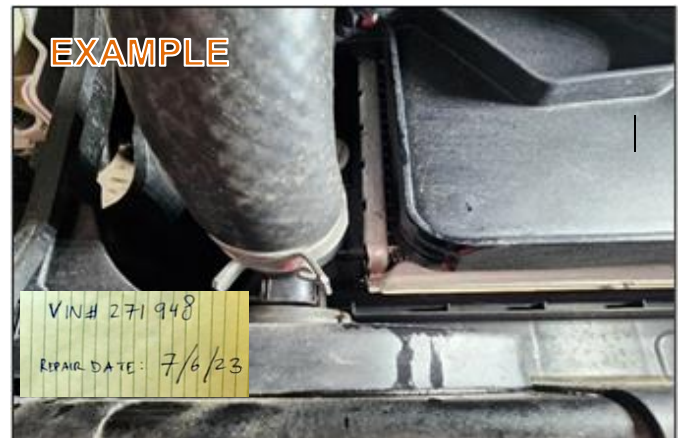
Using STUI, take a photo of the leaking area(s) of the radiator with the last 6 digits of the VIN and the date of repair on a piece of paper.

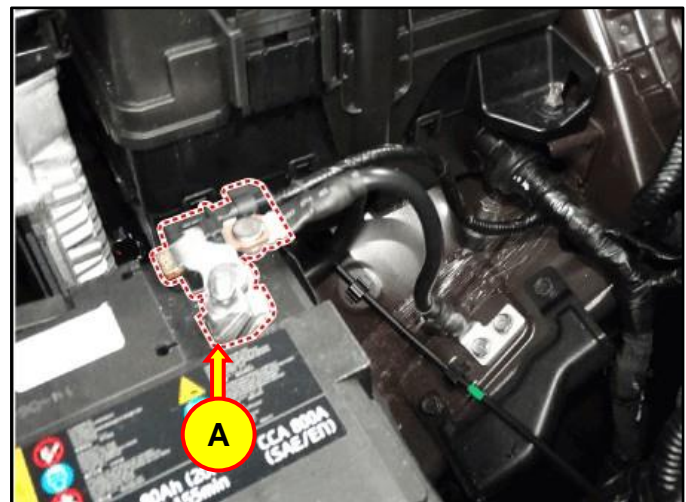
Remove the air duct and disconnect the negative (-) battery terminal (A).

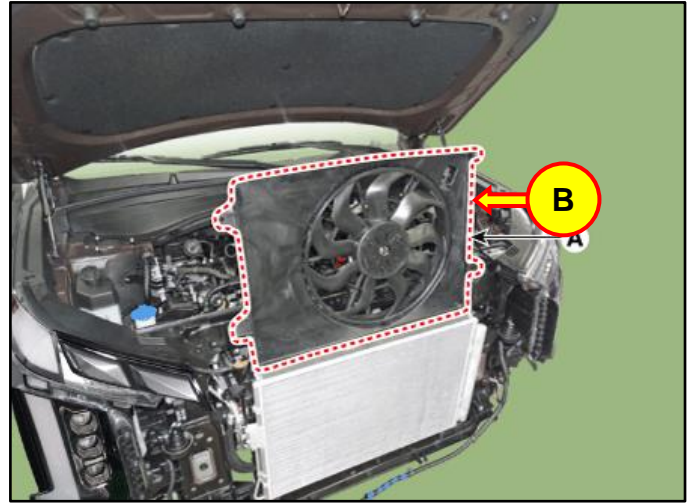
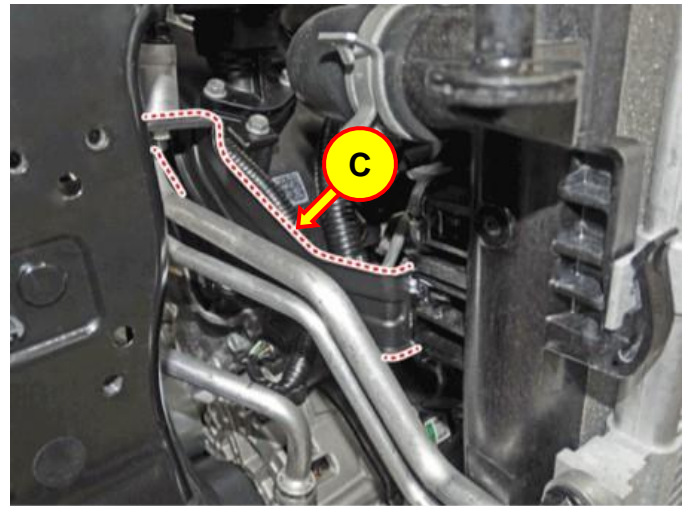
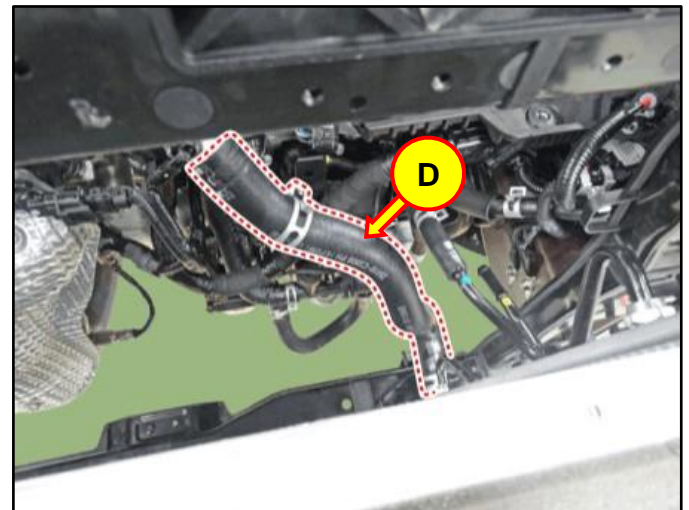
5. Drain the engine coolant.  
Refer to the shop manual:
  - **Engine Mechanical System > Cooling System > Coolant > Repair procedure**
6. Remove the cooling fan (B) assembly.  
Refer to the shop manual:
  - **Engine Mechanical System > Cooling System > Cooling Fan > Repair procedure**

7. Remove the A/C condenser bracket (C).

8. Disconnect the radiator lower hose (D).

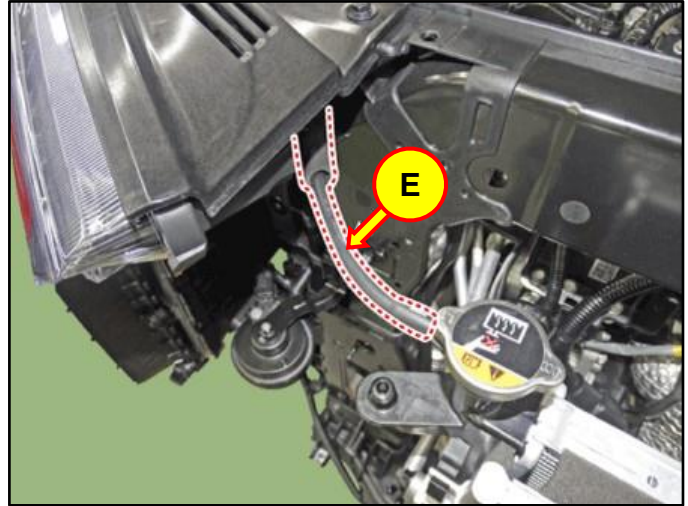
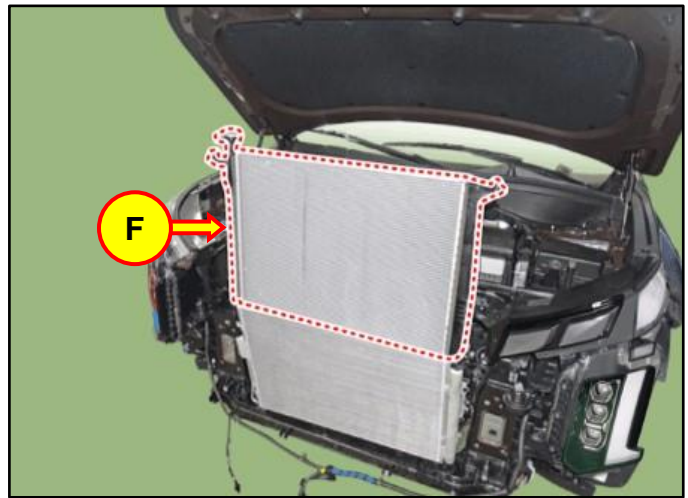
9. Disconnect the overflow hose (E).
10. Separate the A/C condenser from the radiator assembly and remove the radiator assembly (F).
11. Install the new radiator in the reverse order of the removal along with the other components that were removed.
12. Fill the radiator with coolant.  
Refer to the shop manual:
  - **Engine Mechanical System > Cooling System > Coolant > Repair procedure**
13. Start the engine and then check the radiator and hose connection for any leaks.
14. Adjust the coolant level as necessary to the FULL line.
15. Service procedure is now completed.
