Technical Service Bulletin

GROUP HVAC	NUMBER 23-HA-002H
DATE AUGUST 2023	MODEL(S) IONIQ 5 (NE1)

SUBJECT: HVAC SYSTEM DTC B169588/B160C88/B183088
INSPECTION AND REPAIR

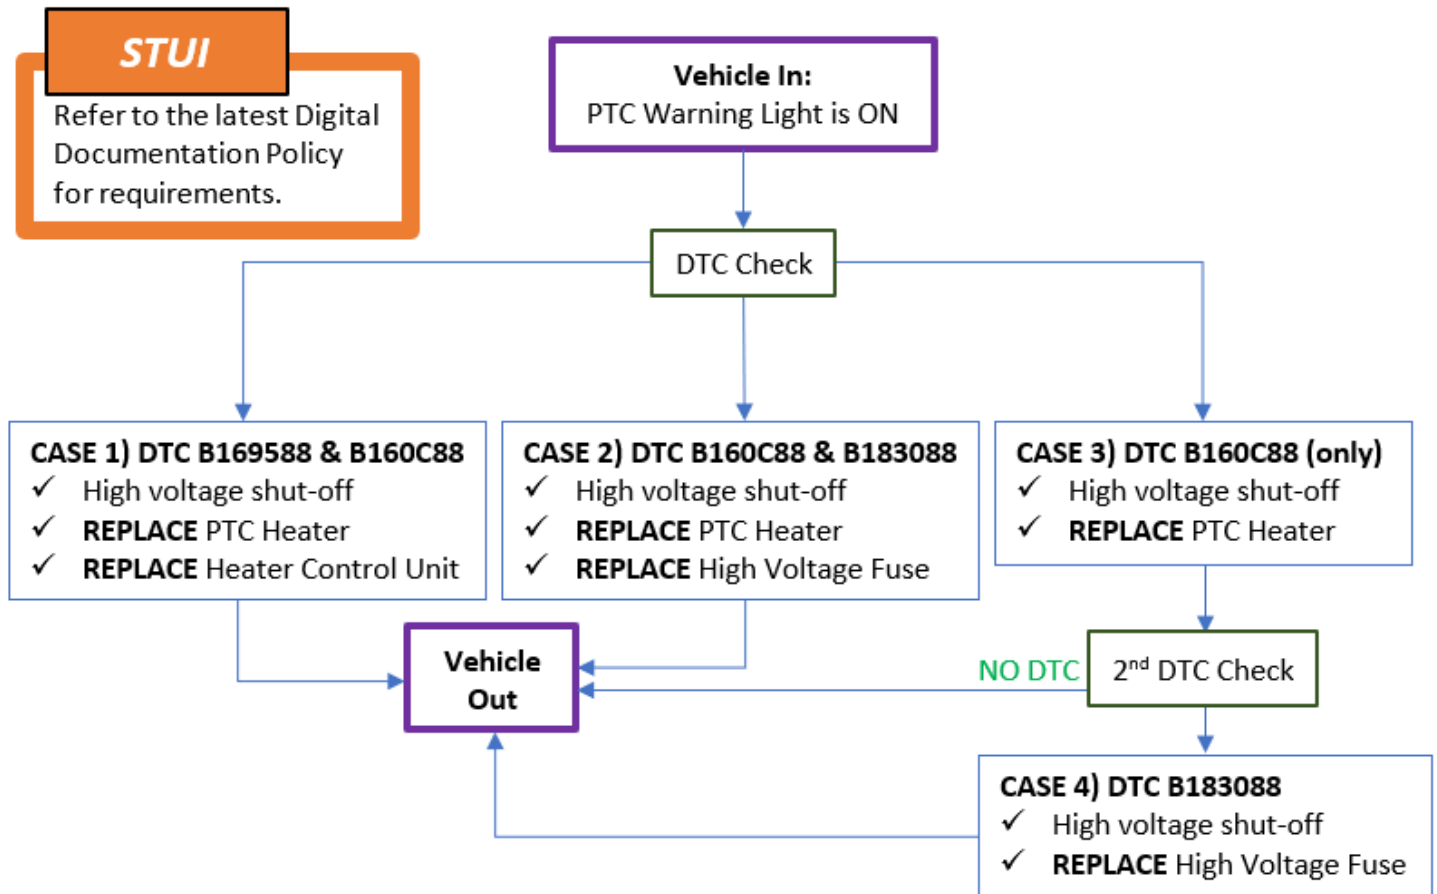
Service Procedure:

- **High voltage shut-off**
 - Heating, Ventilation And Air Conditioning > High Voltage Shut-off Procedures
- **Heater Control Unit Replacement**
 - Heating, Ventilation And Air Conditioning > Controller > Heater Control Unit > Replacement
- **PTC Heater Replacement**
 - Heating, Ventilation And Air Conditioning > Heater > PTC Heater > Replacement
- **High Voltage Fuse Replacement**
 - Heating, Ventilation And Air Conditioning > Heater > PTC Heater > Replacement

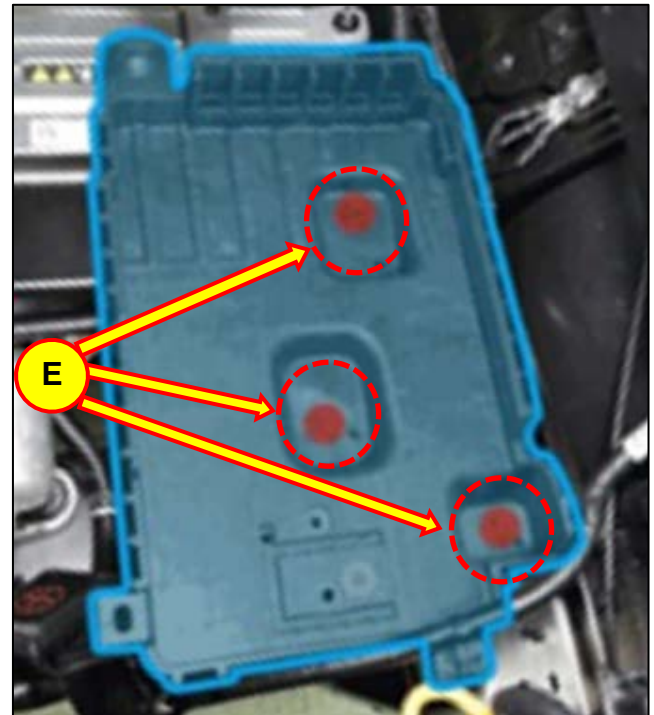
3. Loosen the battery tray fixing bolts (E).
