**SERVICE BULLETIN**

**APPLICABILITY:** 2019-21MY Forester  
 2020-22MY Outback & Legacy  
 2018-21MY Crosstrek  
 2022-23MY WRX

**NUMBER:** 12-299-20R  
**DATE:** 09/04/2020  
**REVISED:** 08/15/2023

**SUBJECT:** 6/8-way and Driver's Seat Hinge Cover-  
 Design Change

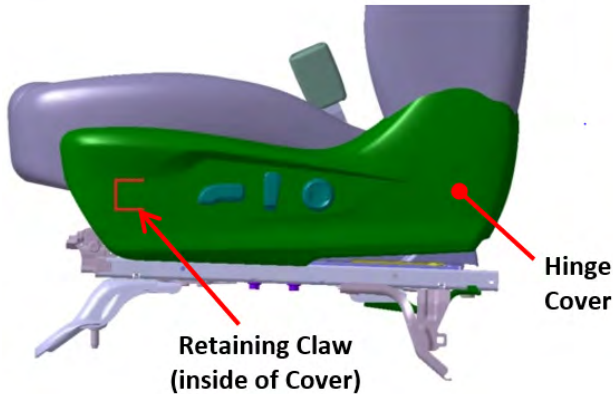
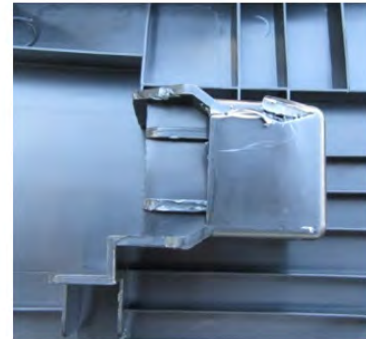
This bulletin announces a design change made to the outer hinge cover on the driver's 10-way adjustable power seats. The change has been made to address several reports about the cover coming loose over time as a result of getting into and out of the driver's seat. The retaining claw portion securing the cover to the seat frame has been changed to improve its strength and durability.

Enlarged View of Damaged Claw

The new Hinge Cover was incorporated into production as listed below:

- Forester: MH408966
- Crosstrek: M8251680
- Outback & Legacy: TBD

Description	Part Number	Application
COVER-HINGE FRONT SEAT OUTER LEFT	64115SJ232VH	For 10-way power seat
	64115AN15B	
	64115FL311VH	For 6/8-way power seat
COVER-HINGE FRONT SEAT OUTER RIGHT	64115SJ201VH	For 8-way power seat
	64115AN16B
