## Technical product information

<b>Topic</b>	HVAC refrigerant leakage suspected Or reports of a damp/musty smell within the cabin - Diagnosis guidelines
<b>Market area</b>	Australia E04 Bentley rest Asia and Australia (6E04),China 796 VW Import Comp. Ltd (Vico), Beijing (6796),Germany E02 Bentley rest Europe (6E02),Japan E03 Bentley Japan (6E03),Korea, (South) E08 Bentley South Korea (6E08),United Arab Emirates E06 Bentley Middle East and Africa (6E06),United Kingdom E01 Bentley UK (6E01),United States E05 Bentley USA and rest America (6E05)
<b>Brand</b>	Bentley
<b>Transaction No.</b>	2069806/3
<b>Level</b>	EH
<b>Status</b>	Approval
<b>Release date</b>

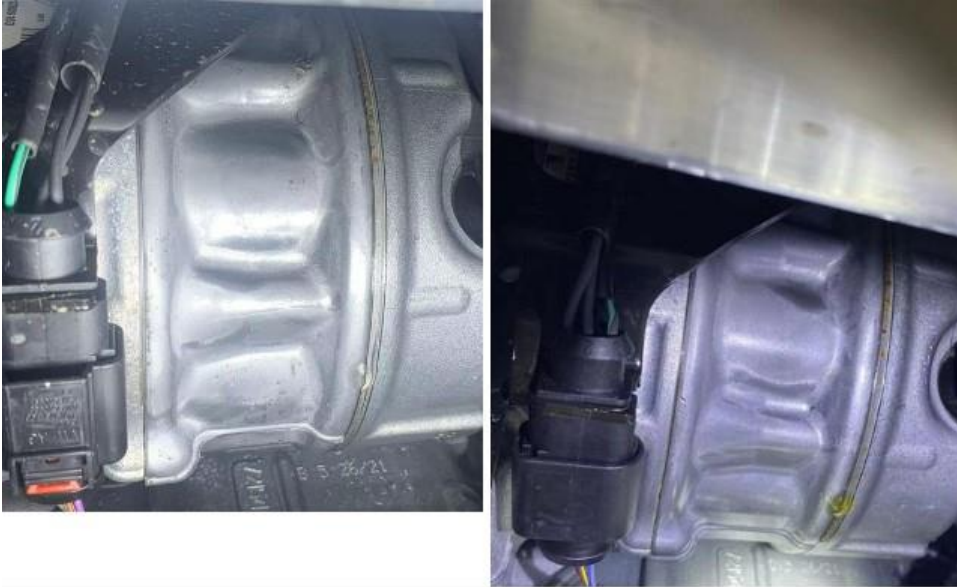
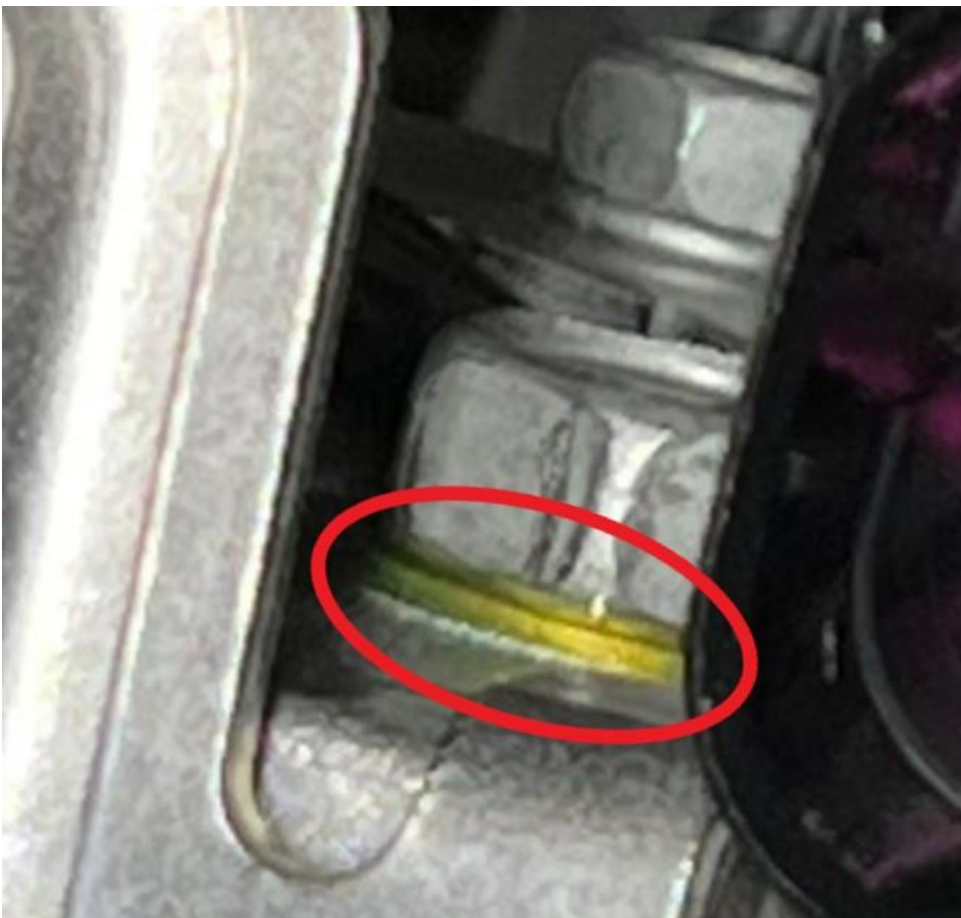
please refer to the examples shown below (Figures 1,2 and 3) of leaks found on the HVAC compressor

The leaks in these scenarios were repaired after component replacement however as the parts were not at fault the actual fix of the leak would have been resolved by replacing O-rings only

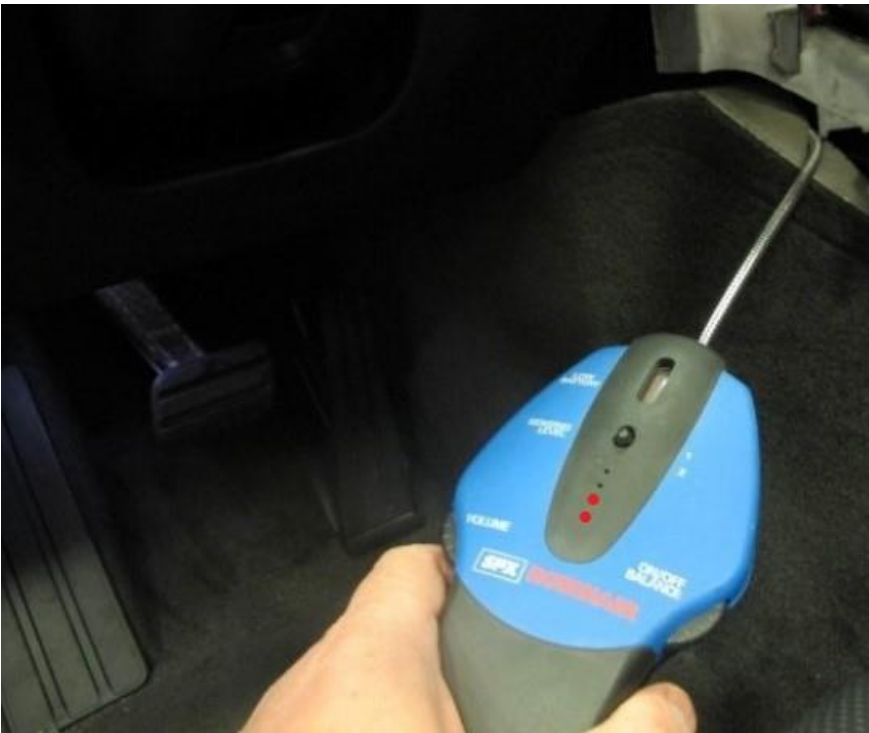
A complaint is received that refrigerant is evident within the cabin the operative MUST first ensure that a leak is not evident within the plenum chamber or around the centre console (Figures 5 and 6) as refrigerant could be leaking into the plenum chamber/cabin and recirculated back into the cabin as this could lead to misdiagnosis and/or incorrect part replacement
