# Technical product information

| Topic | Bentayga Hybrid - HVAC not cooling - DTC B16A1F0 is evident within diagnostic address 00C5 |

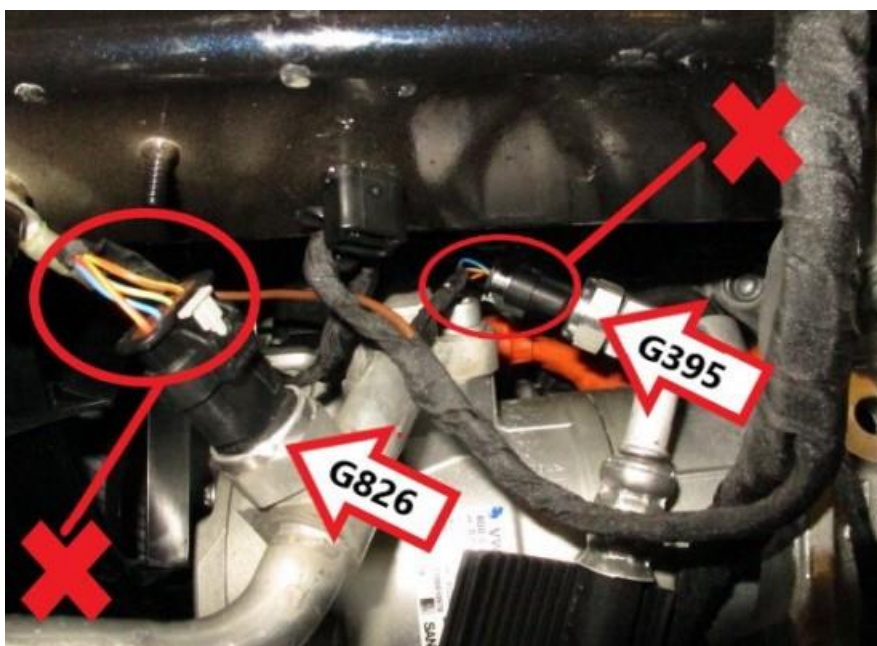
- 1) Referring to Rep.Gr 44 - Remove the left hand front wheel
- 2) Referring to Rep.Gr 66 - Remove the left hand front foremost wheel arch liner
- 3) Remove (x3) speaker box fixings (5Nm)
  - Disconnect the speaker box electrical connector
  - Remove the speaker box
- 4) Access can now be gained to the required connector plugs - Figure 1 shows G826 and G395 with the connector plugs fitted incorrectly
  - Low pressure sender G826 connector plug with 4 wires (Incorrect)
  - High pressure sender G395 connector plug with 3 wires (Incorrect)

In the event the pressure sender connector plugs are fitted incorrectly the plugs should be disconnected and refitted correctly as shown in Figures 2 and 3

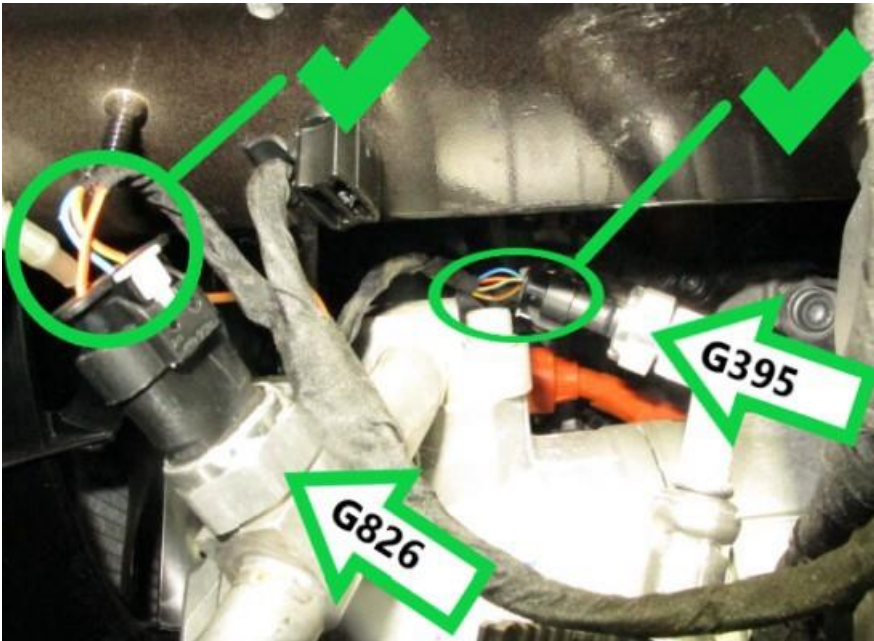
- Figure 2 shows G826 and G395 connector plugs fitted correctly
- Low pressure sender G826 connector plug with 3 wires (**Correct**)
- High pressure sender G395 connector plug with 4 wires (**Correct**)

- 5) Once the orientation of the connector plugs is correct - Refit all previously components
- 6) Check the HVAC system is operating to specification

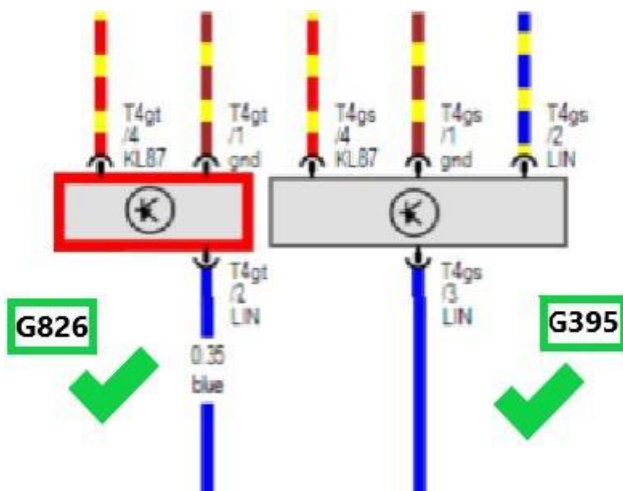
Hint: Figure 3 shows G826 and G395 as per the applicable Current Flow Diagram (Correct)
