GROUP	MODEL
Subsequent Repair Action	2019-2020MY Optima P/HEV (JF P/HEV) w/Nu 2.0L GDI
NUMBER	DATE
PI2108Y/Z	August 2023

SUBJECT: **ENGINE REPLACEMENT INSTRUCTIONS
FOR DTC P1326 (PI2108Y/Z)**

This bulletin provides information related to the Technical Service Bulletin previously published in (PI2108) titled "Knock Sensor Detection System - ECU Logic Improvement" for certain 2019-2020MY Optima P/HEV (JF P/HEV) vehicles equipped with Nu 2.0L GDI engine, produced from July 6, 2018 through October 28, 2019. Specifically, this bulletin provides instructions on which procedures to follow if, after installation of the KSDS, any one of the subject vehicles below return to the dealer with Diagnostic Trouble Code (DTC) P1326 (Knock Signal Range/Performance).

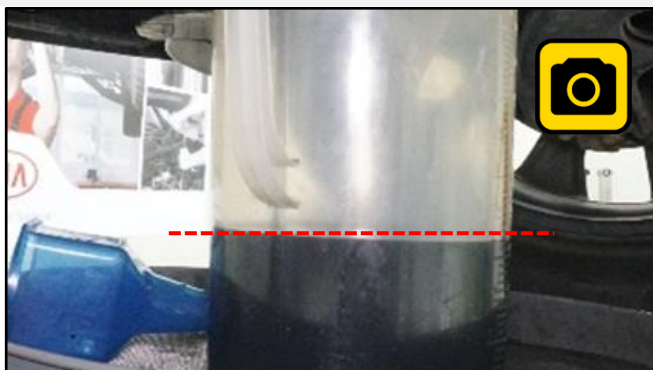
**Oil Level Measurement: (Flowcharts B & C → PWA Request)**

1. Remove oil filler cap, remove oil drain plug and drain oil into the supplied measuring container SST067BUCK and check oil level.
2. Record oil level reading on the RO.
3. Take photo of the drained oil container using KDS and attach to warranty claim PWA request.

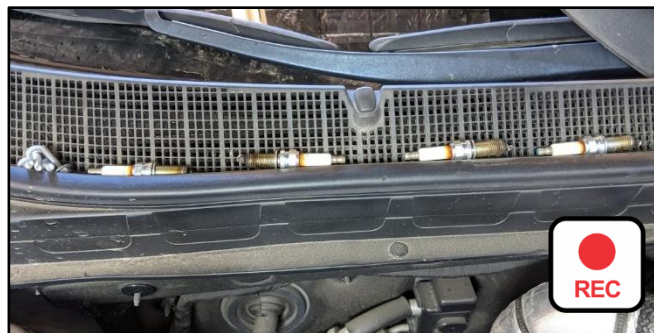
2. Show the removed spark plugs.

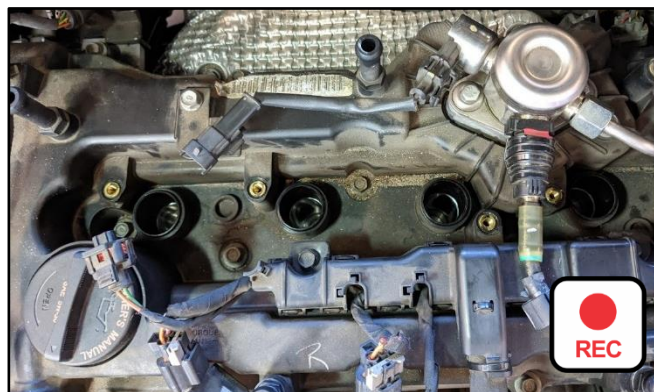
3. Show the empty spark plug holes from the engine.

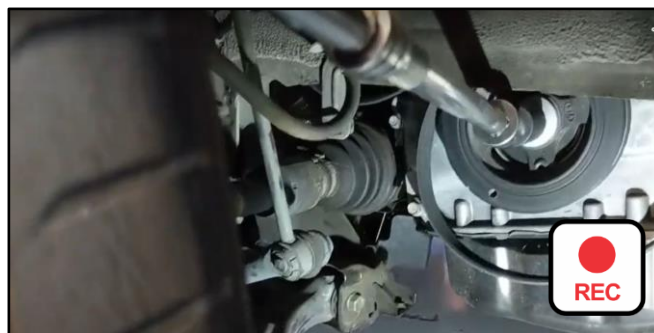
5. Show the removed drive belt and attached torque wrench to crank bolt.

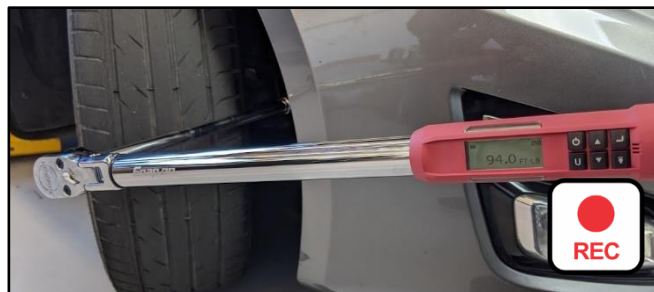
6. Show the engine being cranked and torque specification exceeding 94 lb.ft. torque.

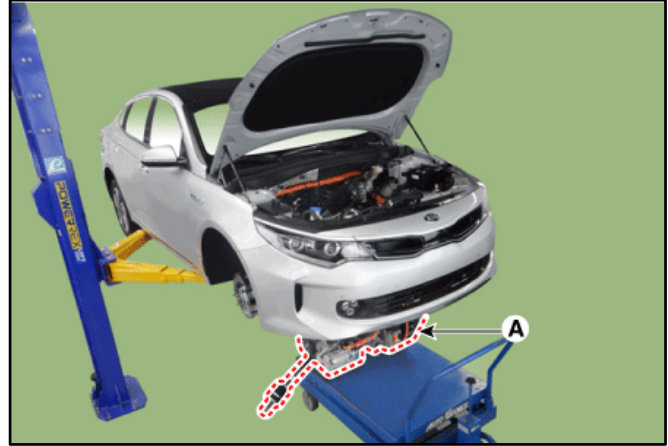
1. Replace the engine assembly by referring to the "Engine Mechanical System → Engine And Transaxle Assembly → Engine And Transaxle Assembly → Repair Procedures" chapter in the applicable Shop Manual on KGIS.

Refer to [TSB ENG190](#) for information regarding engine replacement practices.
