Technical Service Bulletin

GROUP ENGINE ELECTRICAL	NUMBER 23-EE-009H
DATE AUGUST 2023	MODEL(S) SONATA (DN8a)

SUBJECT: EGR VALVE REPLACEMENT FOR DTC P0401

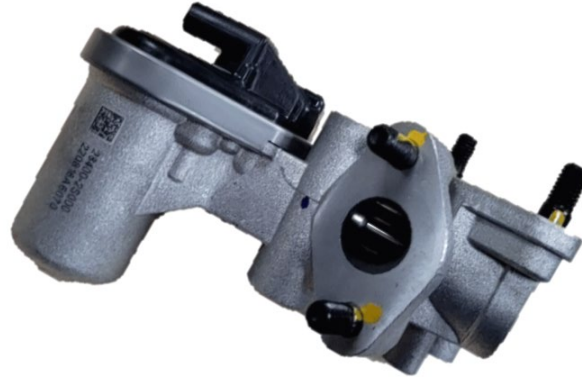
Description: This bulletin provides warranty procedure for EGR Valve replacement related to DTC P0401 EGR Flow Insufficient on 2020 and 2021MY Sonata (DN8a) equipped with 2.5 GDI Vehicles.
