GROUP	NUMBER
	AUTOMATIC TRANSMISSION	23-AT-003H-1
HYUNDAI	DATE	MODEL
Technical Service Bulletin	AUGUST 2023	SONATA (LFa) SANTA FE (TMa) PALISADE (LX2) SANTA CRUZ (NXT) SONATA (DN8a) TUCSON (NX4/NX4a)

SUBJECT: AUTOMATIC TRANSAXLE SOLENOID DTC P074100, P074300,

P074800, P075300, P075800, P076300, P076800, P077300 & P270900

This TSB supersedes TSB 23-AT-003H to add Tucson (NX4) and revise the Parts Information.

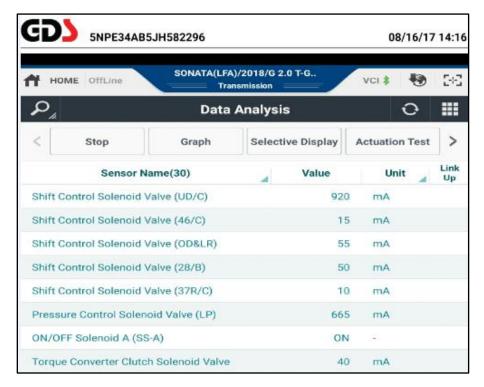
- 2. From the GDS home screen, select **Data Analysis** and **A/T** menu and the solenoid parameters shown below. If the solenoids show:
 - Continuous and changing output while driving, the wiring <u>currently</u> has no open/short circuits. Go to Step 4.
 - No continuous and changing output, go to Step 3.

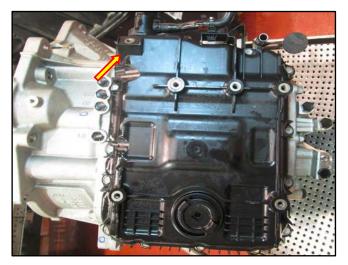
9. Remove 14 oil pan bolts and remove the pan.

Use a rubber hammer to tap the oil pan cover on a corner until the cover is loose.

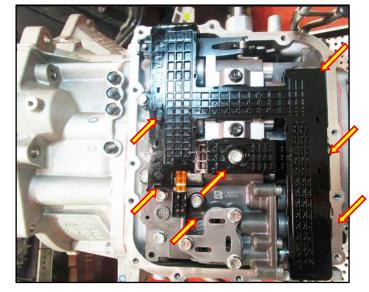
10. Remove 6 bolts to the harness and 1 bolt to the oil temperature sensor.

Pull the harness outward and move the harness out of position.

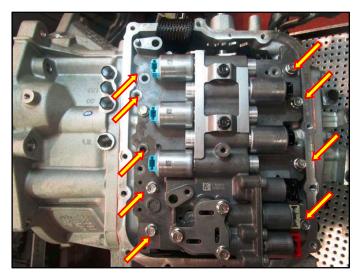
12. Remove 9 valve body bolts in order from the outermost bolts to the innermost bolts.

Remove the valve body.

Place the valve body on a clean paper towel. Placing the valve body on a rag may cause lint to enter the valve body.

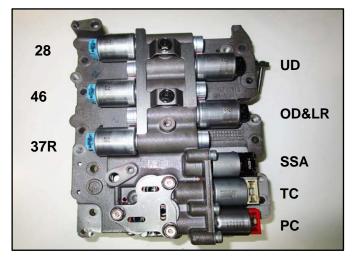
14. Record the 8-digit code on the solenoid.

DTC		SOLENOID
P074100	TC	TC clutch
P074300	TC	TC solenoid
P074800	PC	Pressure control
P075300	UD	Shift solenoid (UD)
P075800	46	Shift solenoid (46)
P076300	37R	Shift solenoid (37R)
P076800	OD&LR	Shift solenoid (OD&LR)
P077300	28	Shift solenoid (28)
P270900	SSA	Shift solenoid (SSA)

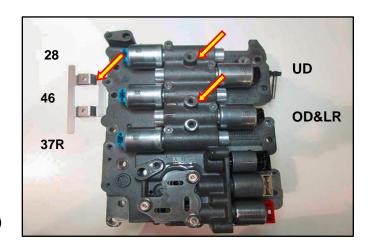
16. For 28, 46, 37R, UD, OD&LR solenoids:

Remove two bolts to the upper solenoid support. Remove the support.

- Use a magnet to remove the pin for the solenoid to be replaced.
- Remove the solenoid and install a new solenoid.
- Reinstall the pin.
- Reinstall the support and tighten to specification.

Torque: 7~9 lb.ft (1.0~1.2 kgf.m/10~12 N.m)

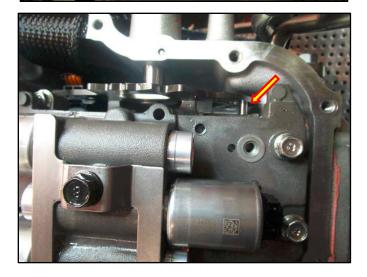
19. Align the manual shaft to the shift lever and install the valve body.

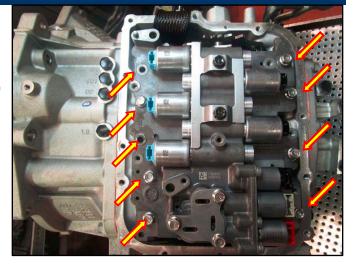
20. Install the valve body bolts and torque the bolts in order from the innermost bolts to the outermost bolts.

Torque: 7~9 lb.ft (1.0~1.2 kgf. m/10~12 N.m)

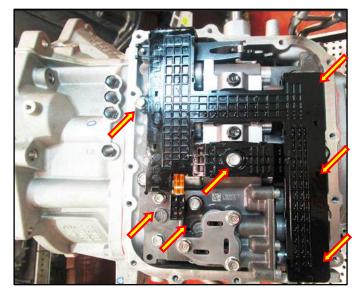
22. Reconnect the harness to the solenoids and install the temperature sensor.

Install 6 bolts to the harness and 1 bolt to the oil temperature sensor and torque to specification.

Torque: 7~9 lb.ft (1.0~1.2 kgf.m/10~12 N.m)

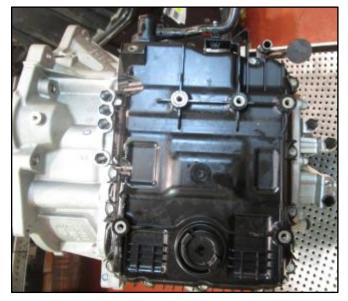
23. Install a new gasket, P/N 45283-4G*** to the oil pan and reinstall the pan.

Install 14 bolts to the pan and tighten the bolts to specification.

Torque: 8~10 lb.ft (1.2~1.4 kgf.m/12~13 N.m)

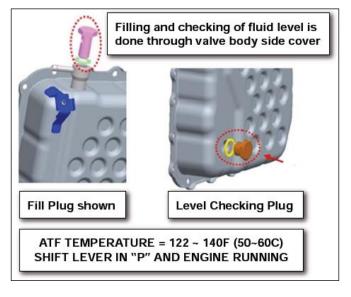
Use a funnel to add approximately 5~6 quarts of SP4-M ATF through the fill plug opening.

Attach the GDS and select **Data Analysis**, **A/T menu** and **Oil Temperature Sensor**.

Start the engine and shift to Park. When the ATF is 122°F~140°F (50~60°C), remove the level checking plug. The level is correct when oil flows out of the level checking plug in a thin steady stream.
