HYUNDAI
Technical Service Bulletin

GROUP AUTOMATIC TRANSMISSION	NUMBER 23-AT-011H
DATE AUGUST 2023	MODEL(S) SANTA FE (TMa) SONATA (DN8a) SANTA CRUZ (NXT)

SUBJECT: 8-SPEED WET DCT REPLACEMENT INSTRUCTIONS FOR 2.5T
VEHICLES

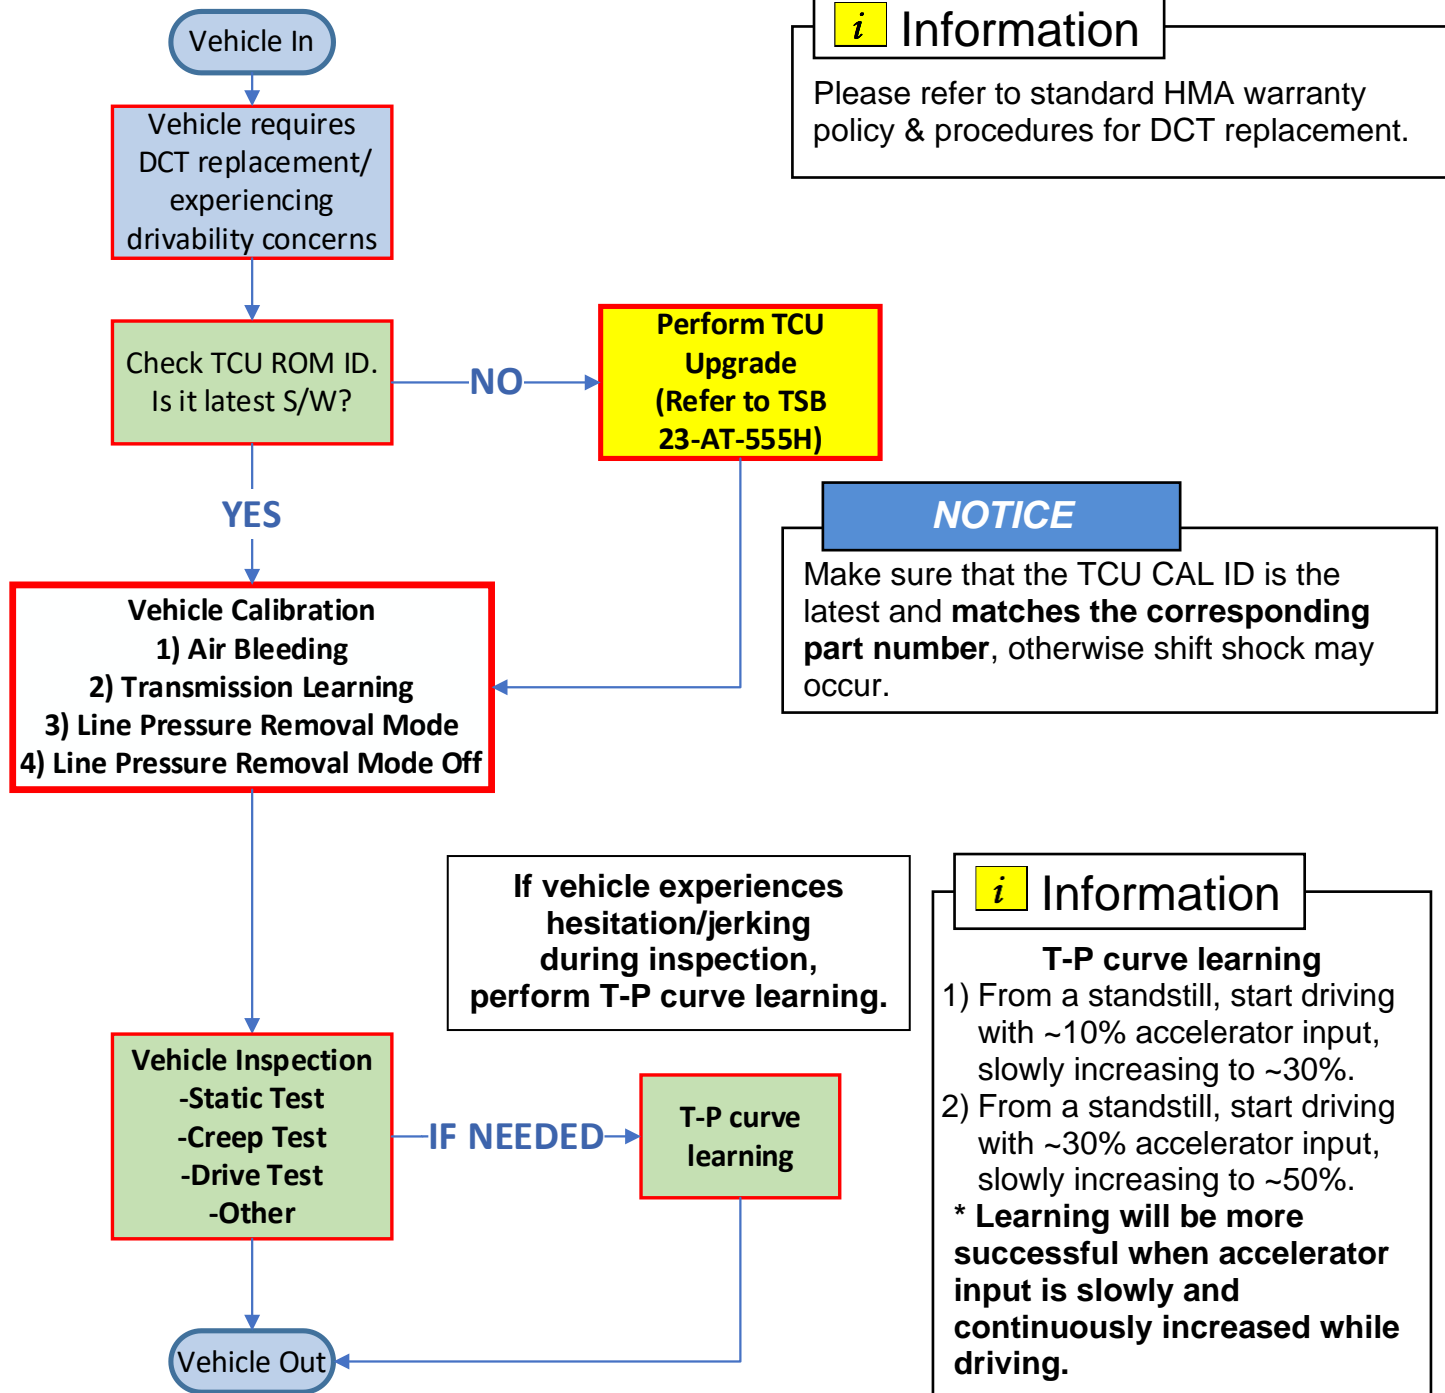
1. Refer to the flowchart below for overall procedure.

3. After replacing the DCT/TCU, perform the air bleeding/DCT initialization/DCT Learning according to the flow chart on page 5. See the table below regarding if DCT learning is required.

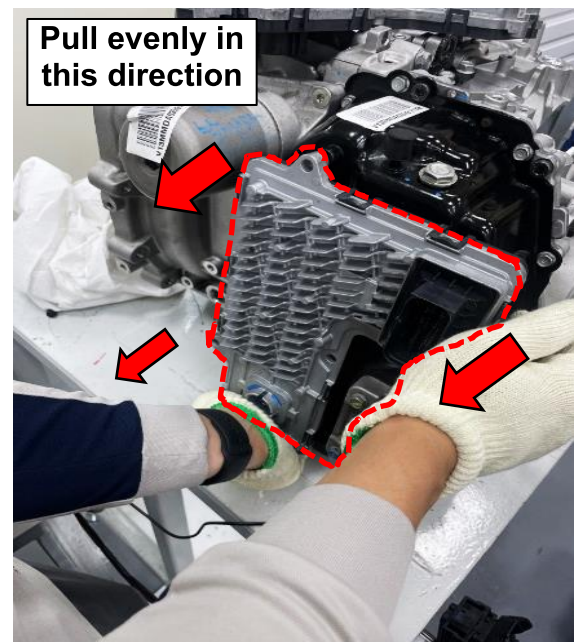
Make sure the TCU 24-pin terminal is aligned properly during removal/installation, otherwise the pins may get damaged.

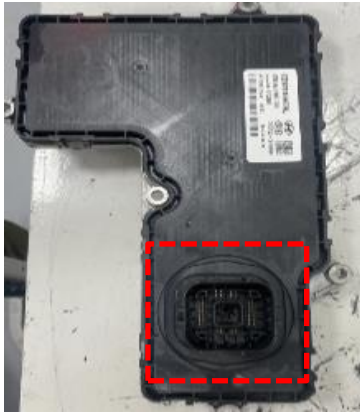
Male terminal of TCU

2. When reinstalling the TCU, make sure to align the connector on the TCU to the E-module on the DCT.

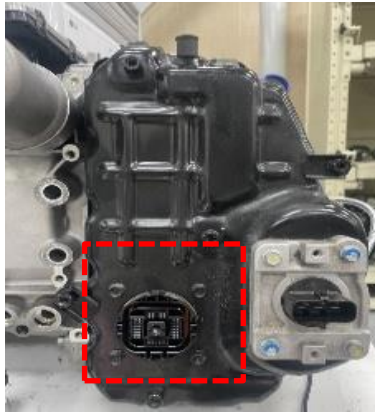
Female terminal of E-module (on DCT)

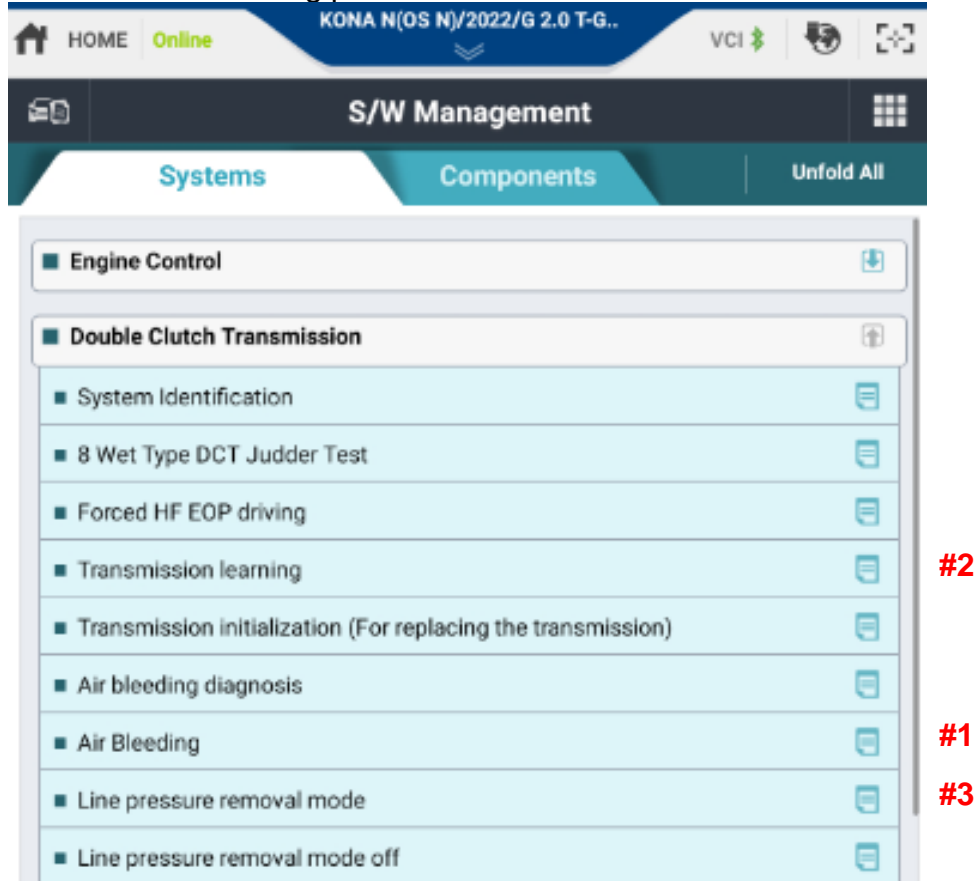
1. After performing the TCU Upgrade, select **S/W Management** and **Double Clutch Transmission** within the GDS. Perform the following procedures in the order shown.
