Technical Service Bulletin

23-01-066H

IONIQ 5 (NE1)

SUBJECT: POWER SEAT SWITCH (FRONT LH) REPLACEMENT AND WIRING REVISION (SERVICE CAMPAIGN TAM)

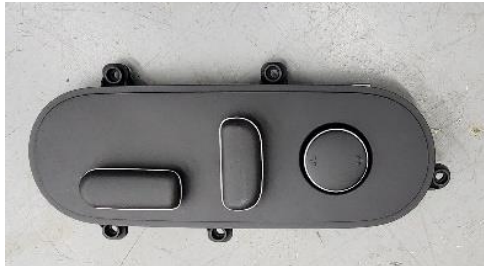
Model	Op. Code	Operation	Op. Time	Causal Part	Nature Code	Cause Code
Ioniq 5 (NE1)	30D066R2	Front LH Power Seat Switch Replacement and Wiring Rework (NNB)	0.4 M/H	88070-GI100NNBQH	I91	ZZ3
	30D066R3	Front LH Power Seat Switch Replacement and Wiring Rework (YGN)		88070-GI100YGNQH

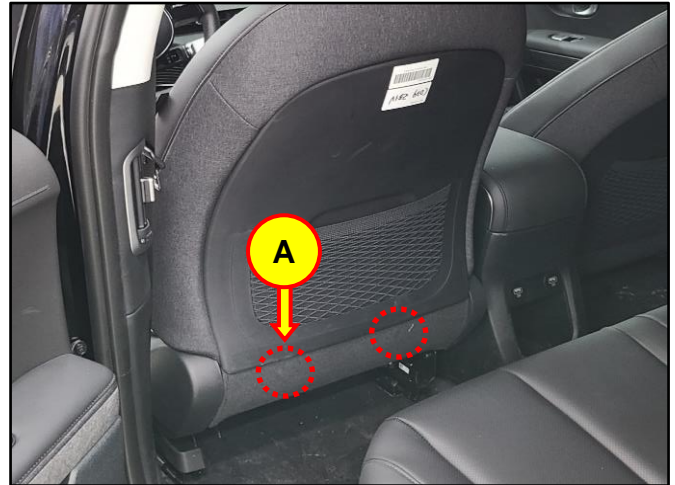
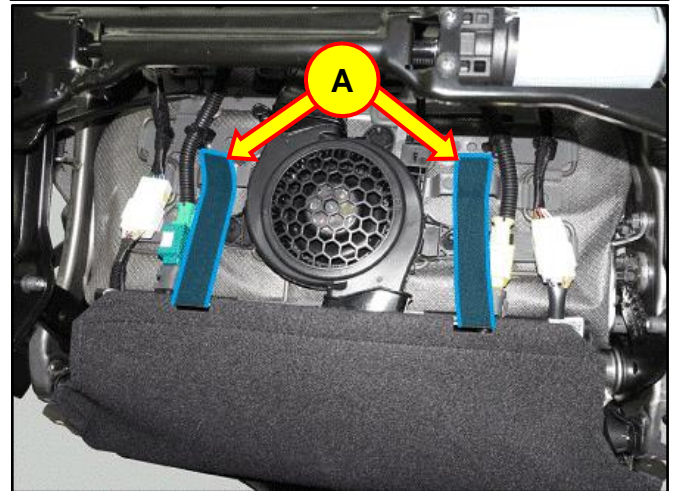
2. Separate the front seat lower protector (A).

Use a trim removal tool when removing components to prevent damage.

Take care not to damage the front seat.

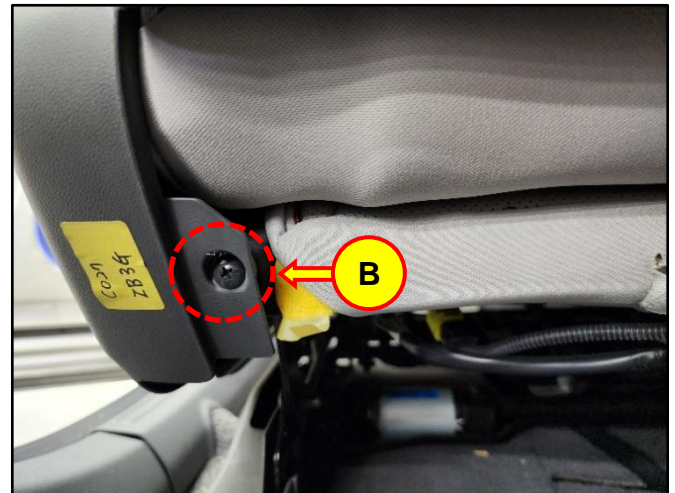
3. Loosen the front seat shield outer cover mounting screw (B).

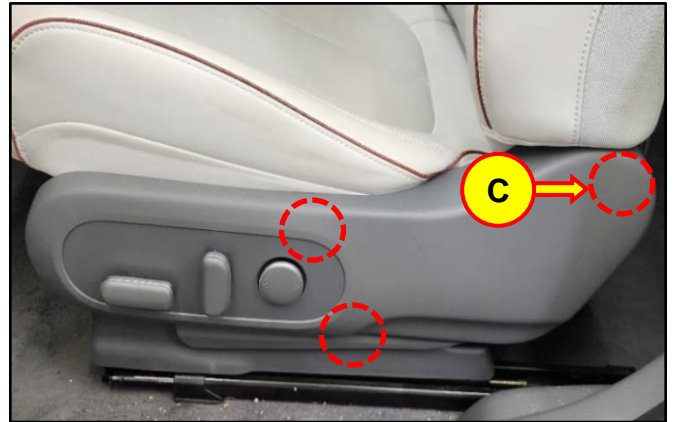
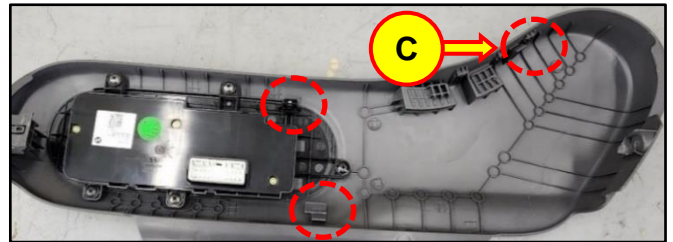
4. Remove the front seat shield outer cover fixing hooks (C).

Take care not to damage the hook and bracket.

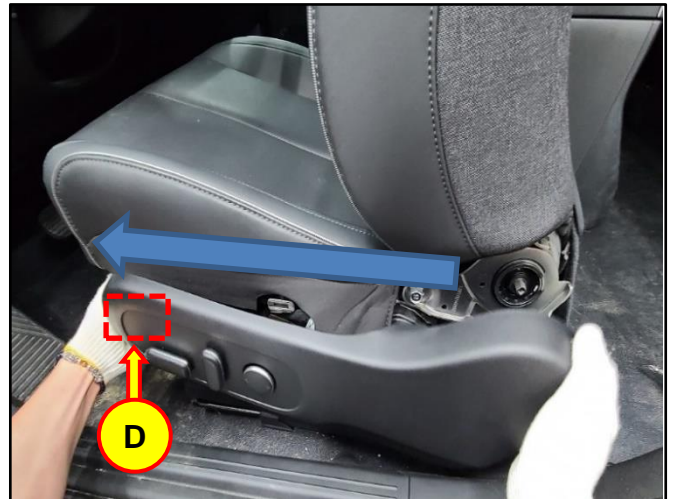
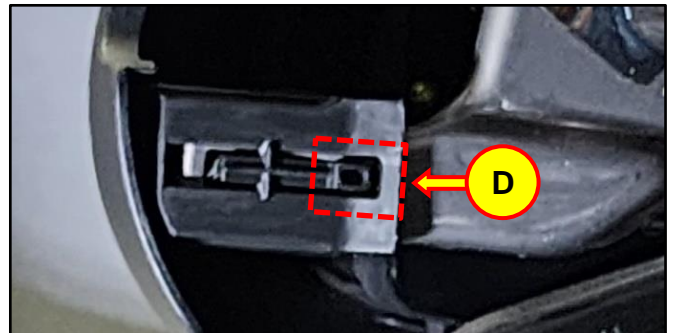
5. Remove the front seat shield outer cover by pressing the lock key (D) and pulling it in the direction of the arrow.

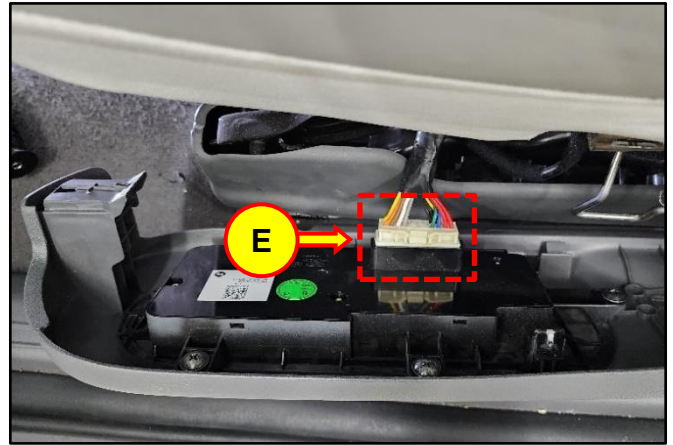
6. Disconnect the front seat power switch connector (E).

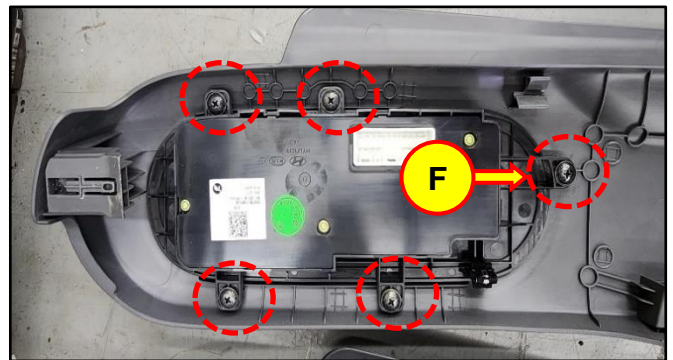
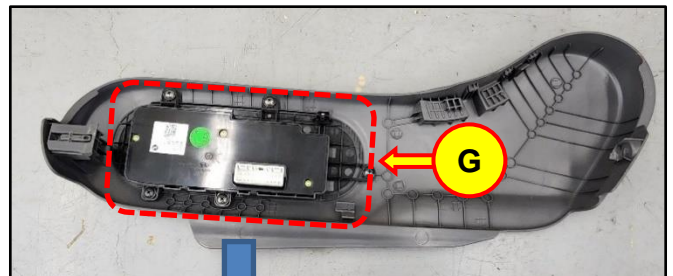
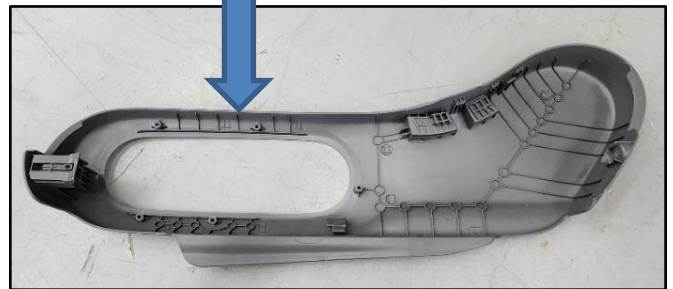
7. Loosen the 5 mounting screws (F) and remove the front seat power switch (G).

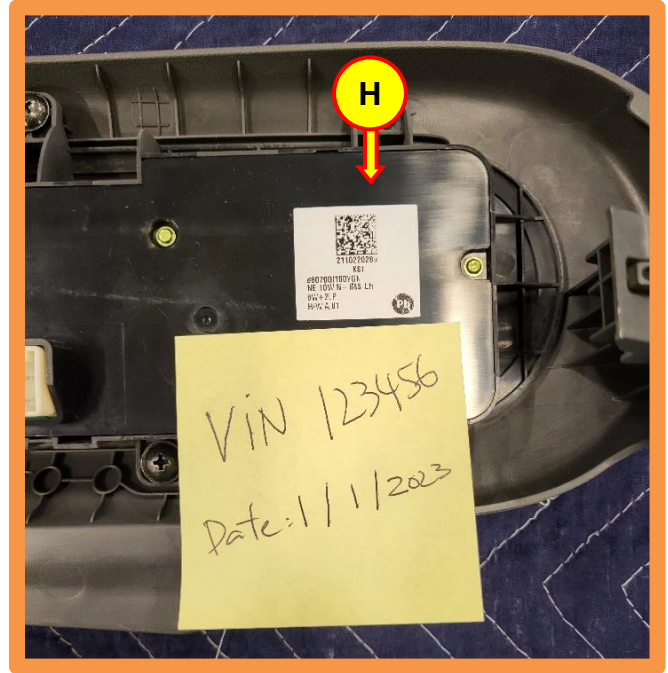
8. Install the supplied front seat power switch (H) onto the front seat shield outer cover.

Using STUI, take a photo of the new power switch with the last 6 digits of the VIN and the date of repair on a piece of paper.

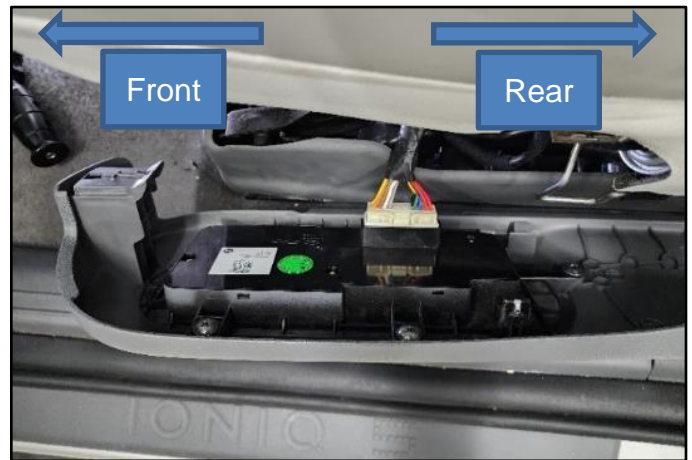
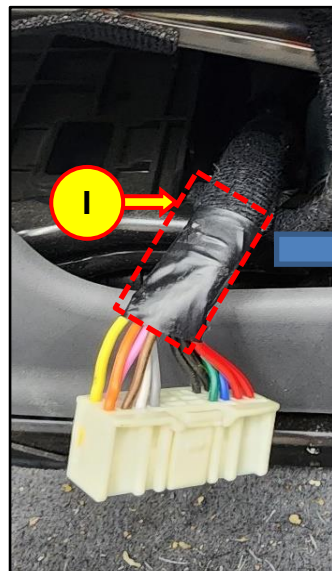
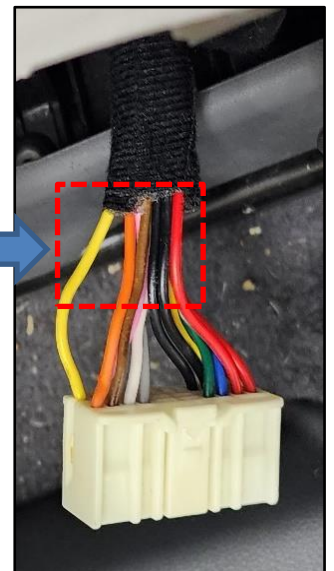
9. Remove the insulating tape (I) wound around the front power seat connector wiring.

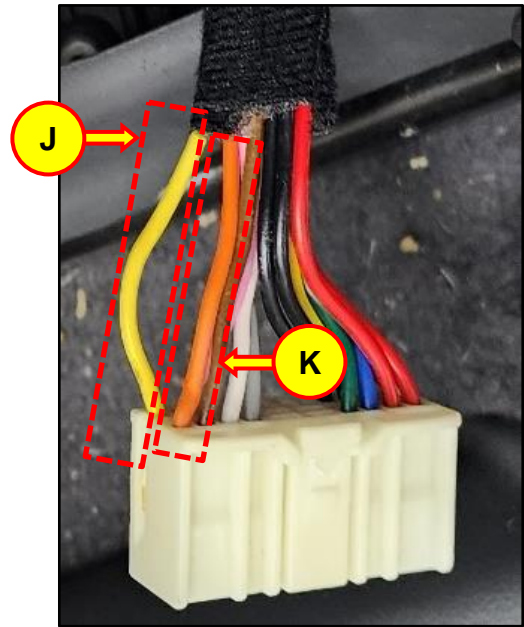
10. Wind electrical tape onto the front-facing yellow (J) and orange (K) wires of the front power seat connector.

Wind electrical tape a minimum of 3 times.

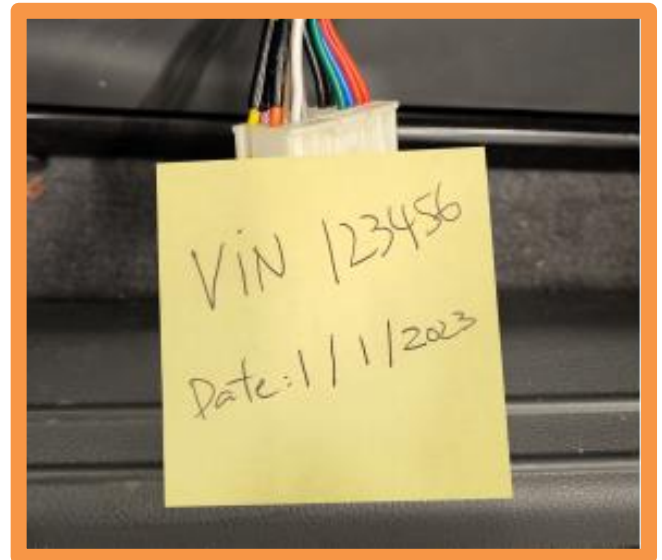
Using STUI, take a photo showing the front 2 wires (J and K) taped with electrical tape with the last 6 digits of the VIN and the date of repair on a piece of paper.

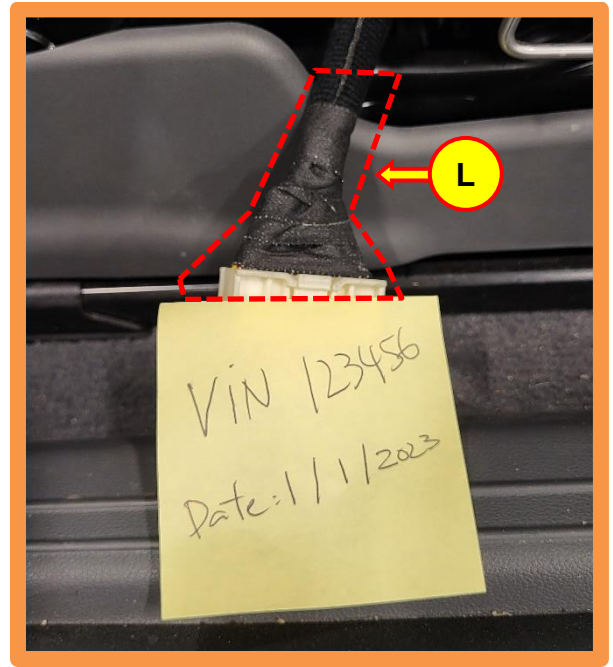
11. Wind the front power seat connector wiring (L) with insulating cloth tape.

Using STUI, take a photo of the taped front power seat connector wiring with the last 6 digits of the VIN and the date of repair on a piece of paper.

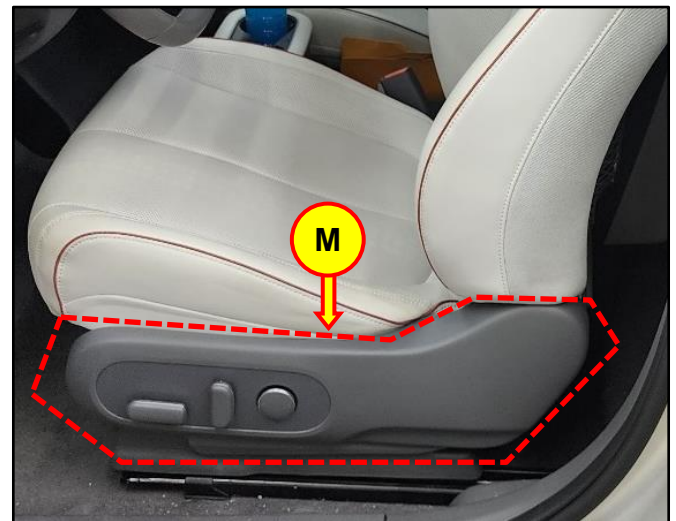
12. Install the front seat shield outer cover (M) in the reverse order of removal.

Reconnect the battery negative (-) terminal.

Check proper operation of the Power Switch module and reprogram radio presets if needed.
