Mack Chassis - Lift Axle Lowers During An Anti-lock Braking System (ABS) Breaking Event Or When Weight Is Added To The 5th Wheel/Rear Suspension- AN Model

Published: 8/30/2023

Valid For:
Mack Model - AN

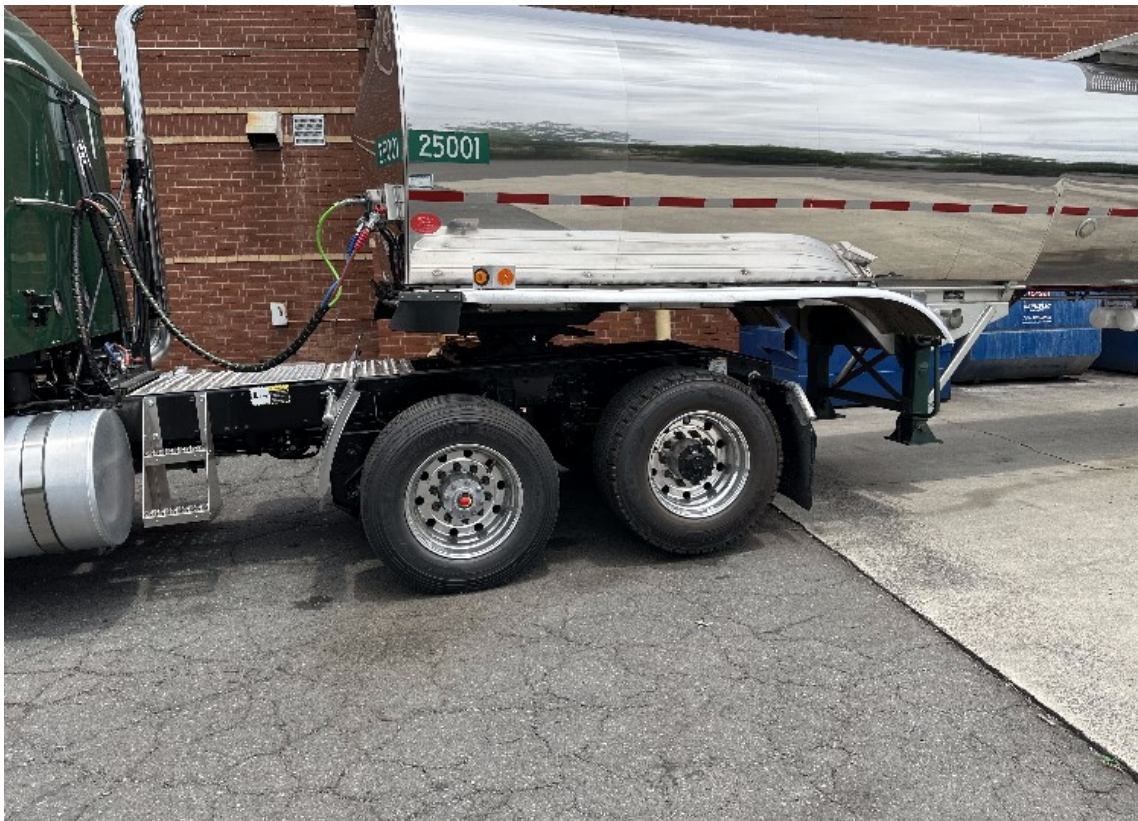
It may be possible for the Electronically Controlled Suspension (ECS) and the ABS circuits to be connected incorrectly, causing the lift axle to lower itself during an ABS breaking event or when weight is added to the 5th wheel/rear suspension. Faults MID 150 SID 24 FMI 4 and/or MID 150 SID 26 FMI 4 may be present.

Inspect and confirm correct assembly of each connector, and verify that the ECS and the ABS connectors are correctly connected to each circuit.

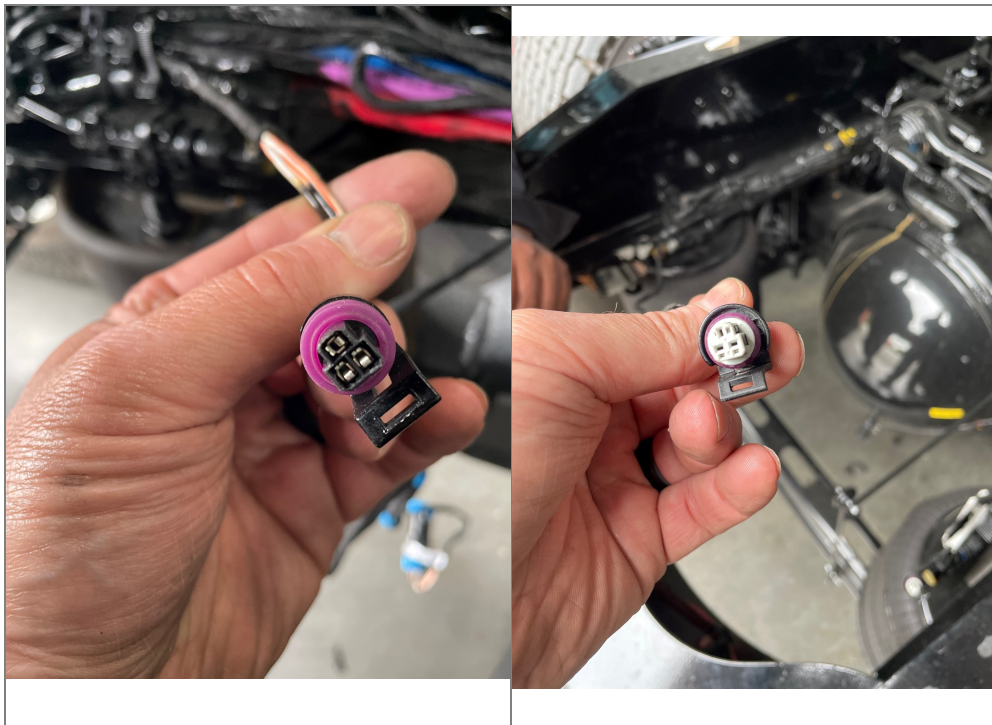
- Pigtail at left front air bag when looking at wiring terminals should be white and the pigtail at the left rear airbag when looking at the wiring terminals should be black.

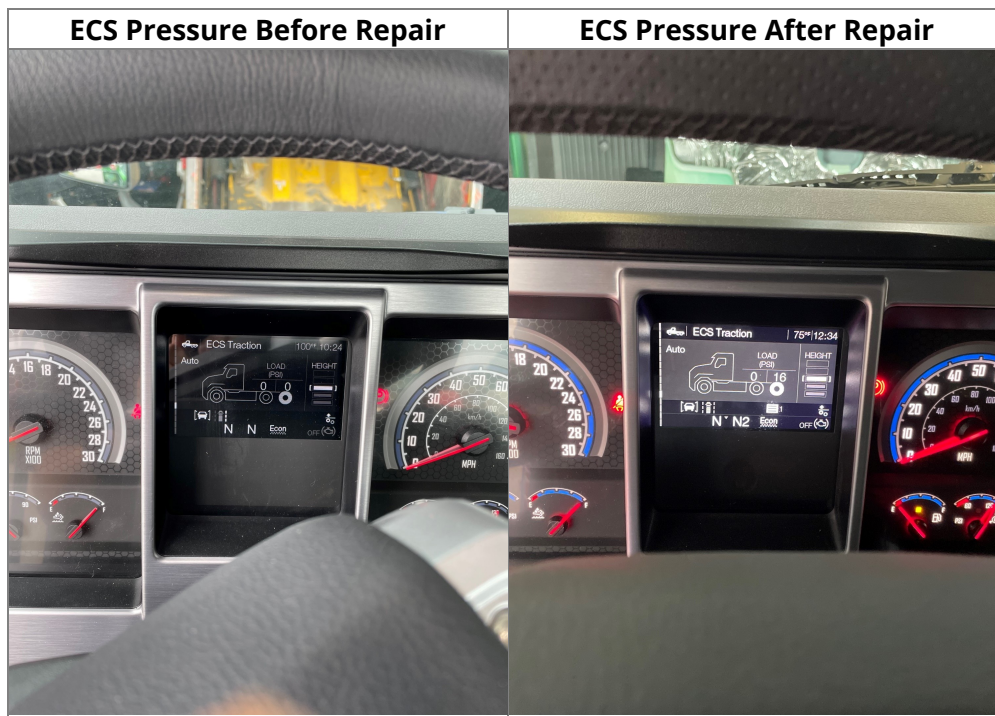
- ABS pigtails (white connector looking at terminals) need to be at Left Front and Right Rear air bags.
- ECS pigtails (black connector looking at terminals) need to be at Left Rear and Right Front air bags.
