# Airstream Service Bulletin

Bulletin Number: 198

Product Line: **Model Year 2023 & 2024 Basecamp 16', 20' & REI**

Subject: **Suburban Water Heater Misfire**

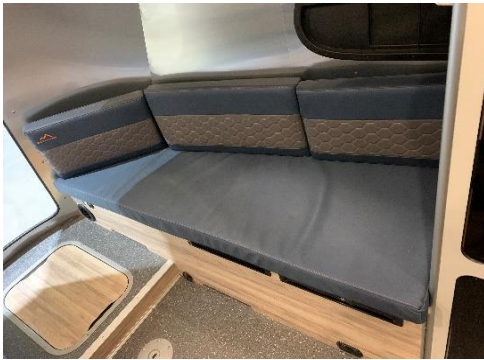
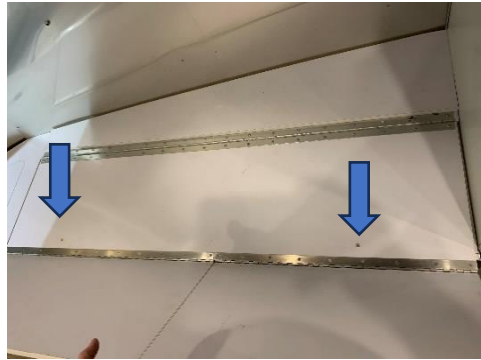
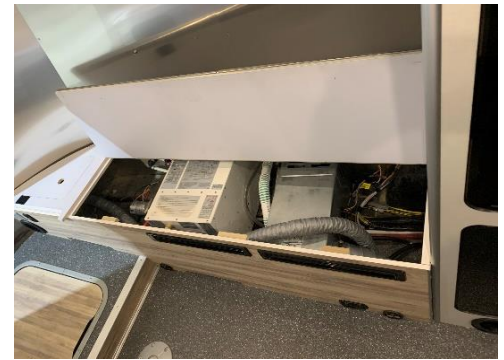
To access the Suburban water heater, remove the road side bench seat cushions. Unfold the bed top to access, and remove, two screws that attach the top to the bench.

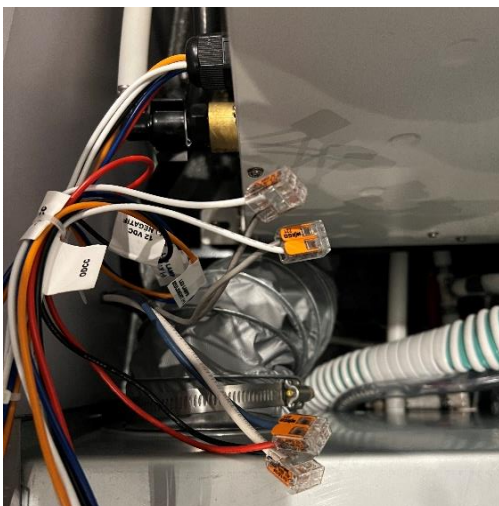
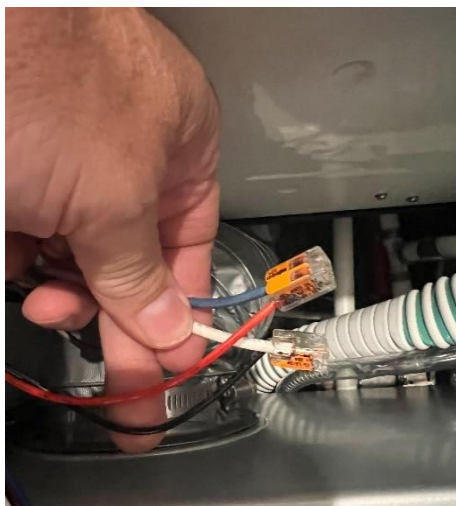
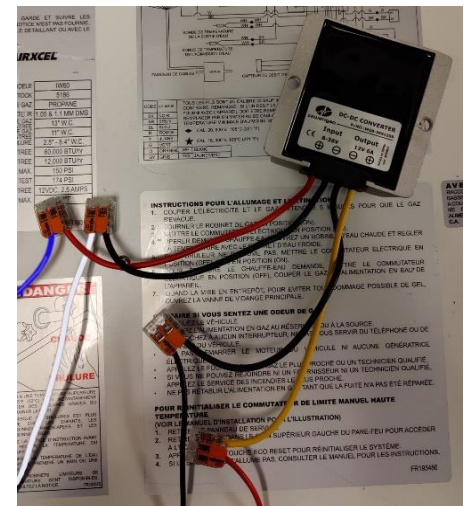
With the battery disconnect turned off, locate the positive blue wire and negative white wire for the furnace.

Install the DC/DC converter (part number 514386) by connecting the following wires:

1. Connect the blue power wire to the input red wire.
2. Connect the white ground wire to the input black wire.
3. Connect the red wire to the output yellow wire.
4. Connect the black wire to the output black wire.
