### **Rosenbauer America Technical Service Bulletin TSB-23002**

**Subject:** Rosenbauer has identified some cylinders in our aerials that need their set screw inspected and possible repair.

**Date:** 08/22/2023**Editor:** JCarpenter**Form ID:** WI23001**Subject: Set Screw in Extension Cylinders**

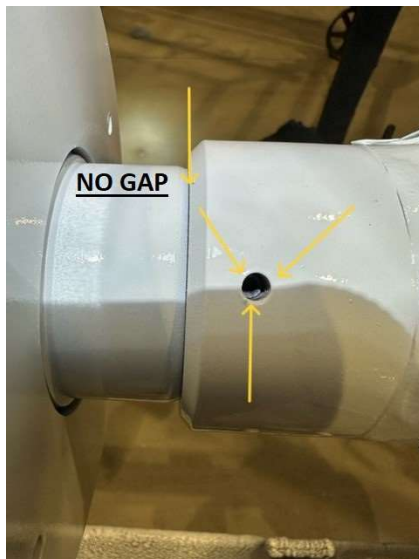
Fig. 1

1. Verify that both extension cylinders have the set screw (see Fig. 2) in the lug at the end of the rod, and there is no gap between the rod and lug (see Fig. 1).
2. Verify the set screw is tight in the cylinder with the allen wrench (see Fig. 1).
3. If it is tight and has no gap like Figure 1, take photo for verification of set screw in the cylinder that looks like Fig. 1.
4. Fill out this online form (link: [bit.ly/TSB23002](https://bit.ly/TSB23002)) and upload the photo to the form.
5. If no set screw is in place, proceed to the installation portion on page 2.
6. If there is a gap between the rod and the lug, proceed to the repair portion on page 3.

- b) Use an allen wrench to tighten jam nut.
15. After following these steps, it should look like Figure 1 on page 1. Please take photo for verification of set screw and submit via the online form (link: [bit.ly/TSB23002](https://bit.ly/TSB23002)).

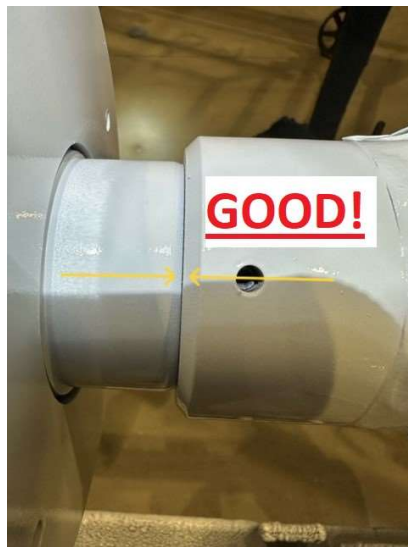
Fig. 3

1. If the set screw is missing verify that the lug has not backed out (see Fig. 4) and there is no gap (see Fig. 3).
  - a) If there is no gap, apply the blue Loctite to the set screw and insert the set screw into the hole then tighten with the allen wrench.
    - After the screw is installed and it looks like Figure 3, take a photo and submit with the online form (link: [bit.ly/TSB23002](https://bit.ly/TSB23002)).
  - b) If there is a gap (see Fig. 4) proceed to Lug Repair on page 3.

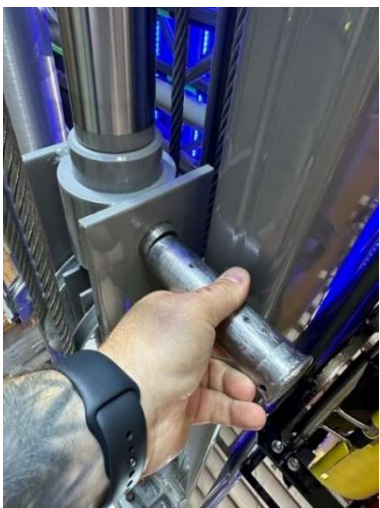
Fig. 5

- A. (1) 1/8" allen wrench
- B. (1) 5-32" allen wrench
- C. (1) 9/16" wrench
- D. (1) Hammer
- E. (2) 7/16" wrenchs
- F. (1) Small prybar
- G. Universal grease
- H. A bar that is smaller than the pin that you are removing from the traveler so you don't damage the pin when removing. (see Fig. 5)

1. Extend the ladder out a foot at 0° elevation, then turn truck off.
2. Verify that the lug has a gap.
3. Remove retaining bolt, use the small bar and hammer and drive this pin out.
  - Be careful not to hit the paint.
4. Locate the extension cylinder counterbalance valves(see Fig. 6)
