# Service Campaign 73-04

**AFFECTED:** 2023 Vista, Sunstar & Adventurer

**SUBJECT:** Window Trim Rings & Taillight Sealant

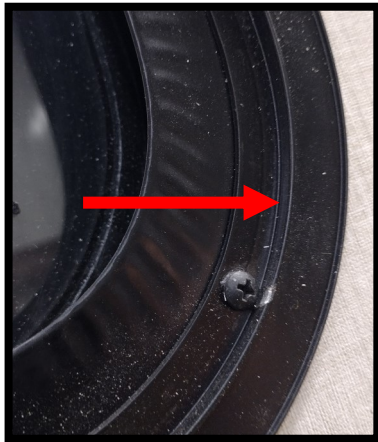
**Fig 1 - INCORRECT** installation - trim ring steps out away from the installer.

1. Inspect all windows in coach (excluding sliding cab windows) to ensure the interior trim ring is placed in the proper orientation. The trim ring should 'step in' towards the installer. If found to be oriented wrong (Fig 1), remove the trim ring and reverse the orientation (Fig 3). Fig 2 shows the orientation from the supplier print.

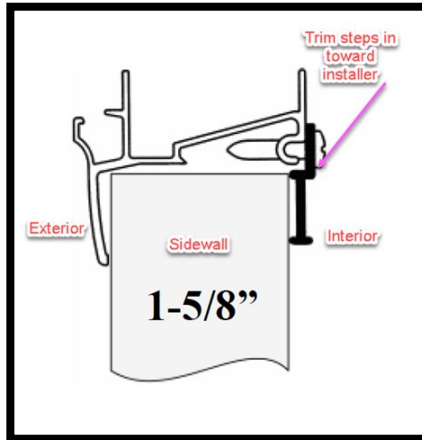
**Fig 2 - Trim Ring orientation** from supplier print.

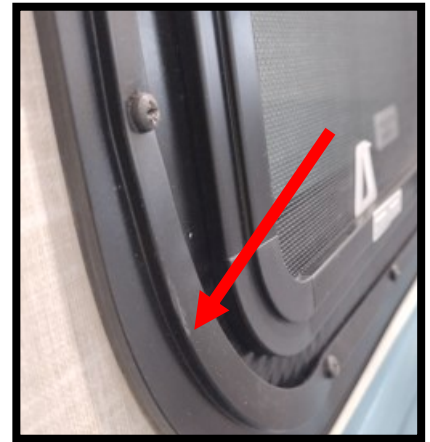
**Fig 3 - CORRECT** installation - trim ring steps in towards the installer.

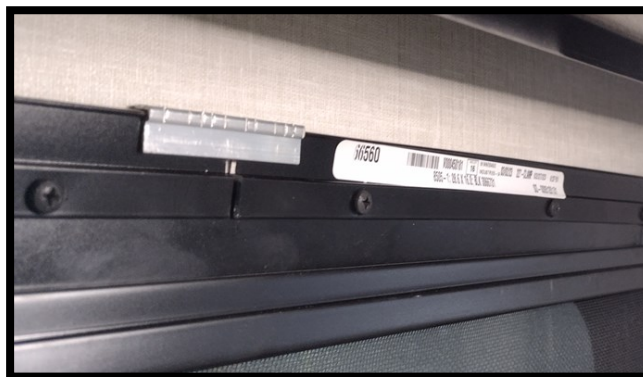
**Fig 4**

2. Remove any labels that are not concealed by window treatments.

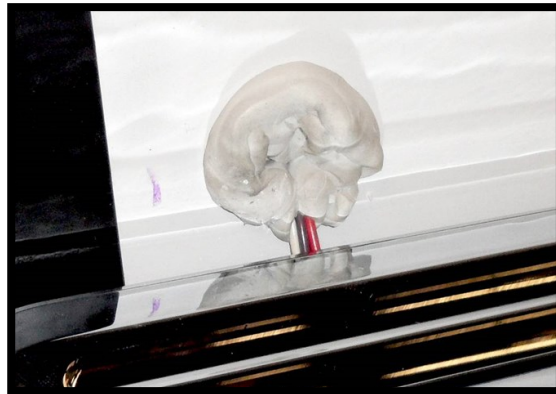
**Fig 5**

3. Remove taillight pods and inspect to see if they are sealed. If properly sealed, skip to Step 6. If not sealed, follow sealing procedure below.
4. With taillight pods removed, place a backing material such as foam or butyl tape into the hole for the wires and ensure there are no voids. This material is intended to provide a backing for the sealant in the next step. (Fig 5)

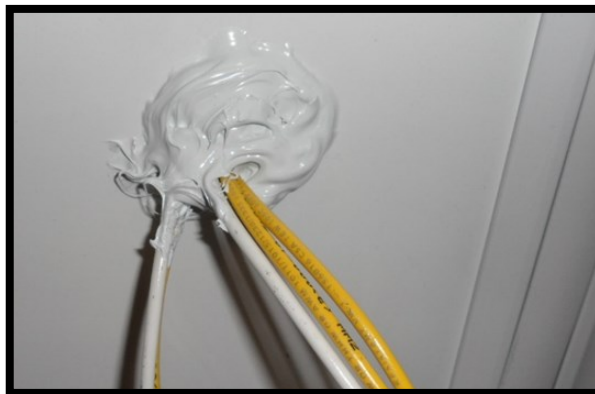
**Fig 6**

5. Cover the wire hole with sealant. The sealant should be tooled to completely surround each wire and cover the entire hole, including the edges. Ensure sealant completely encapsulates each wire and there are no voids. (Fig 6)

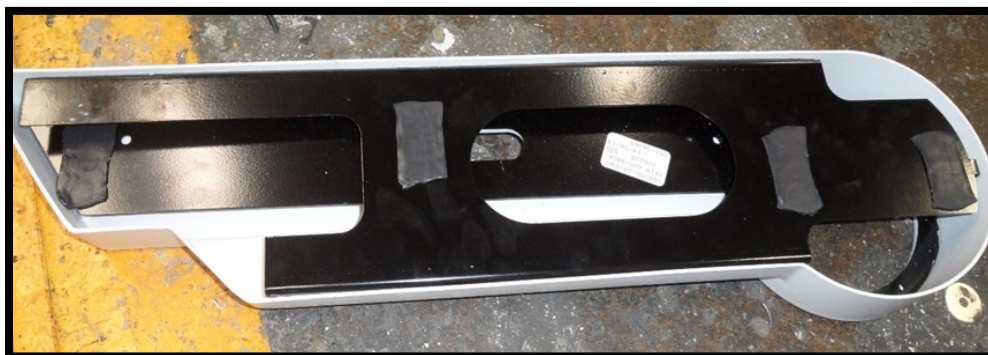
**Fig 7**

6. Place butyl tape over screw holes on backside of taillight pods that go into the backwall when attached. (Fig 7)
