Technical Service Bulletin

Topic	HVAC refrigerant leakage suspected or reports of a damp/musty smell within the cabin - Diagnosis guidelines
Market area	Australia E04 Bentley rest Asia and Australia (6E04),China 723 Volkswagen (Anhui) Automotive CO (6723),China 796 VW Import Comp. Ltd (Vico), Beijing (6796),Germany E02 Bentley rest Europe (6E02),Japan E03 Bentley Japan (6E03),Korea, (South) E08 Bentley South Korea (6E08),United Arab Emirates E06 Bentley Middle East and Africa (6E06),United Kingdom E01 Bentley UK (6E01),United States E05 Bentley USA and rest America (6E05)
Brand	Bentley
Transaction No.	2069806/4
Level	EH
Status	Released for publishing
Release date	Sep 8, 2023

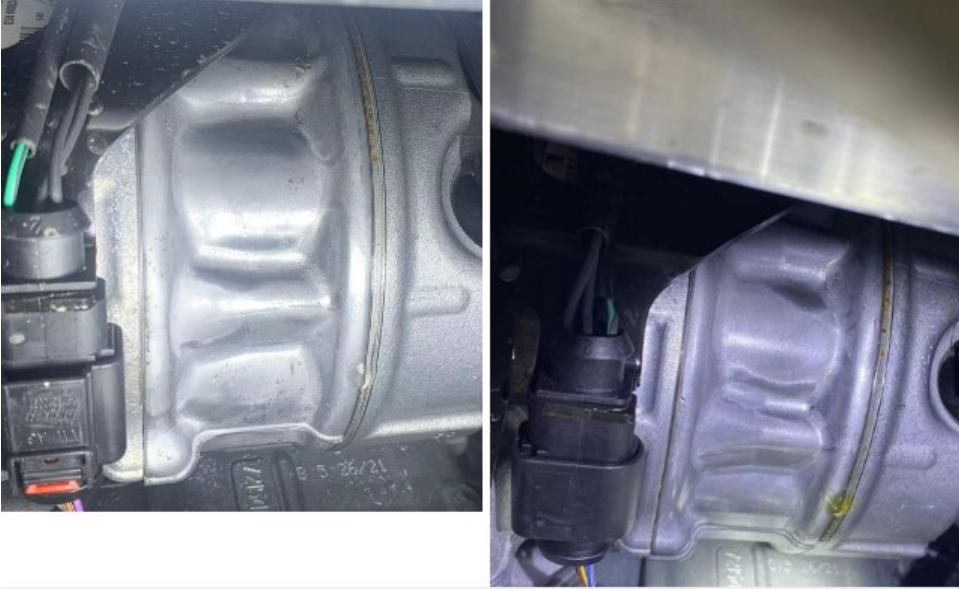
Figure 1

please refer to the examples shown below (Figures 1,2 and 3) of leaks found on the HVAC compressor

The leaks in these scenarios were repaired after component replacement however as the parts were not at fault the actual fix of the leak would have been resolved by replacing O-rings only

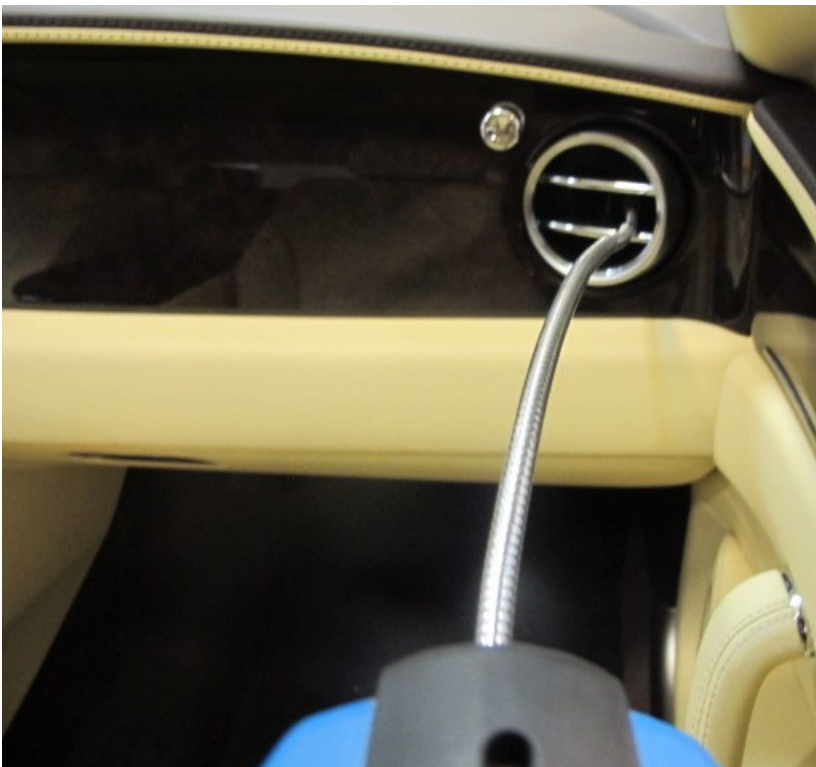
Figure 4

CAUTION
CAUTION: In the event the HVAC sniffer tool traces a HVAC leak from any of the outlets (Figure 4)

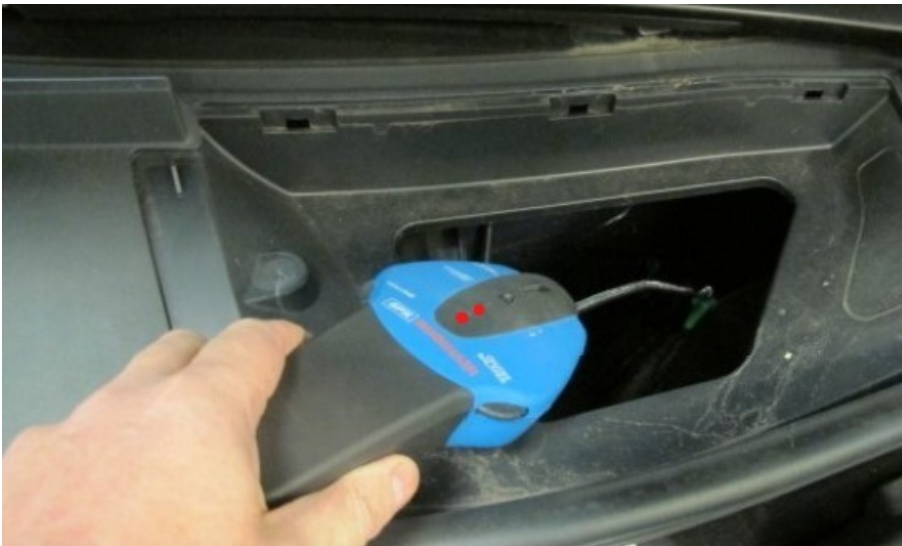
Figure 5

A complaint is received that refrigerant is evident within the cabin the operative MUST first ensure that a leak is not evident within the plenum chamber or around the centre console (Figures 5 and 6) as refrigerant could be leaking into the plenum chamber/cabin and recirculated back into the cabin as this could lead to misdiagnosis and/or incorrect part replacement
